Pipe Segment 2B-23 to 2B-22 – 2/19/2010

Pipe Segment 2B-23 to 2B-22 – 9/11/2014

Pipe Segment 2B-12A to 2B-12 – 3/21/2013

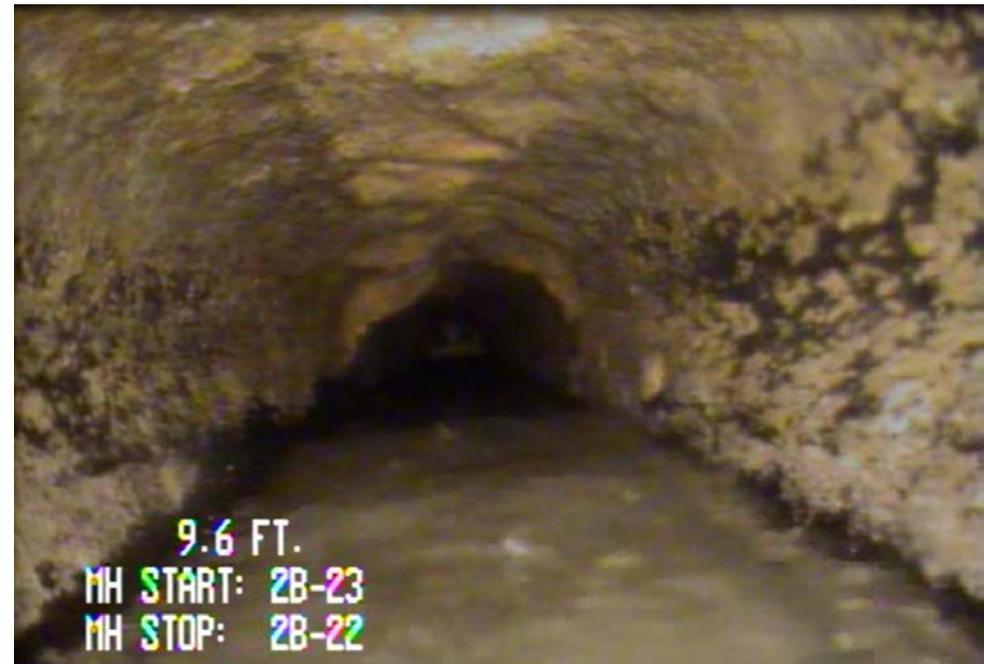
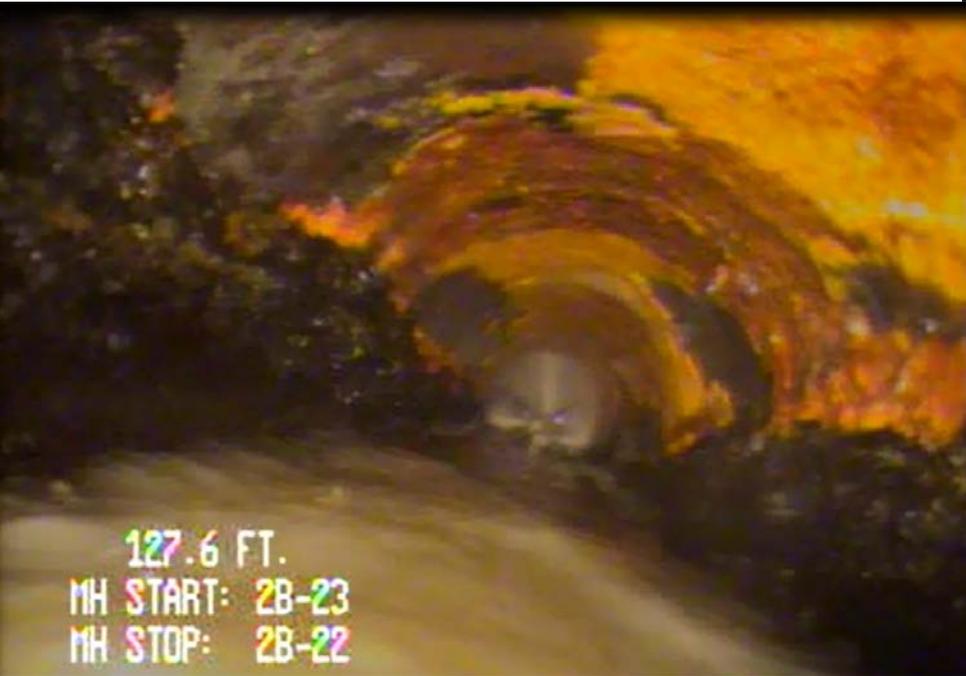
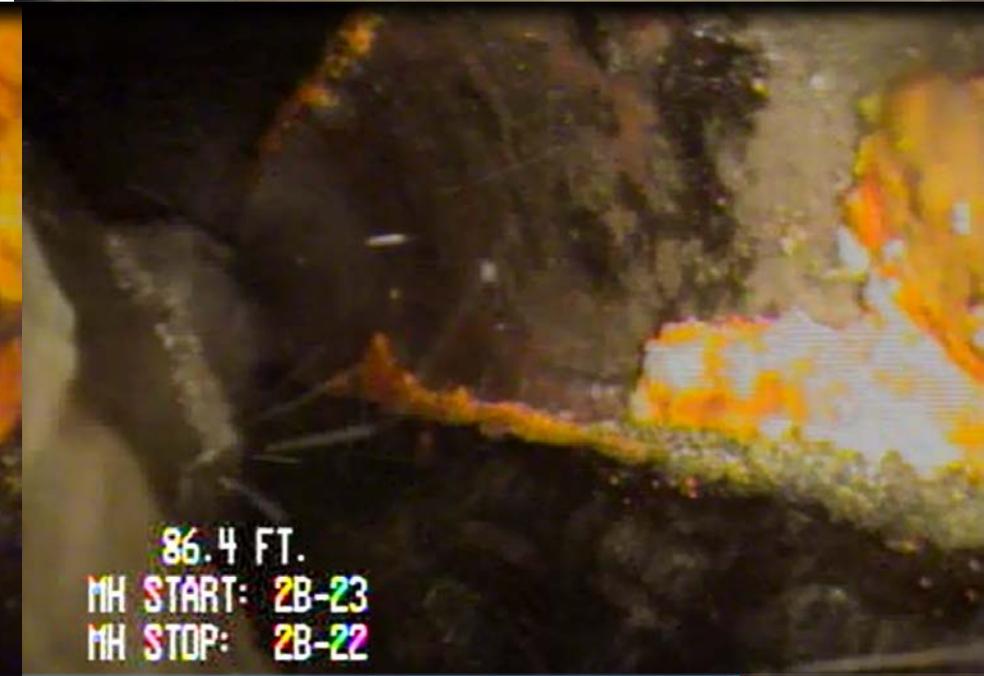
- Reduced capacity due to grease and tuberculation
- Dewatering required to perform television inspection
- Pipe fully surcharges when Cherry Street Pump Station is running

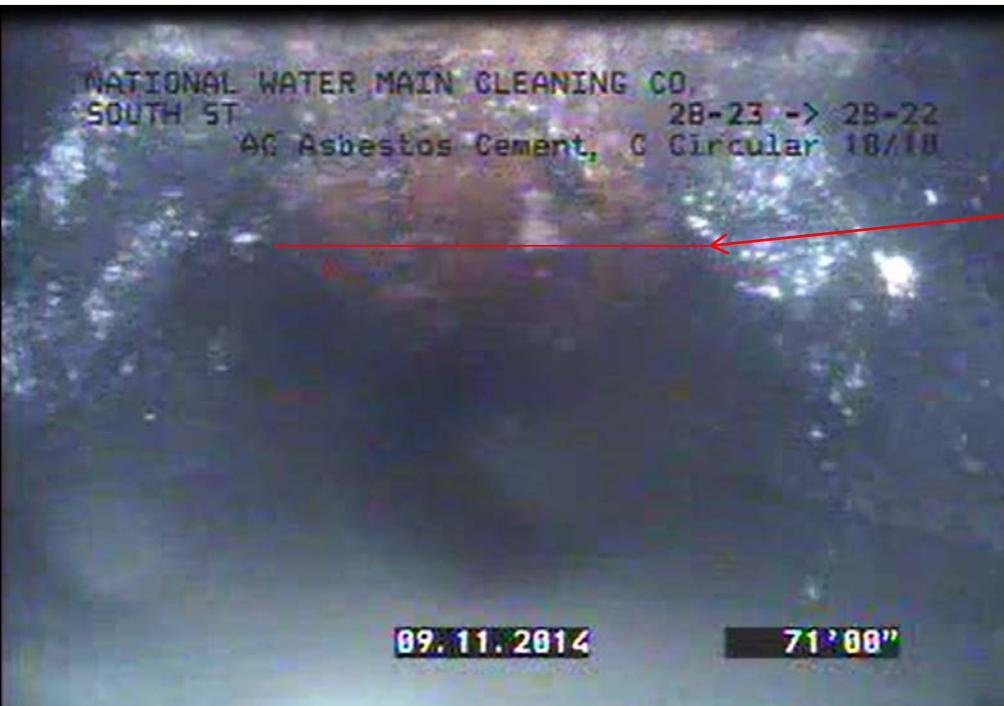
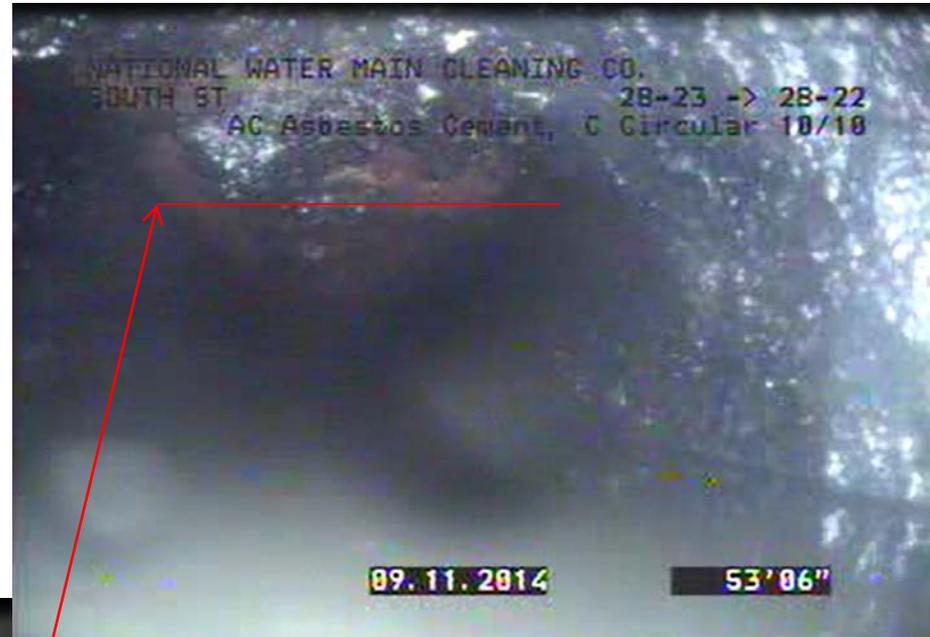
- Reduced capacity due to grease and tuberculation
- Dewatering required to perform television inspection

Approximate flow Level when Cherry Street Pump Station is running

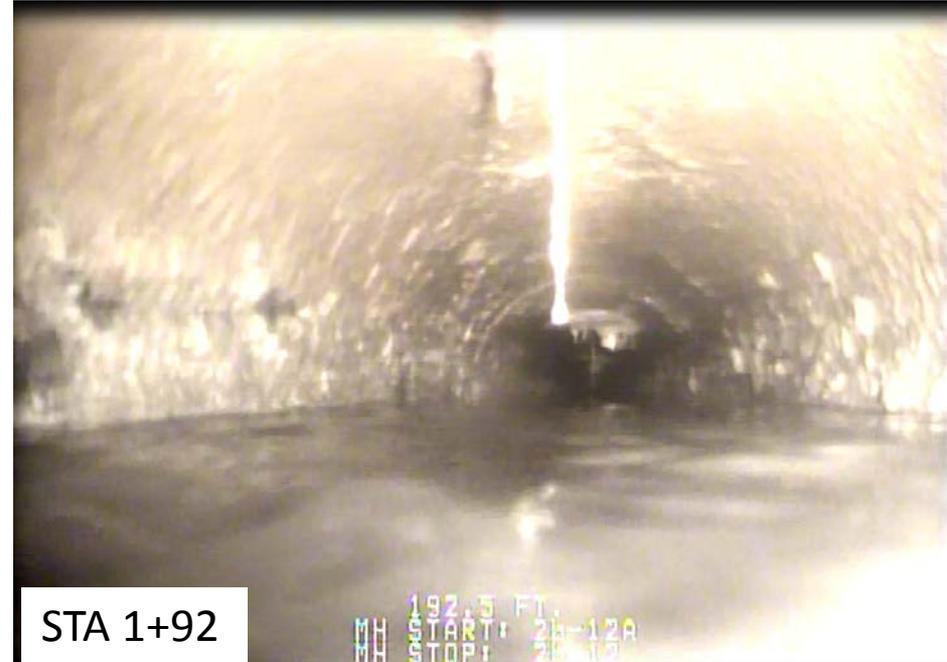
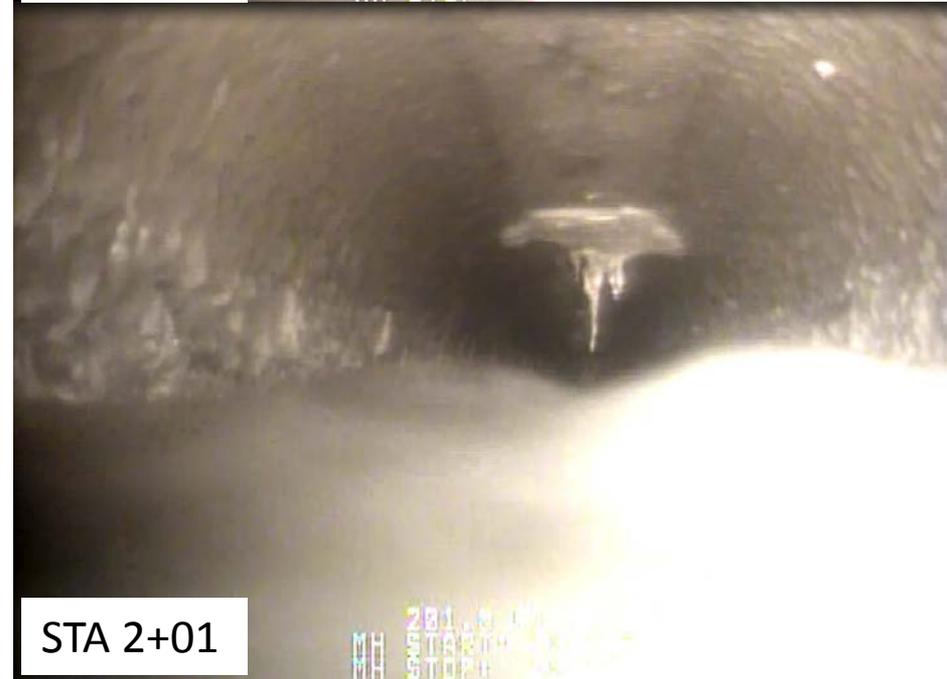
- Water level increases throughout pipe during inspection from March 2013.
- Camera under water at STA 2+05.

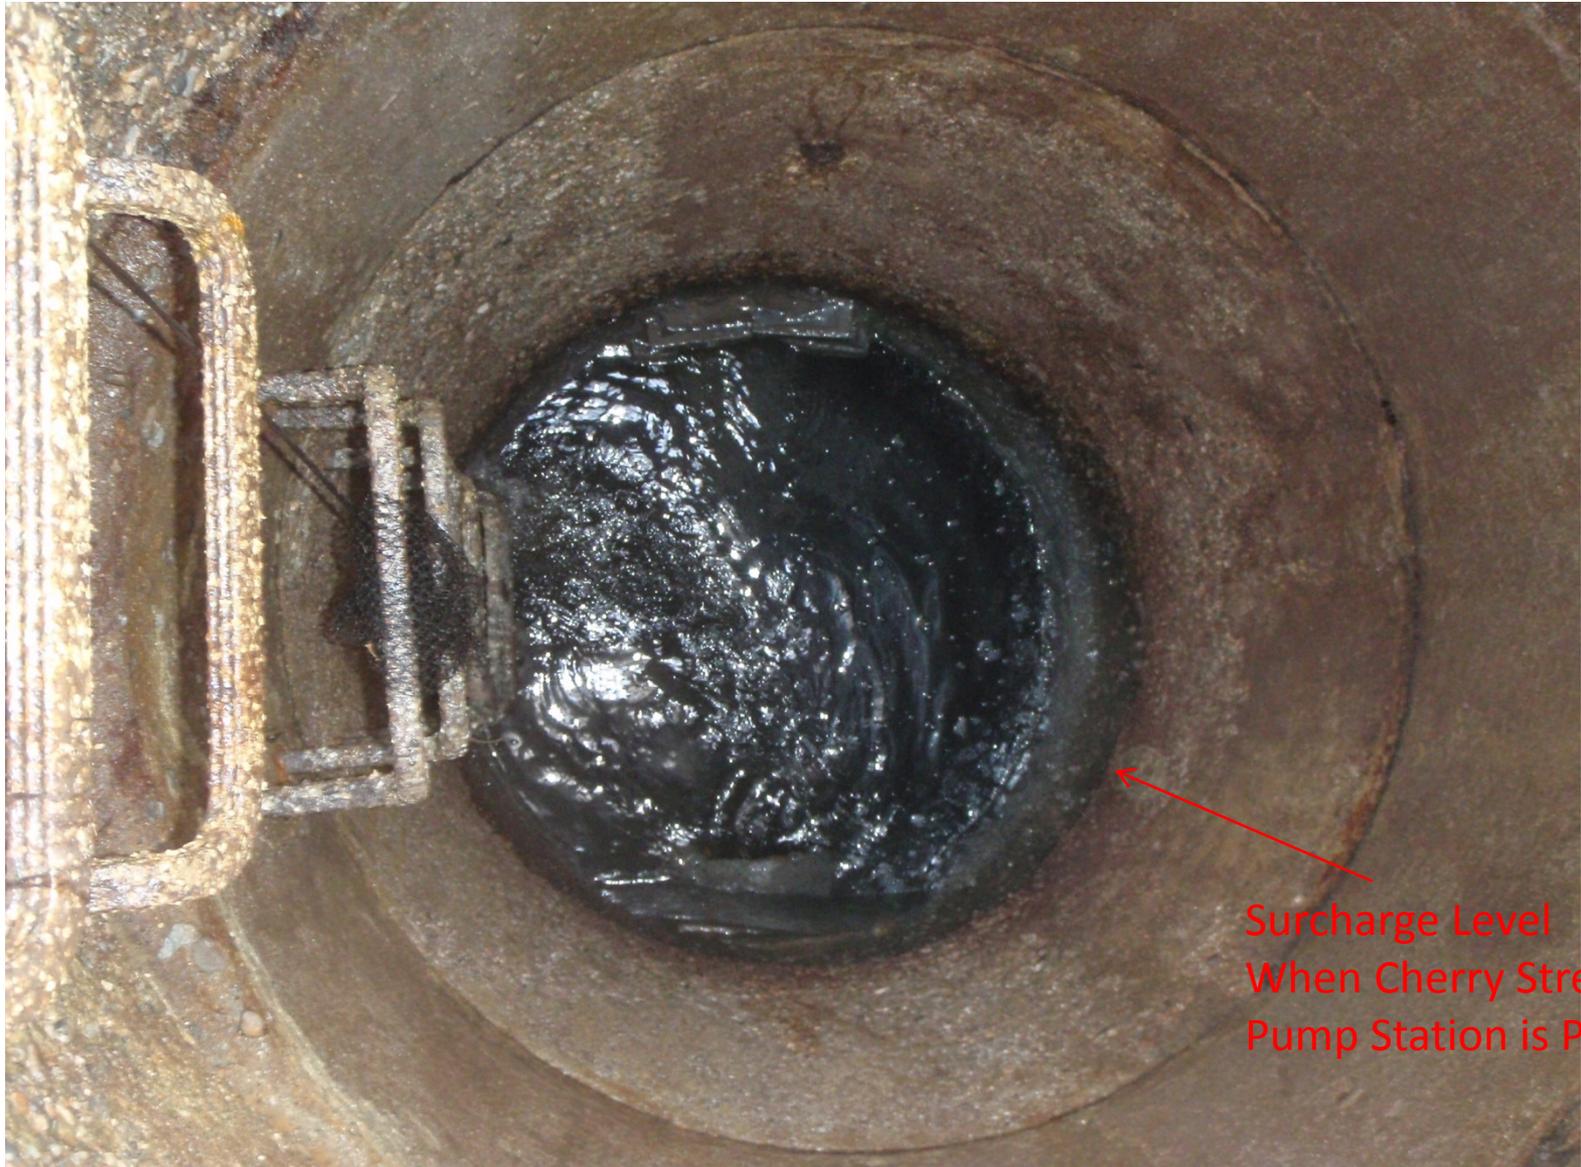
Manhole 2B-23

Surcharge Level
When Cherry Street
Pump Station is Pumping
