**TOWN OF SHREWSBURY**  
FACILITIES CONDITION ASSESSMENT OF  
TOWN BUILDINGS

**FINAL REPORT**

June 1, 2016

**Shrewsbury  
Calvin Coolidge  
Elementary School**

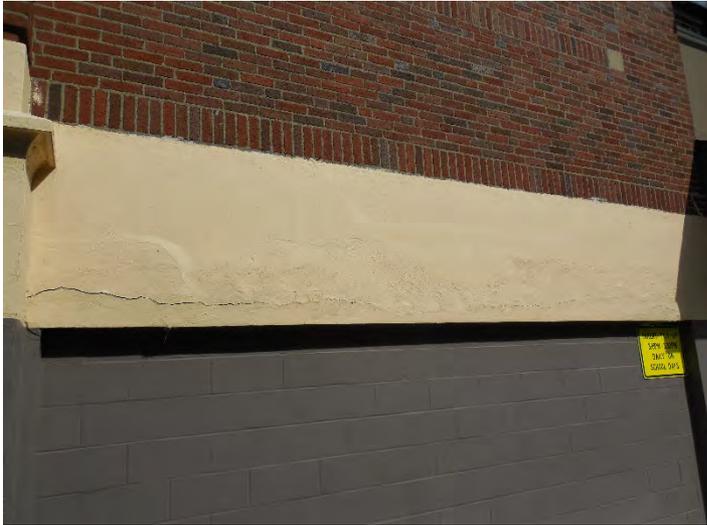
South Elevation, crack in the masonry

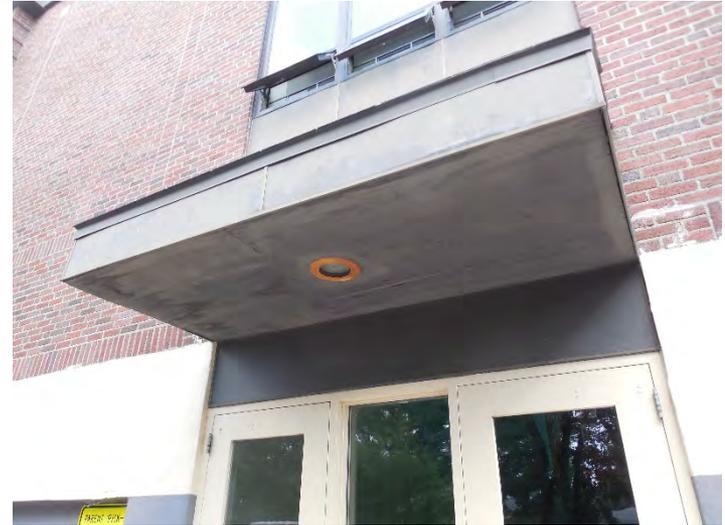
South Elevation, deteriorated plywood soffit

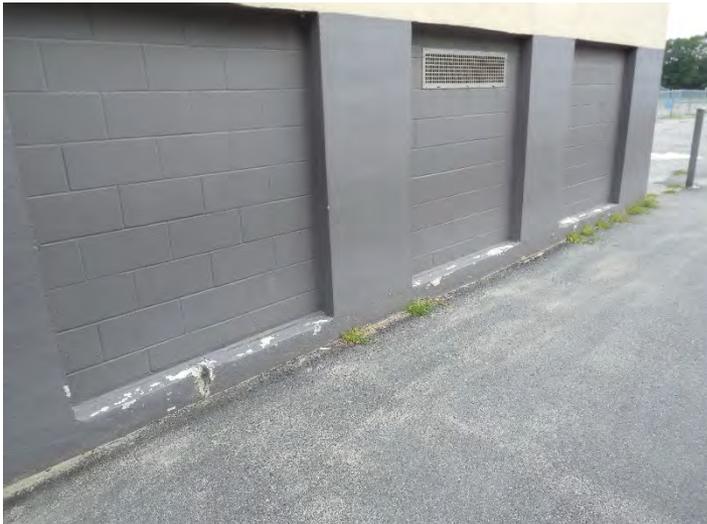
South Elevation, peeling coating and damaged concrete

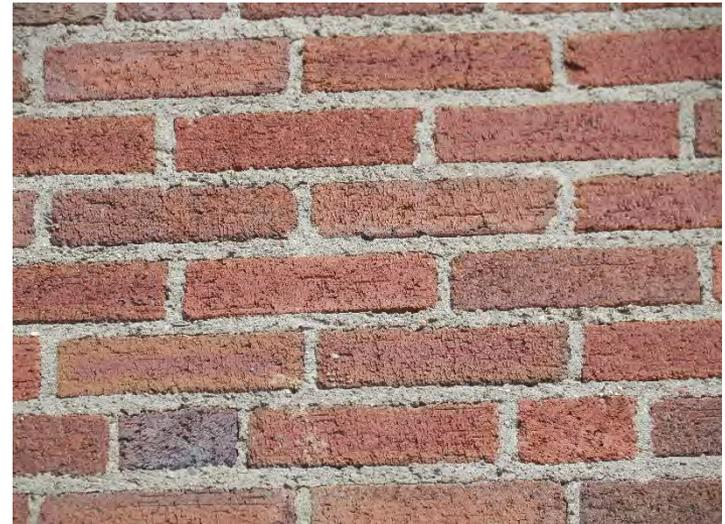
South Elevation, weathered mortar joints

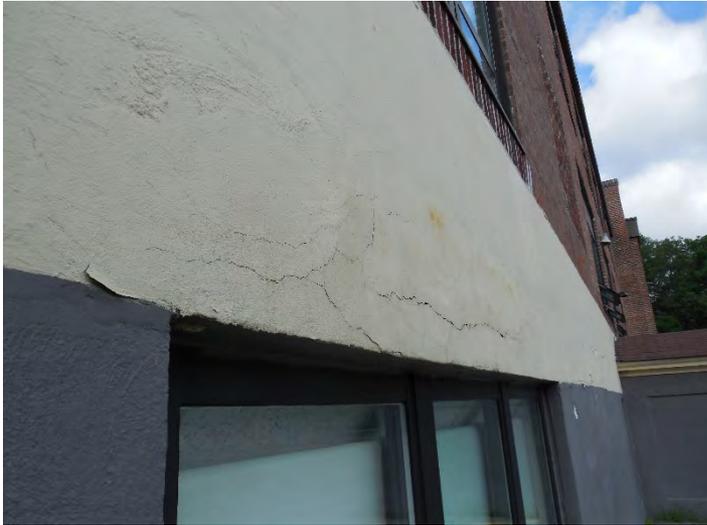
East Elevation, coating is cracked and delaminating

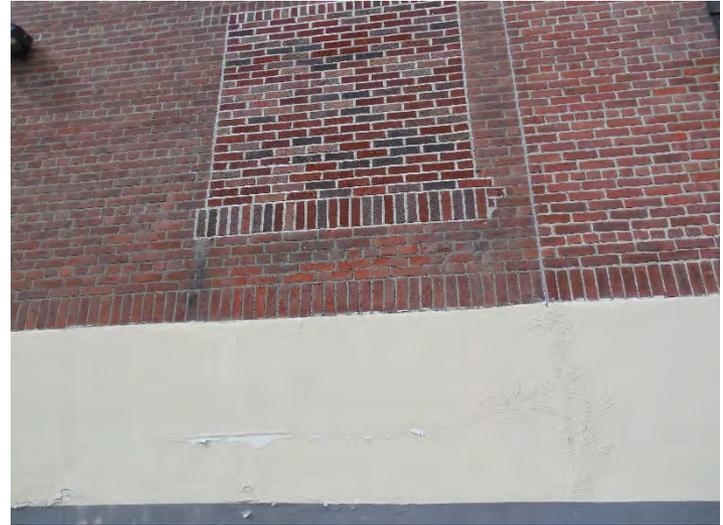
East Elevation, spalled brick and delaminating coating

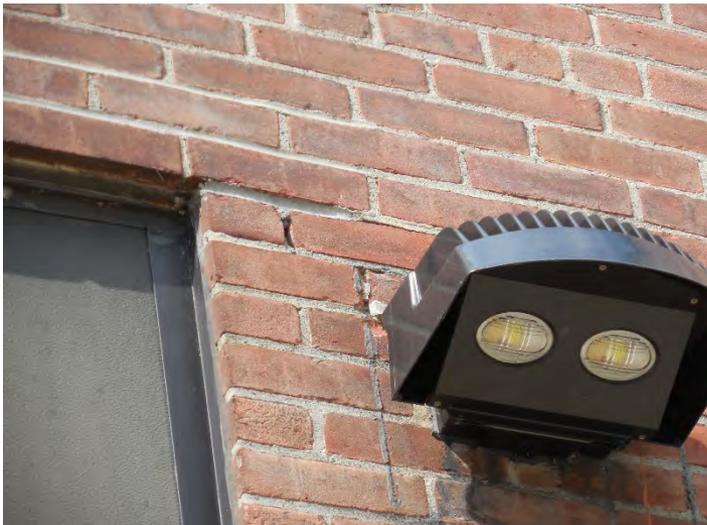
East Elevation, mortar missing

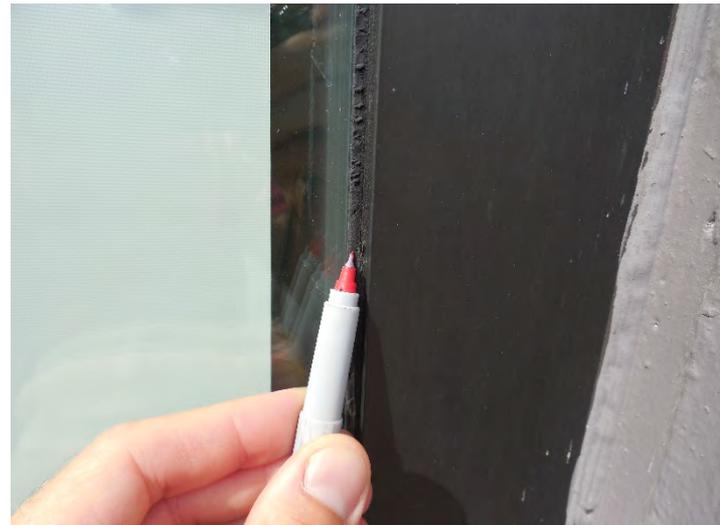
East Elevation, migrated and weathered glazing seal

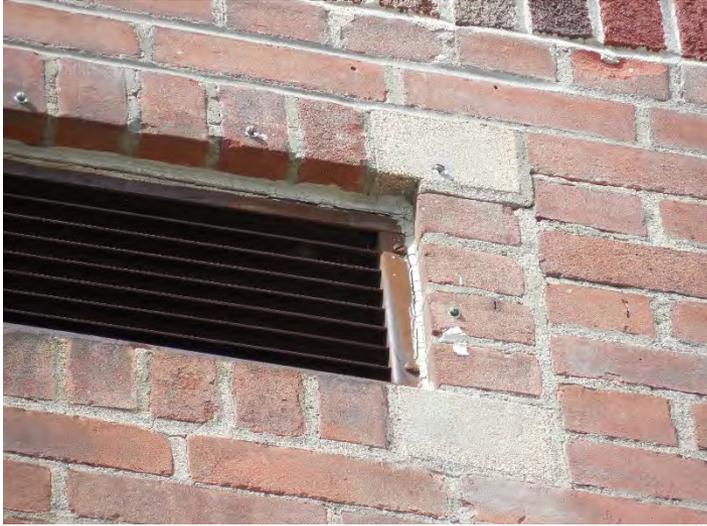
East Elevation, perimeter sealant failure at a louver

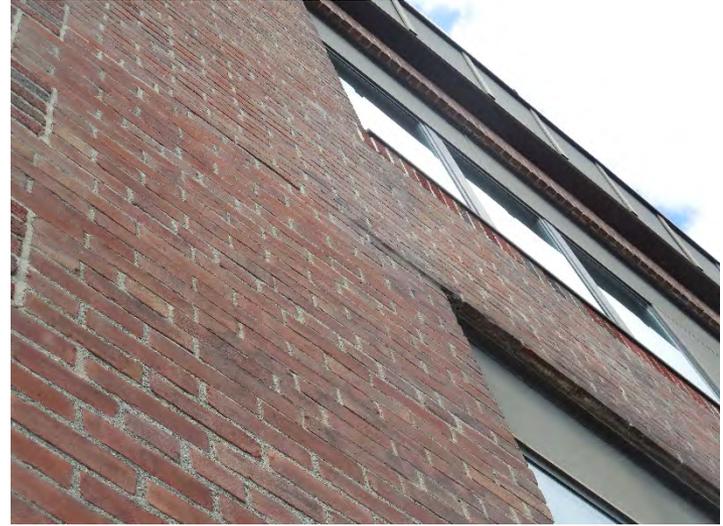
East Elevation, bricks are displaced at lintels

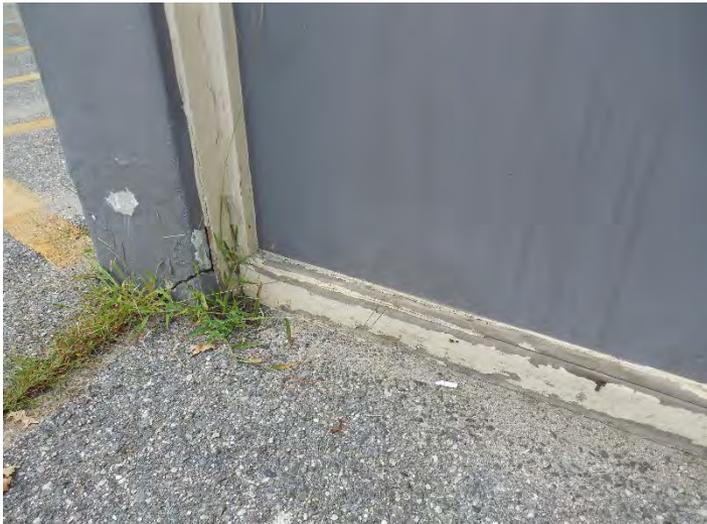
East Elevation, cracked concrete and peeling paint at entry sidewall

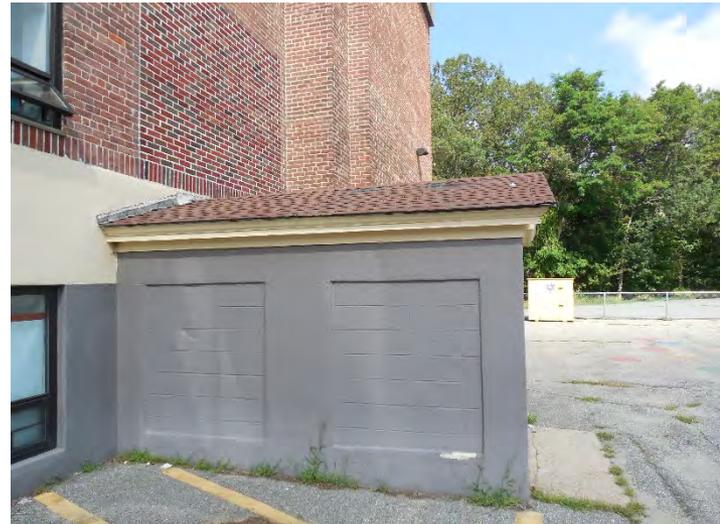
East Elevation, missing/broken shingles at entryway roof

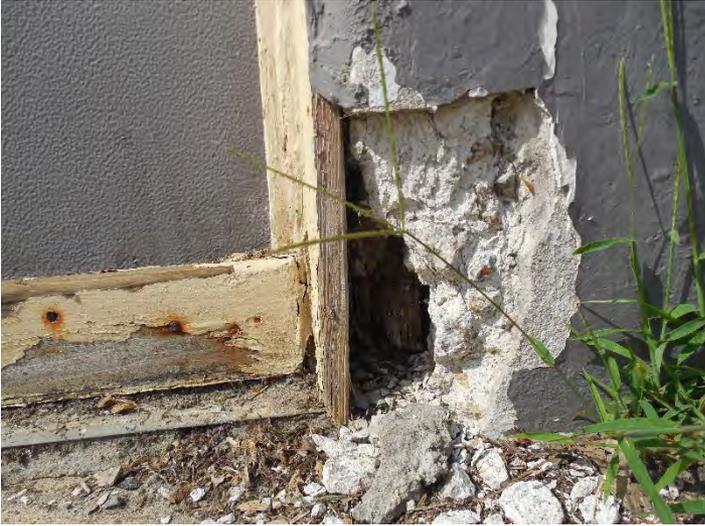
East Elevation, deteriorated masonry and wood at entryway

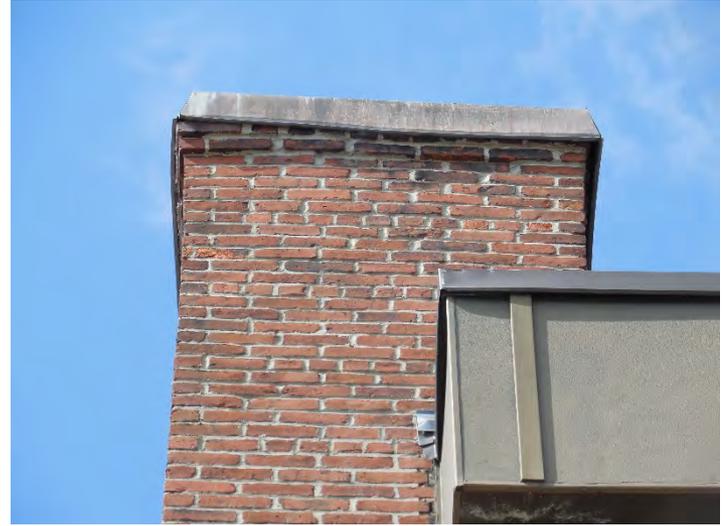
East Elevation, brick chimney masonry is displaced, and flashing is lifted

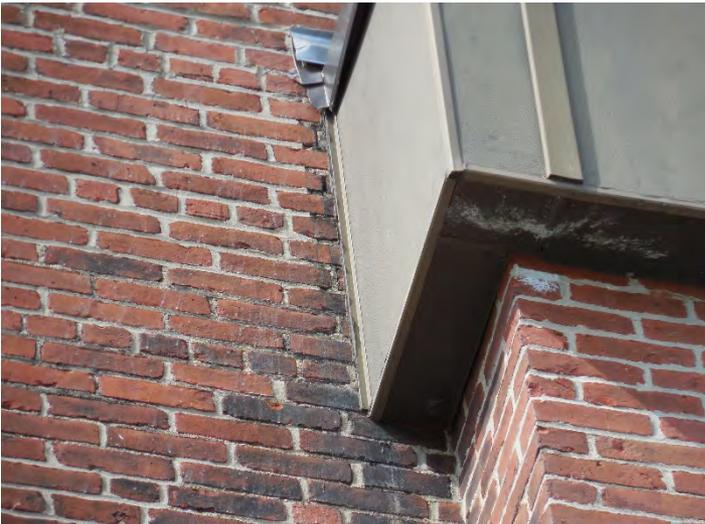
East Elevation, deteriorated mortar joints

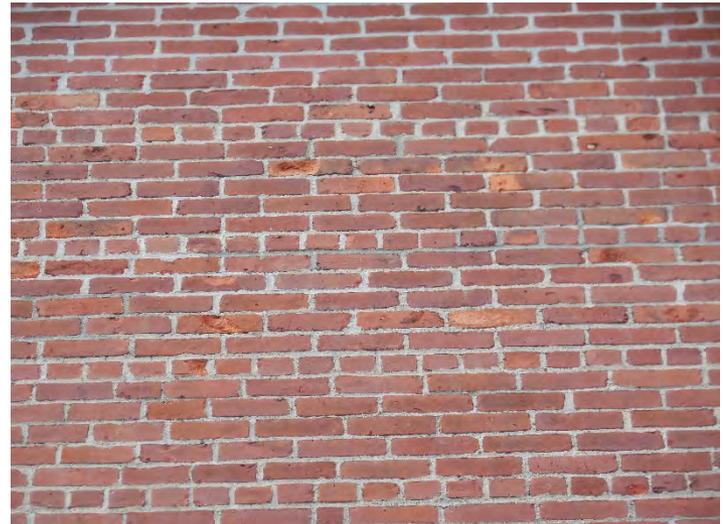
East Elevation, spalled brick faces

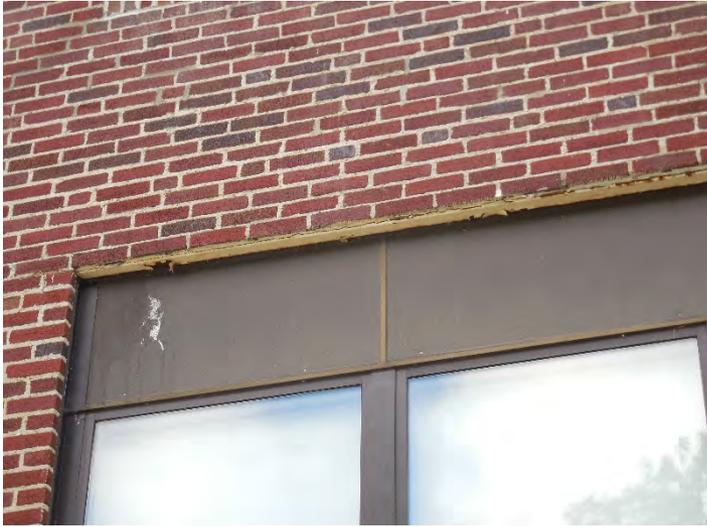
North Elevation, corroded and displaced lintel

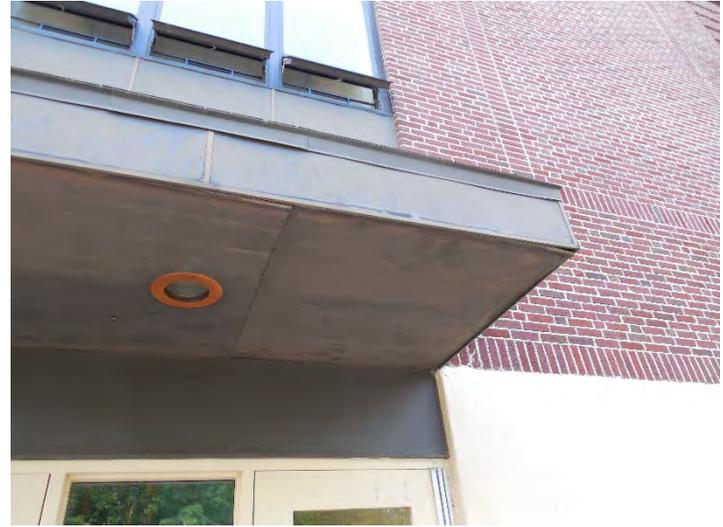
North Elevation, displaced plywood soffit

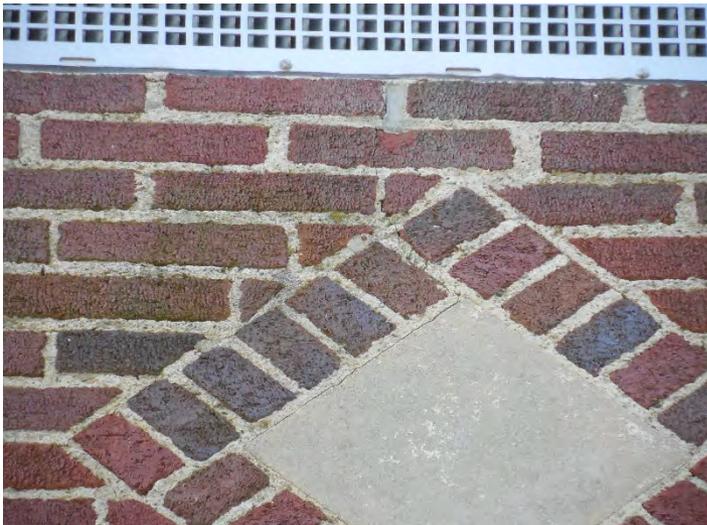
North Elevation, crack in mortar and algae growth on brick

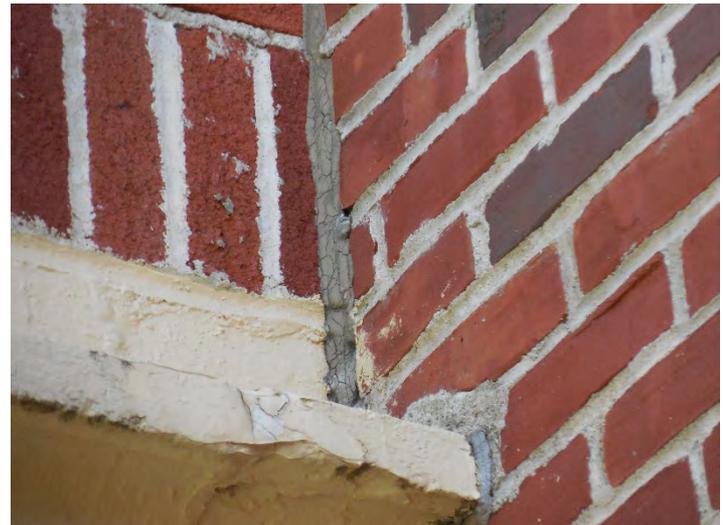
North Elevation, failed sealant at brick expansion joint

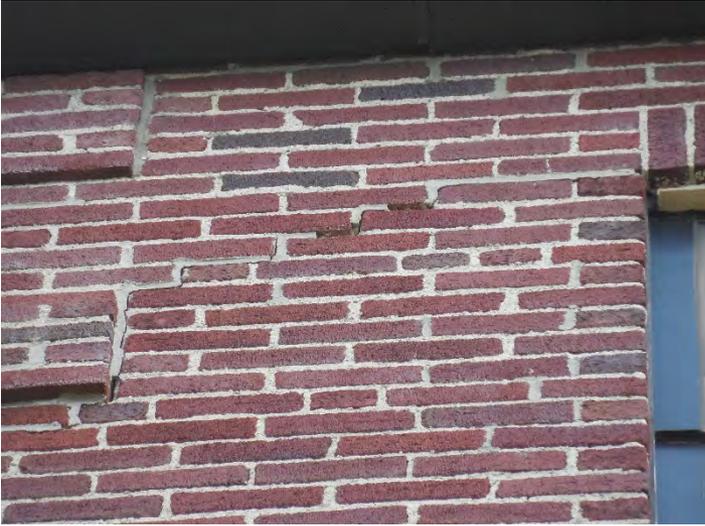
West Elevation, cracked and missing mortar

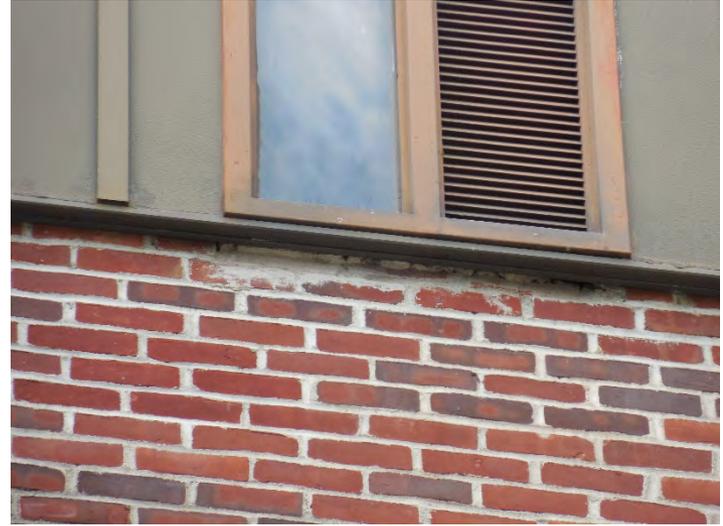
West Elevation, deteriorated masonry below a louver

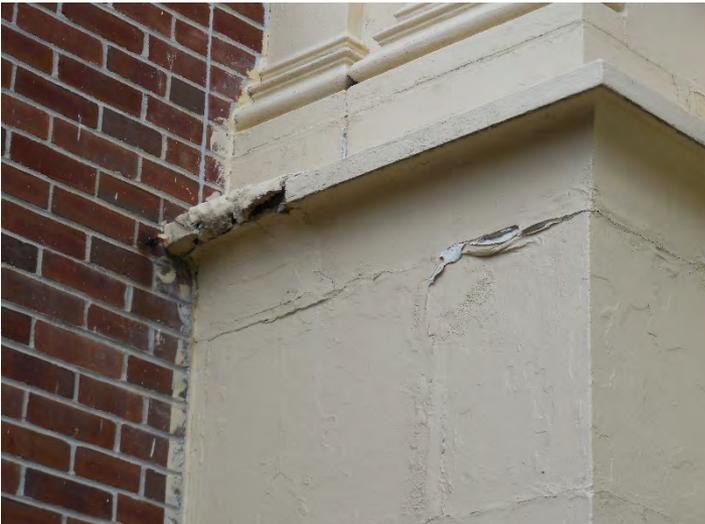
West Elevation, cracked and spalled concrete and delaminating coating

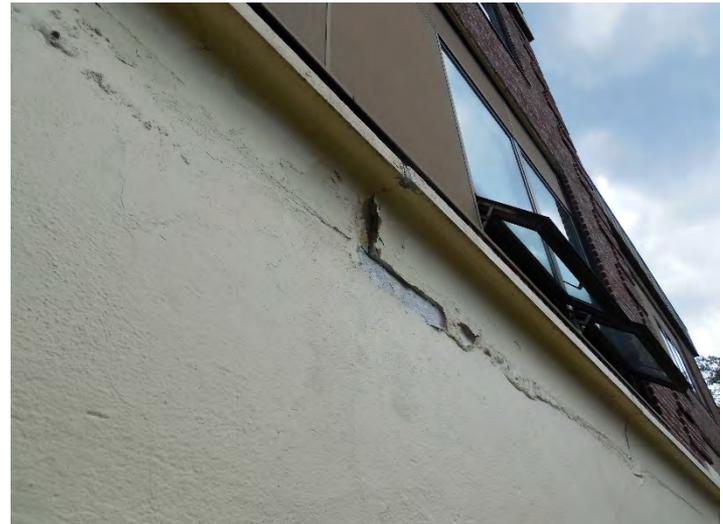
West Elevation, cracked and spalled concrete and delaminating coating

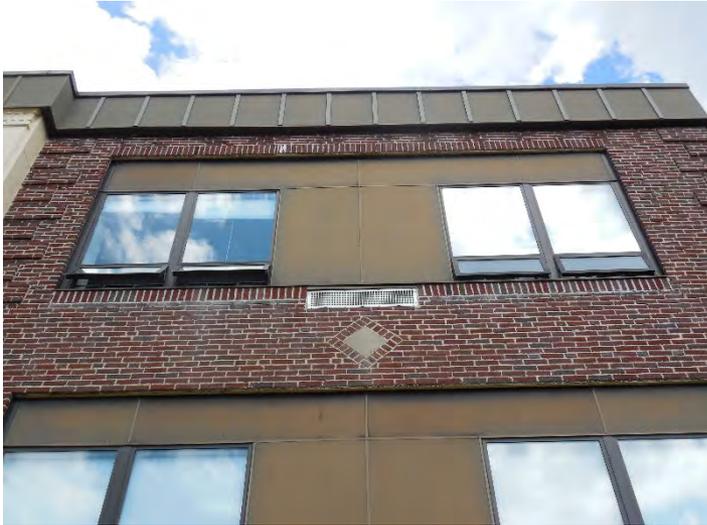
West Elevation, stained masonry, deteriorated mortar, and corroded lintels

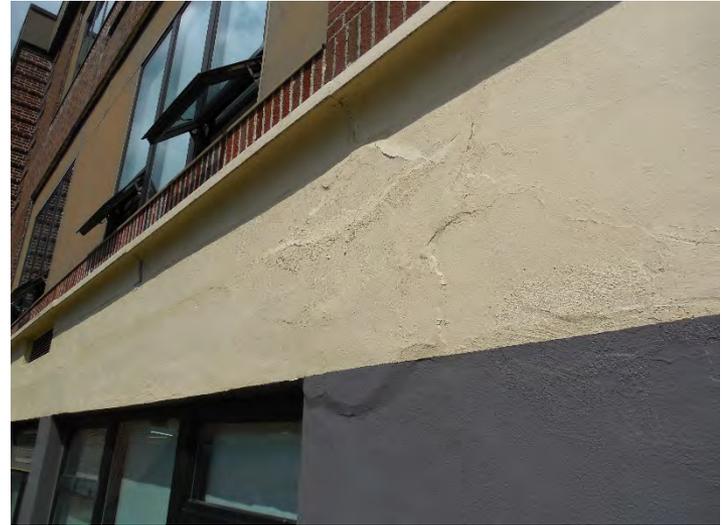
West Elevation, crack in the concrete and delaminating coating

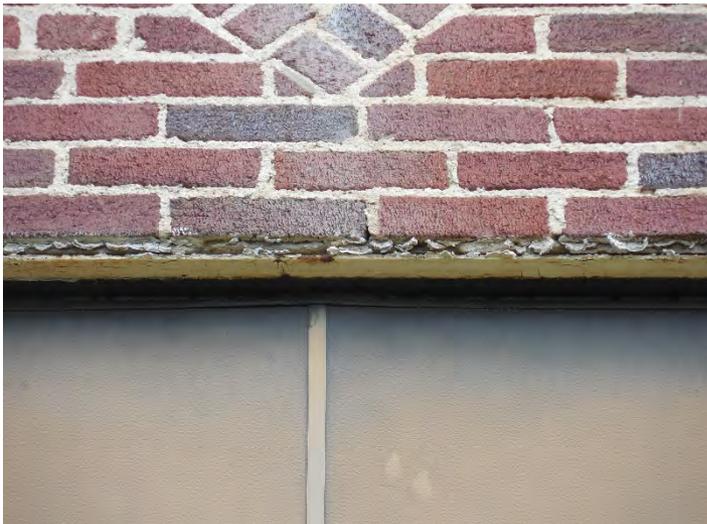
West Elevation, stained masonry, deteriorated mortar and corroded lintel

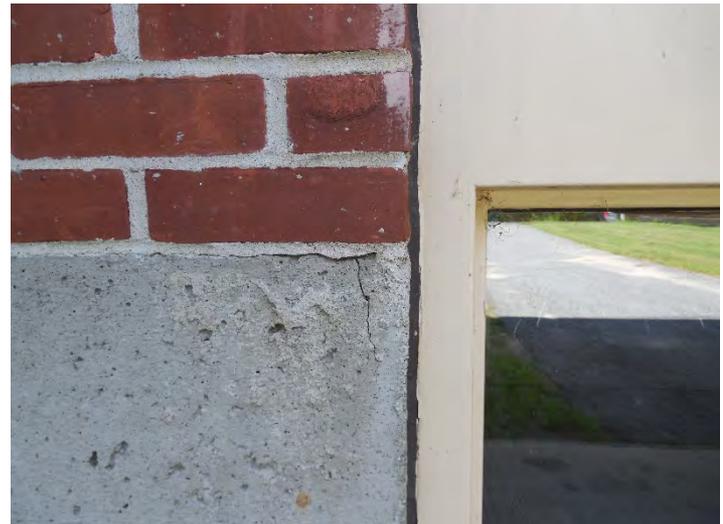
North Elevation, crack in concrete

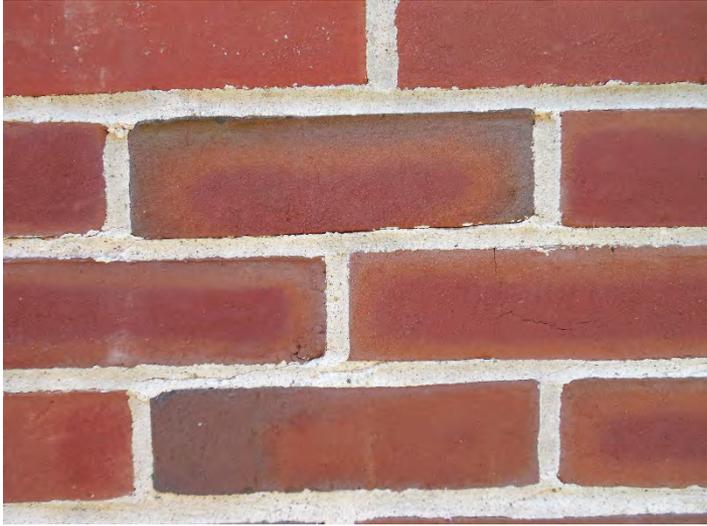
North Elevation, crack in mortar, and there are areas where the mortar is not bonded to the brick.

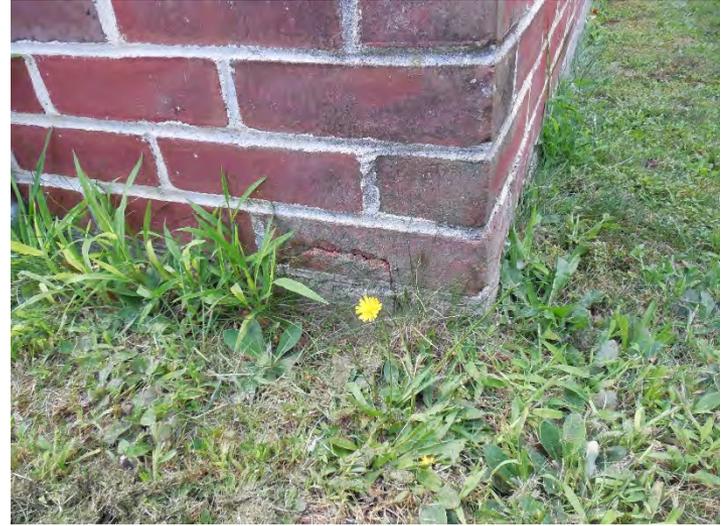
North Elevation, spalled brick and discoloration

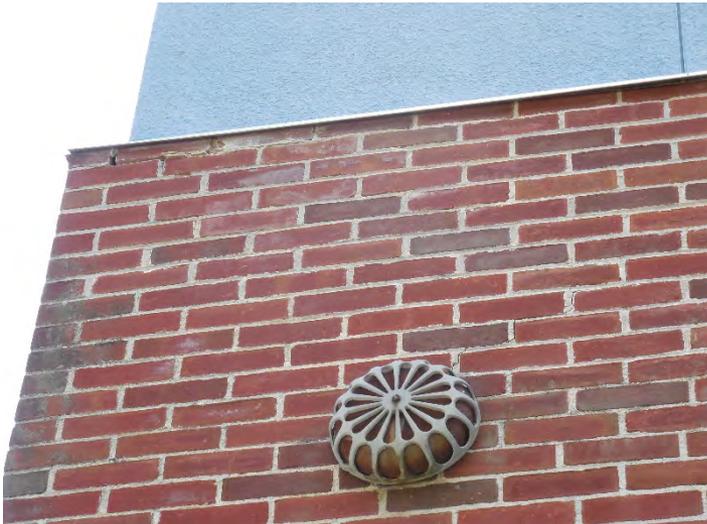
North Elevation, deteriorated mortar joints and discoloration of the brick

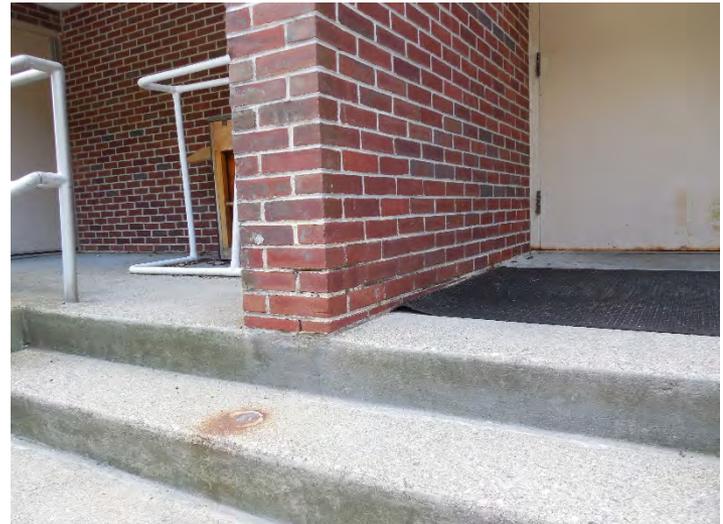
North Elevation, deteriorated mortar joints and discoloration of the brick

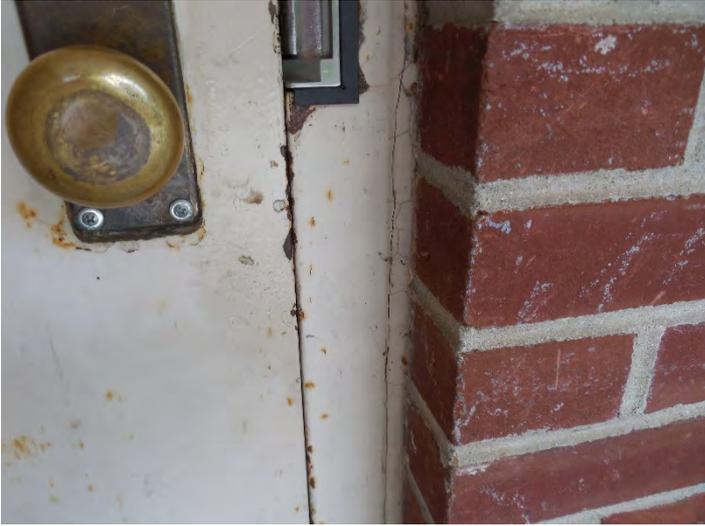
North Elevation, corroded door and frame, and failed perimeter sealant

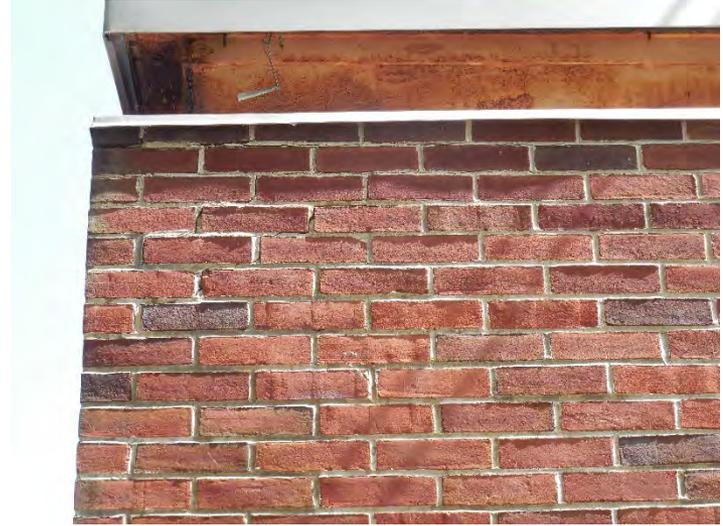
West Elevation, corroded soffit and edge beam at loading dock, and cracked and deteriorated mortar joints

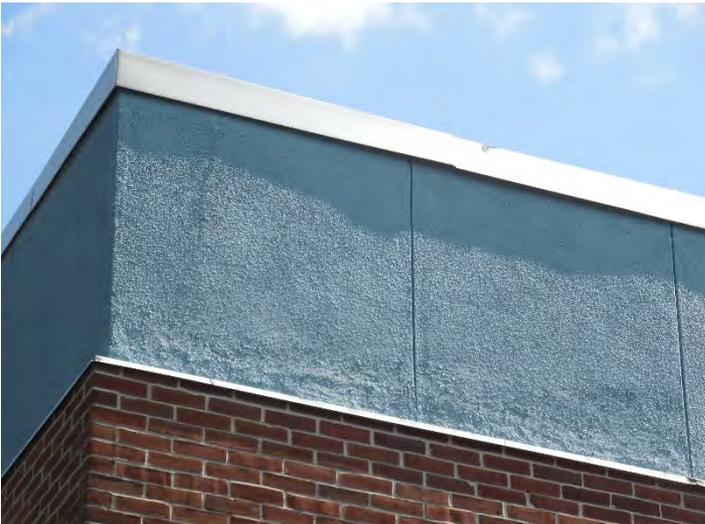
West Elevation at Northwest corner, possible delamination of EIFS

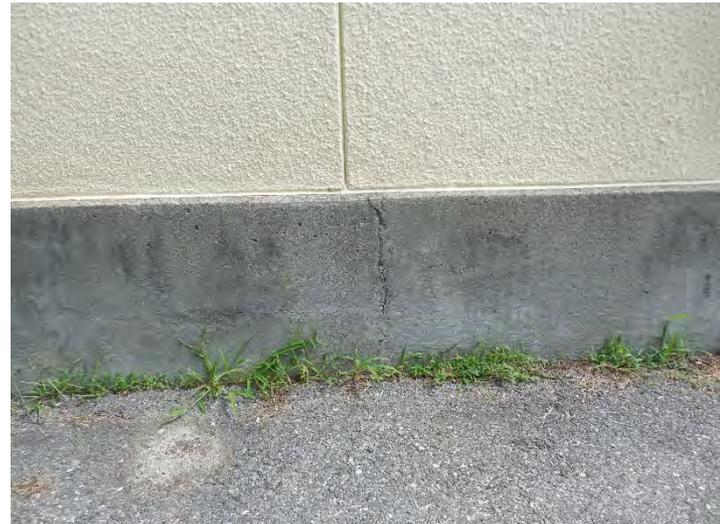
West Elevation, crack in foundation wall

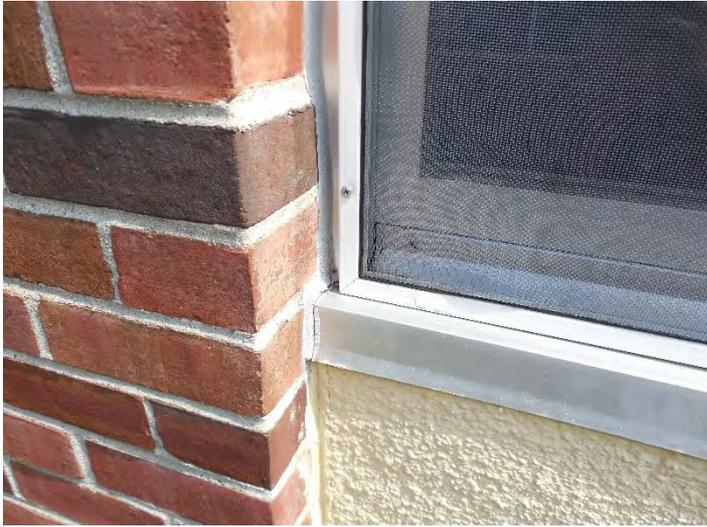
West Elevation, failed window and EIFS perimeter sealants

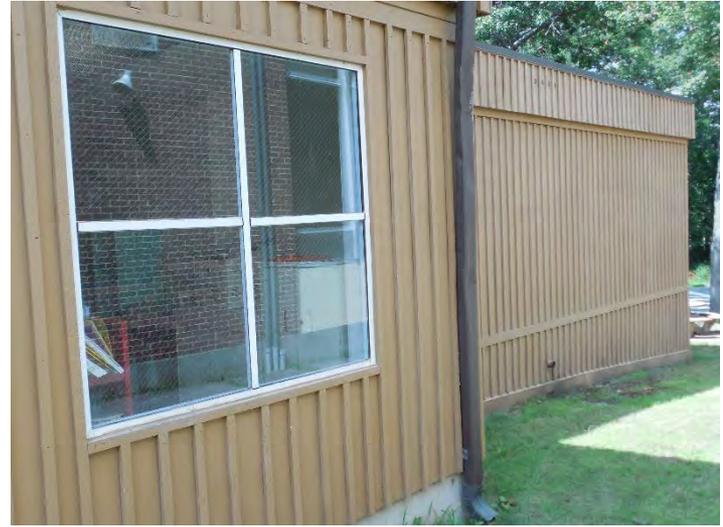
East Elevation, partial view showing damaged downspout

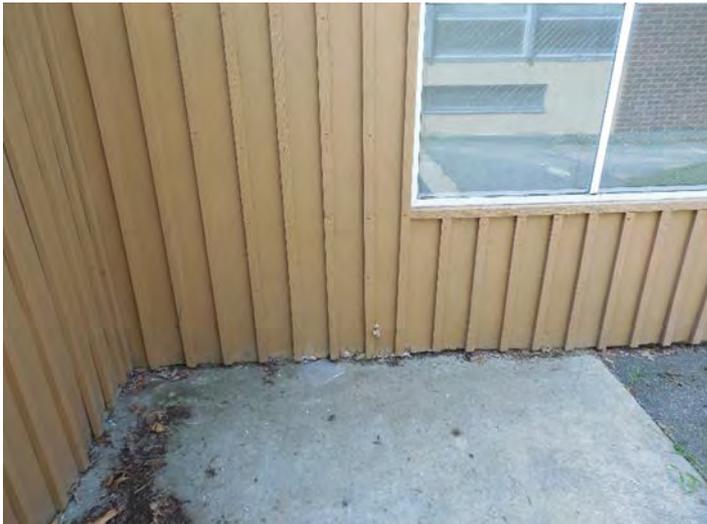
East Elevation, deteriorated wood cladding at grade

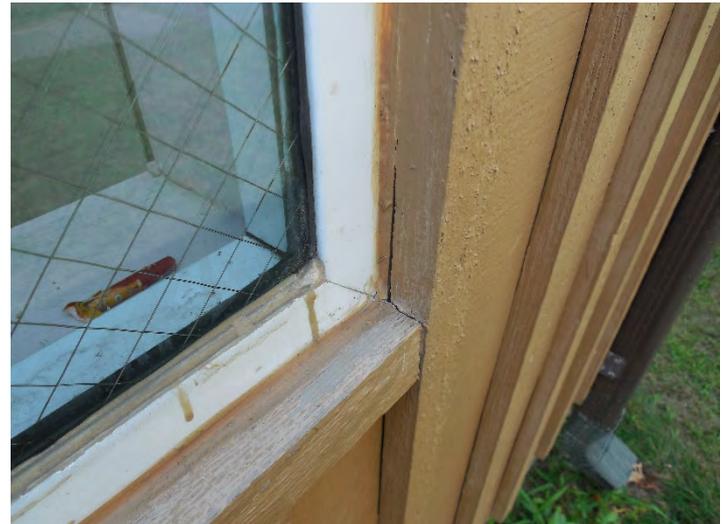
East Elevation, failed window perimeter sealant

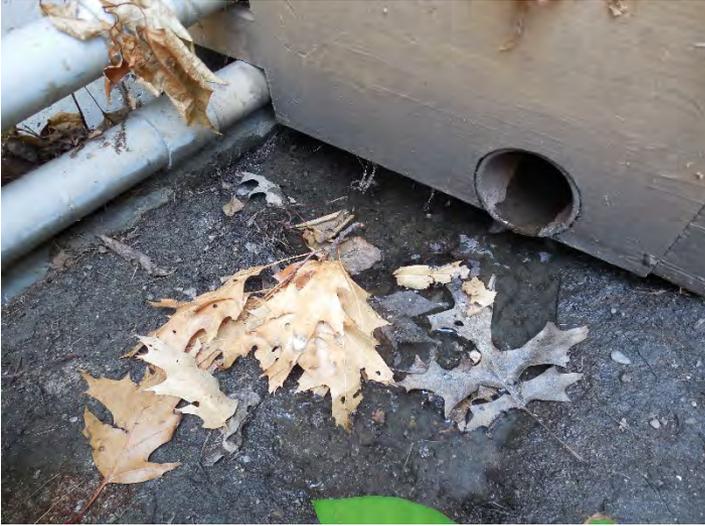
East Elevation, drain pipe outlets at foundation, with water flowing under the building

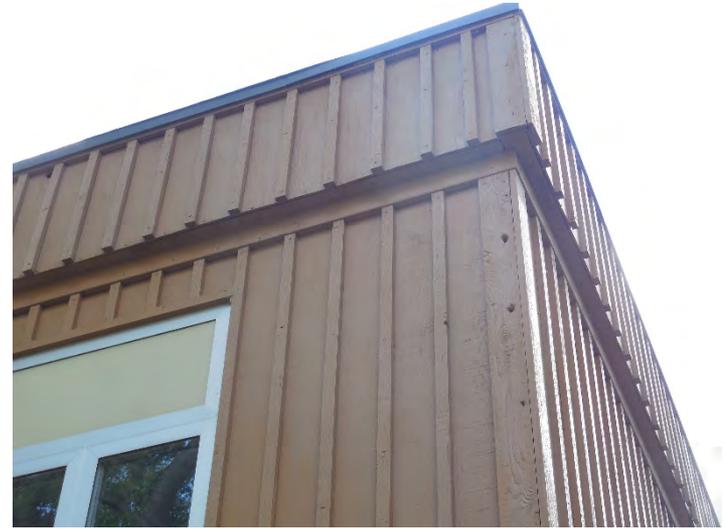
Northwest Corner, holes in trim

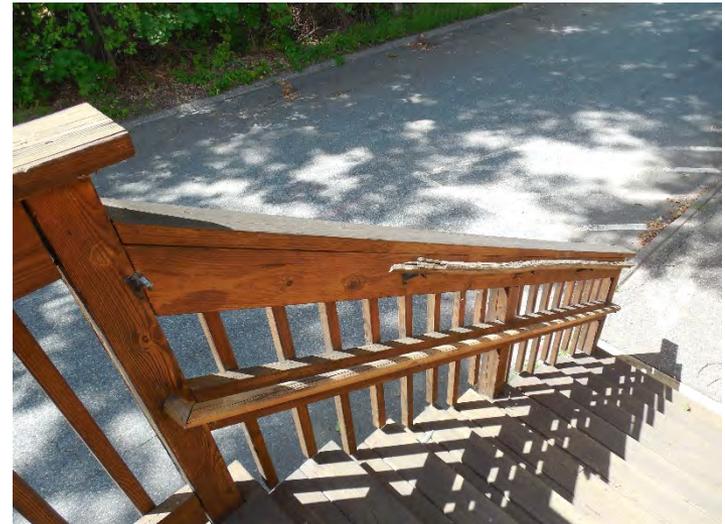
West Elevation entry porch, broken handrail. Guardrail was also loose and unstable.

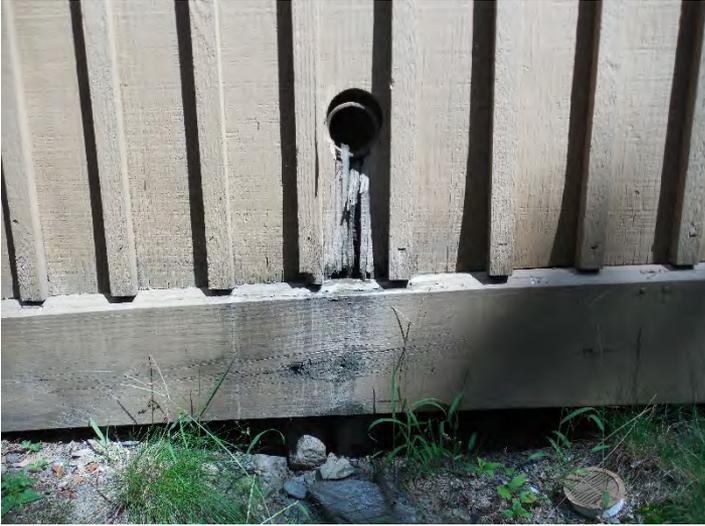
West Elevation, drain pipe outlet with deteriorated wood cladding

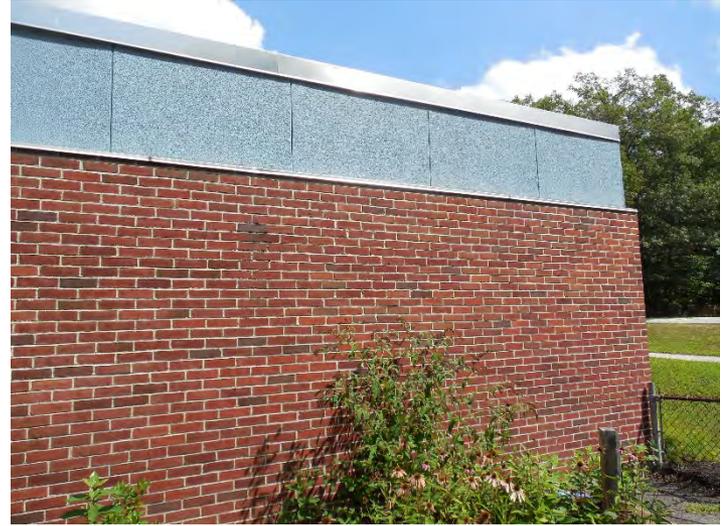
West Elevation, deteriorated mortar

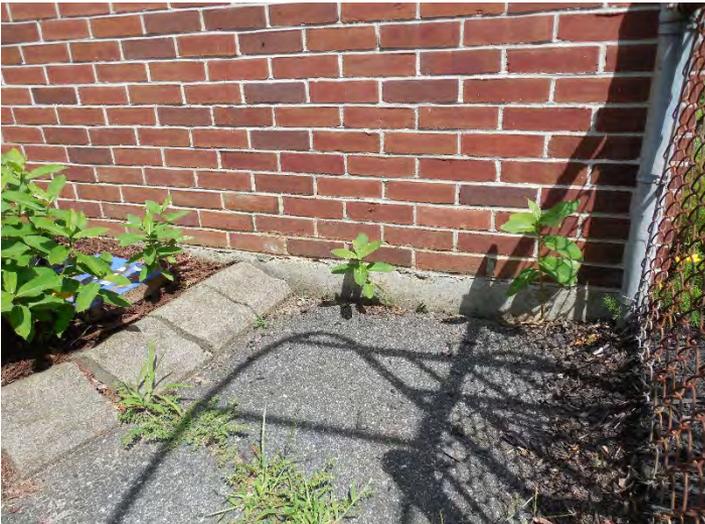
West Elevation, cracked mortar at foundation

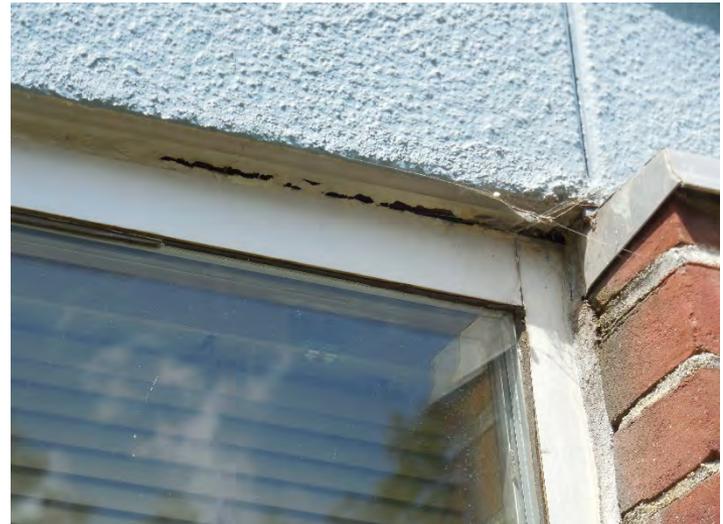
South Elevation, failed window perimeter sealant

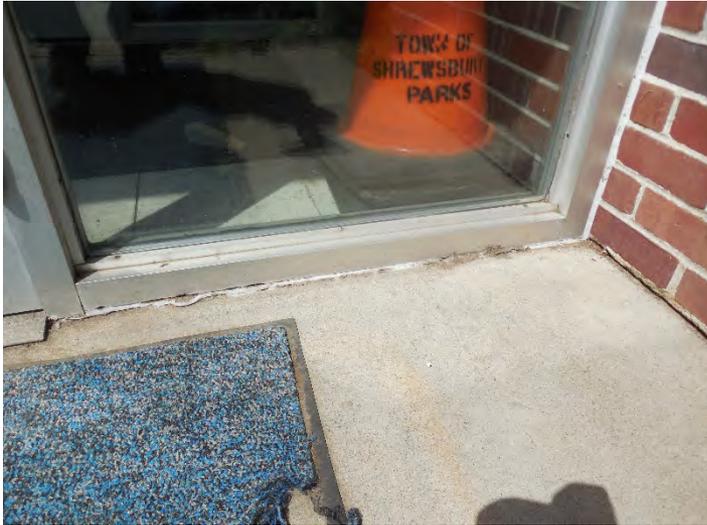
South Elevation, failed perimeter sealant at front entry door

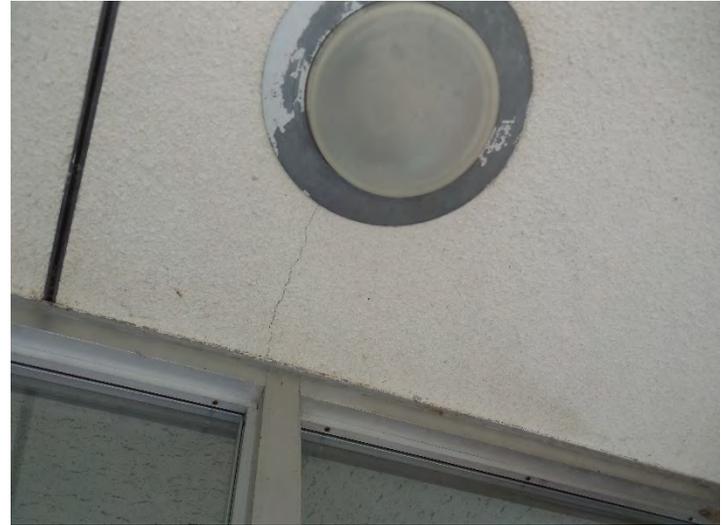
South Elevation, crack in the EIFS soffit at front entry

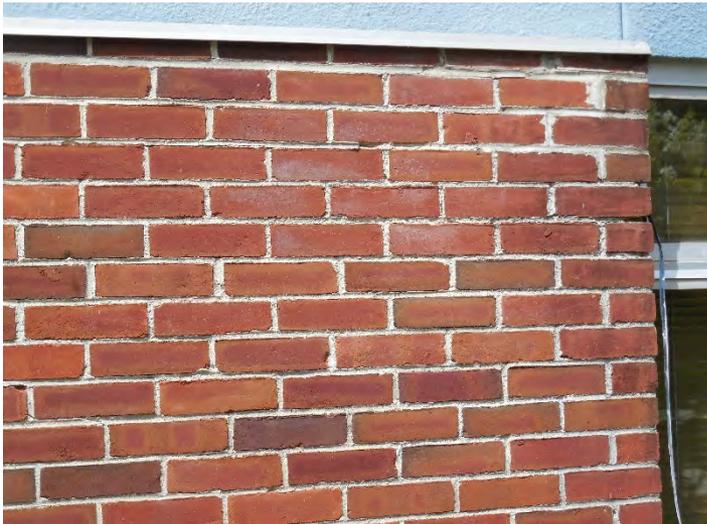
South Elevation, cracked and deteriorated mortar joints

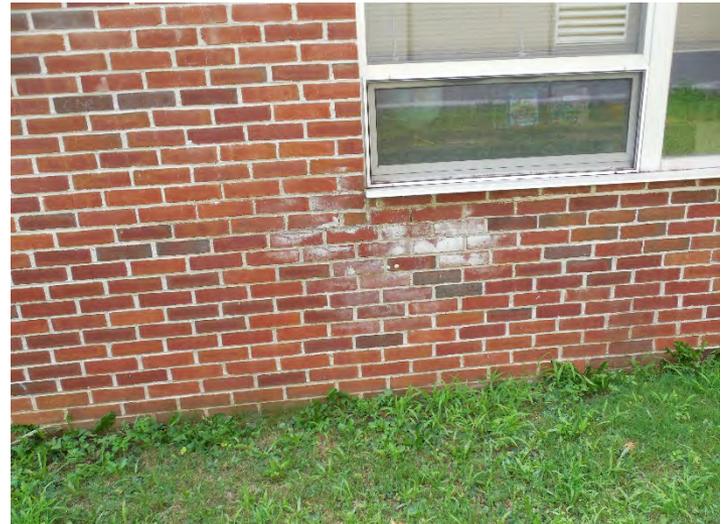
East Elevation, staining below window corner

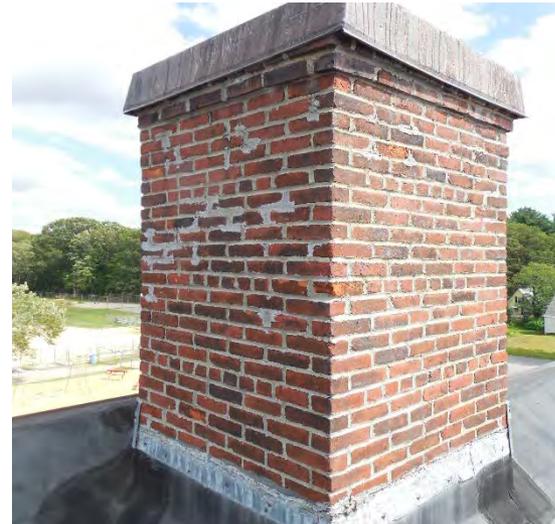
Upper roof, chimney along East side, deteriorated flashing, displaced metal cap, deteriorated masonry and mortar joints

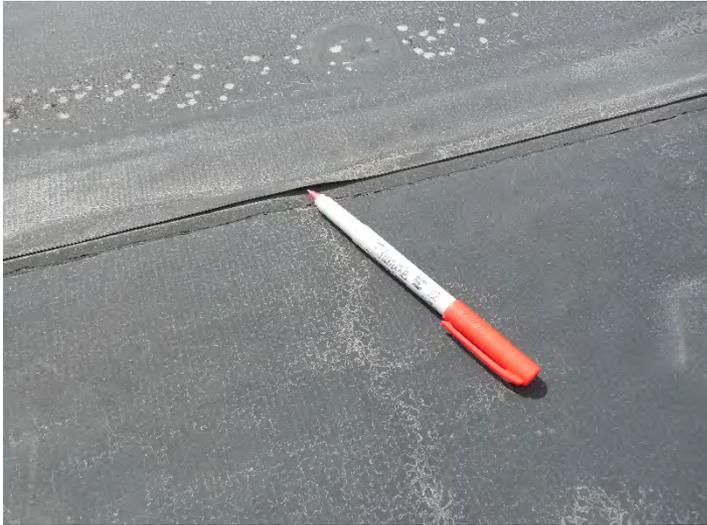
Upper roof, open seam in EPDM

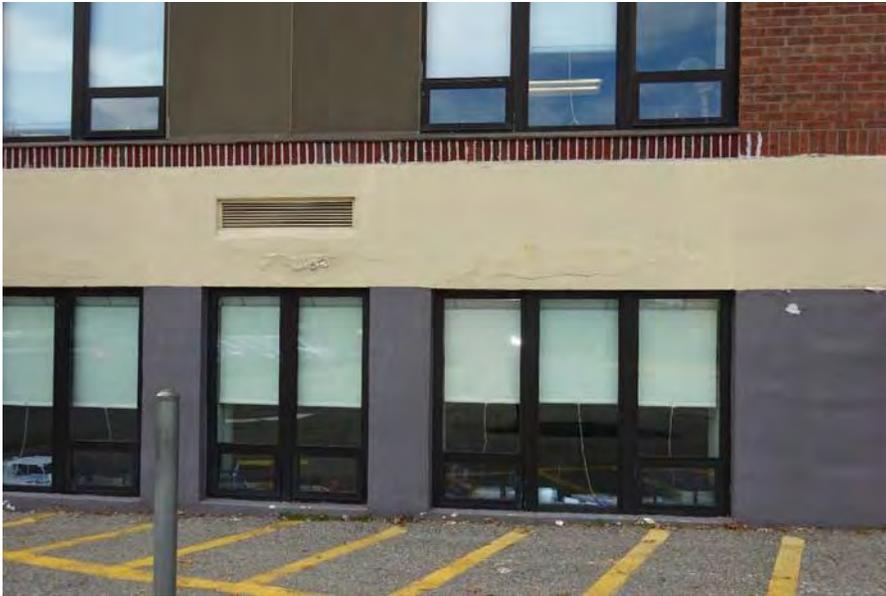
Photo 1: Damaged Concrete (See S-6, S-19, S-26)

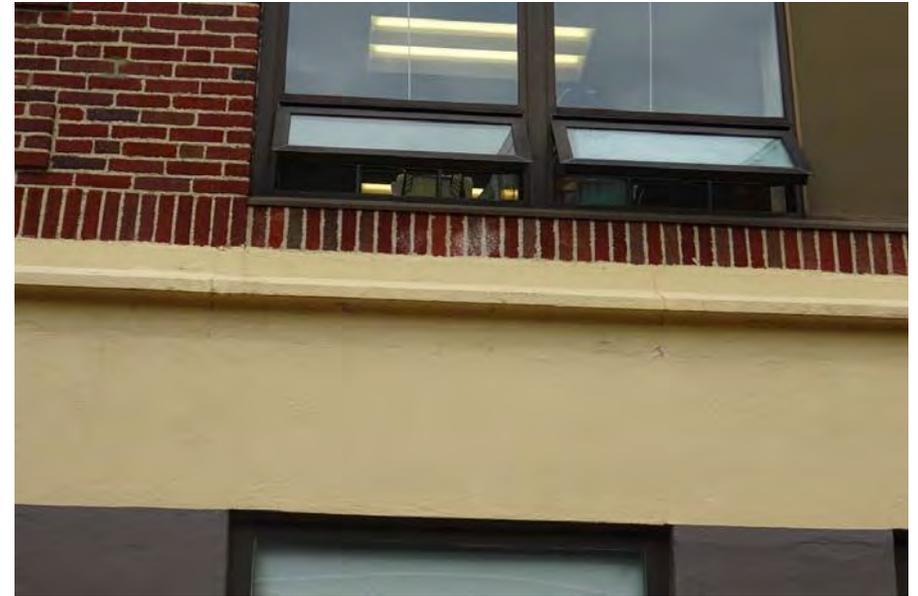
Photo 2: Cracked and Eroded Cast Stone Mortar Joints (See S-13)

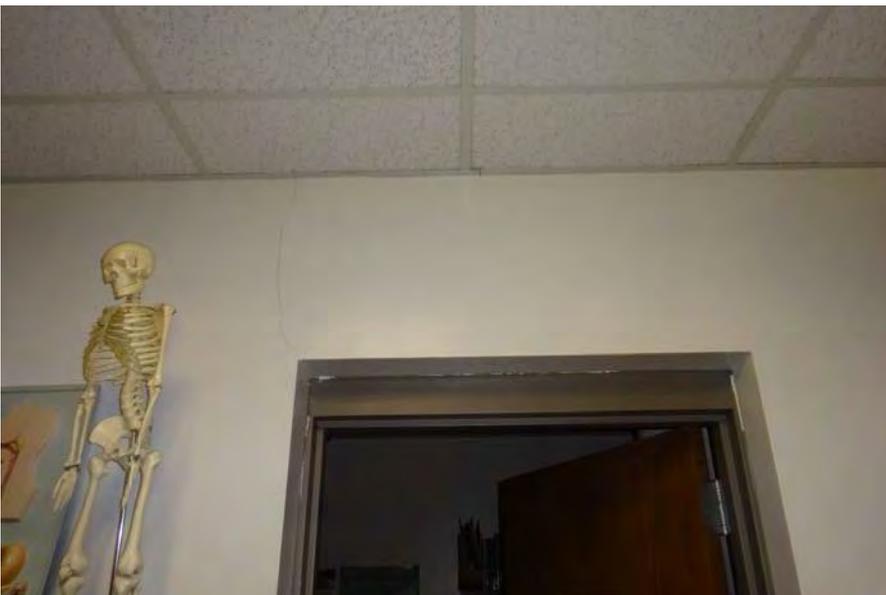
Photo 3: Cracked Finishes (See S-43)
