TOWN OF SHREWSBURY
FACILITIES CONDITION ASSESSMENT
OF
TOWN BUILDINGS

FINAL REPORT

June 01, 2016

**Shrewsbury
Floral St. School**

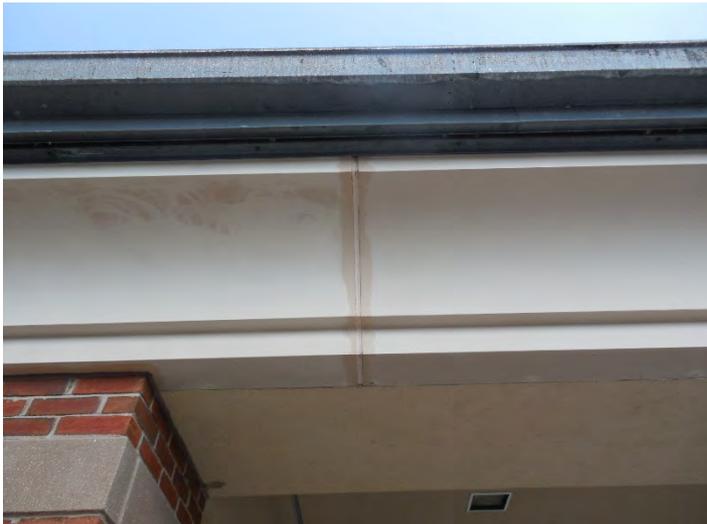
South Elevation, failed joint sealant

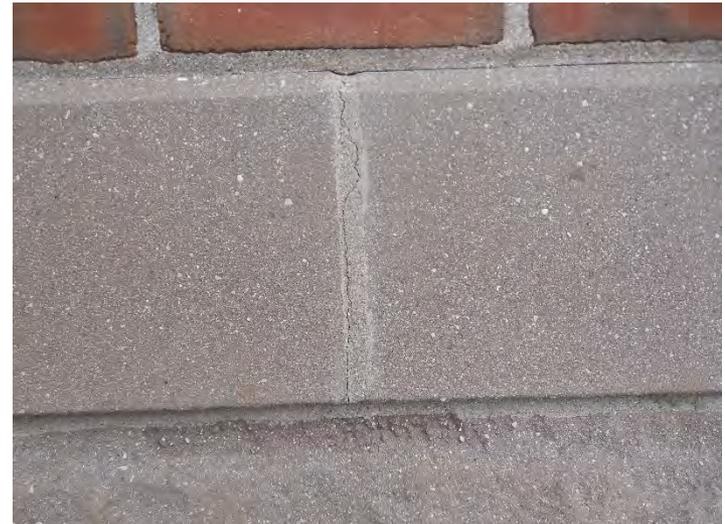
South Elevation, crack in a mortar joint at an entry column

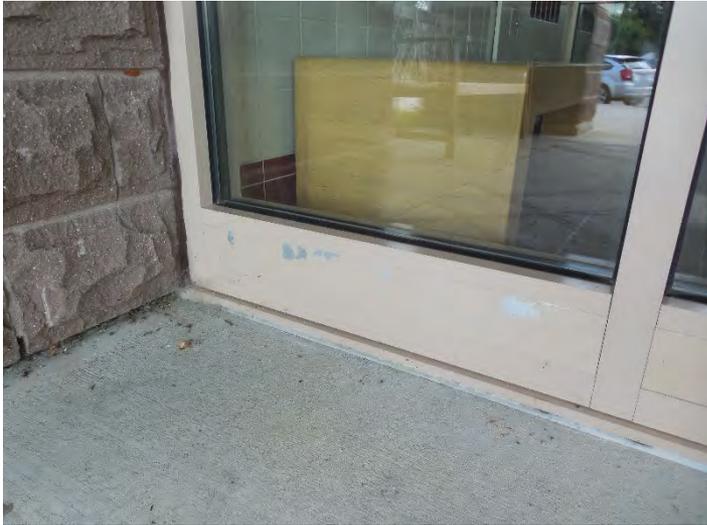
South Elevation, peeling paint at front entry door

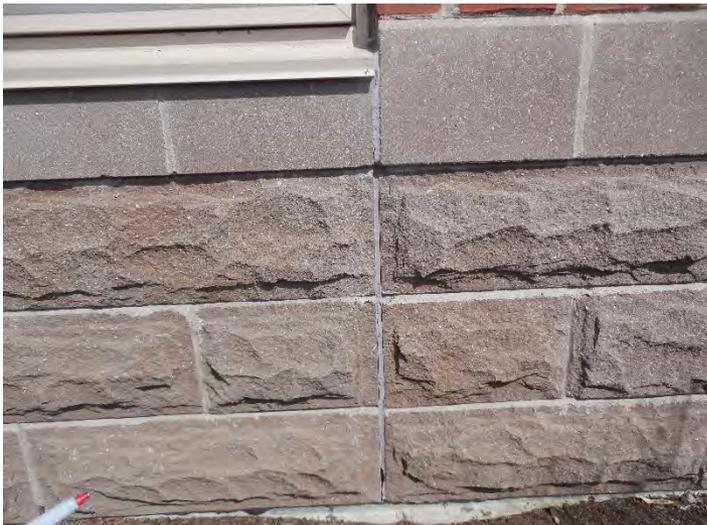
South Elevation, failed sealant at an expansion joint

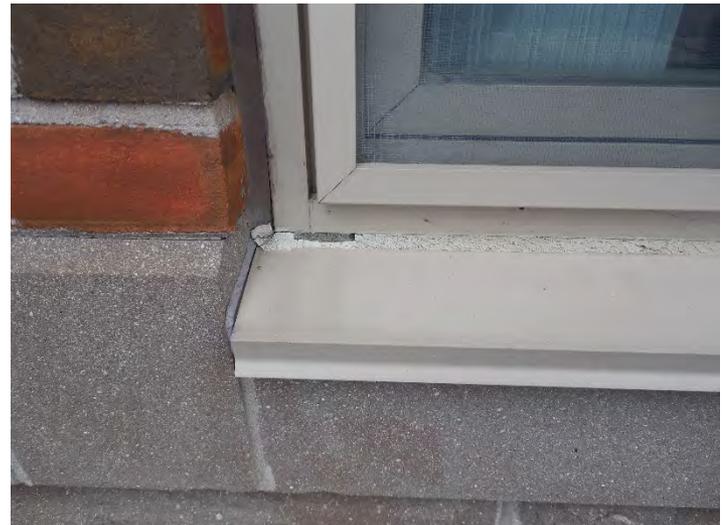
South Elevation, failed window perimeter sealant

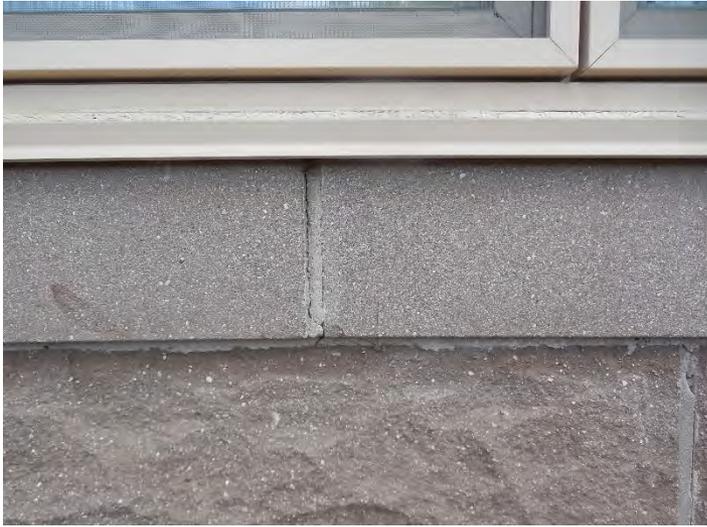
South Elevation, failed sealant, cracked mortar below a window

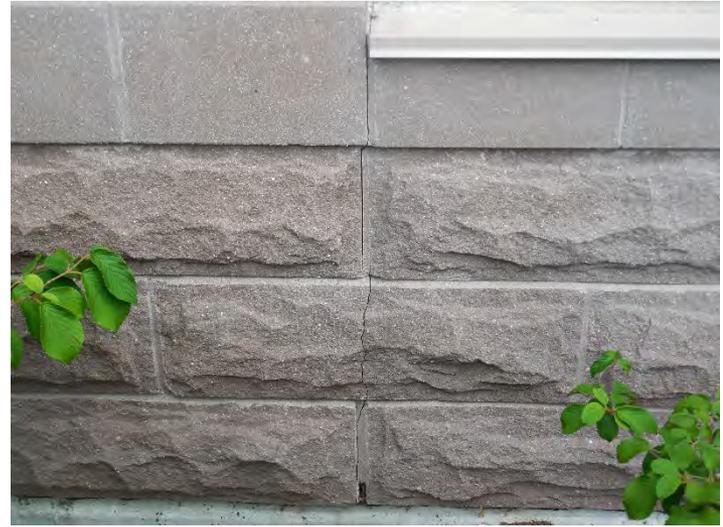
South Elevation, cracked masonry below a window

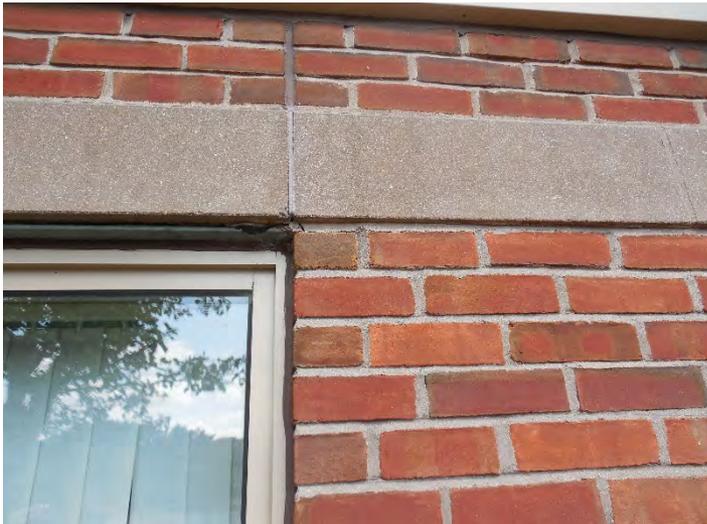
South Elevation, cracked and deteriorated mortar and sealant at a lintel

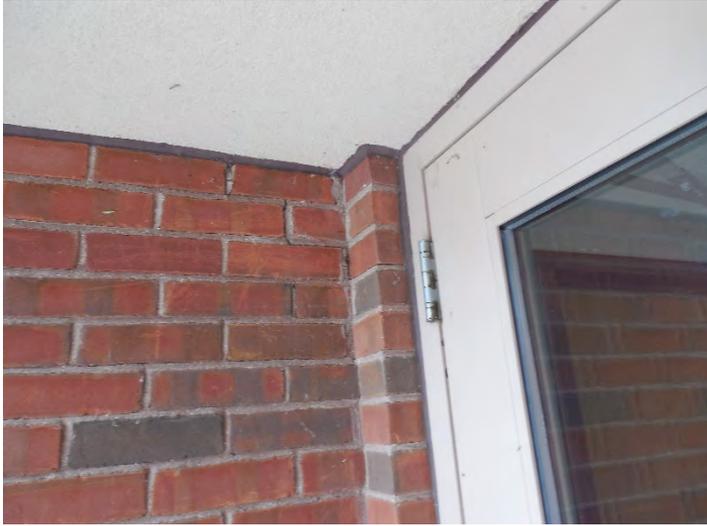
East Elevation, crack in mortar joint

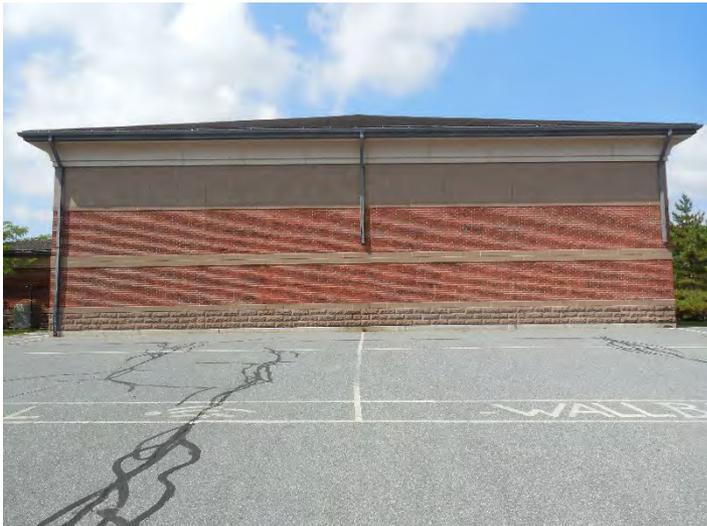
East Elevation, partial view showing missing downspouts

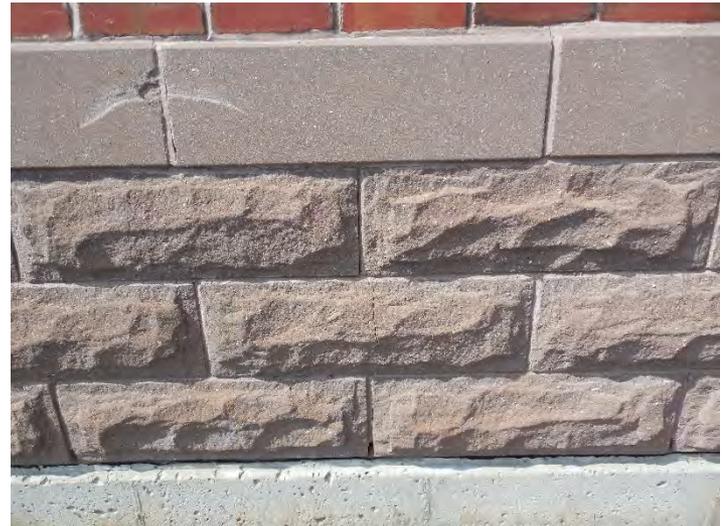
East Elevation, damaged stone and cracks through masonry and mortar

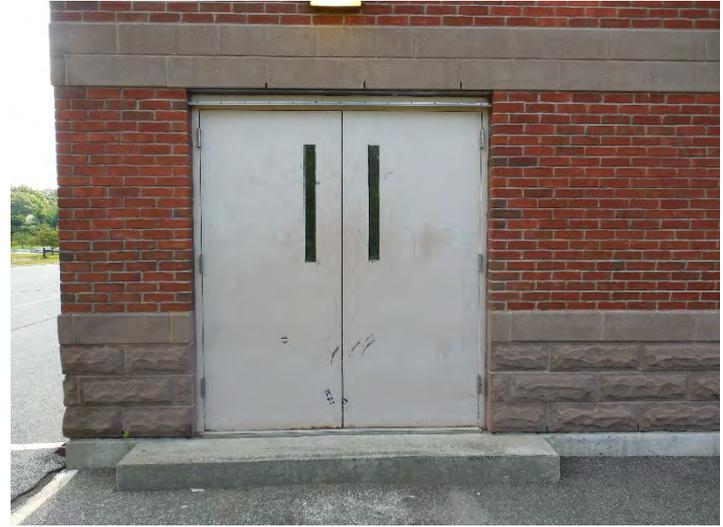
North Elevation, corroded doors, with peeling paint and deteriorated perimeter sealant

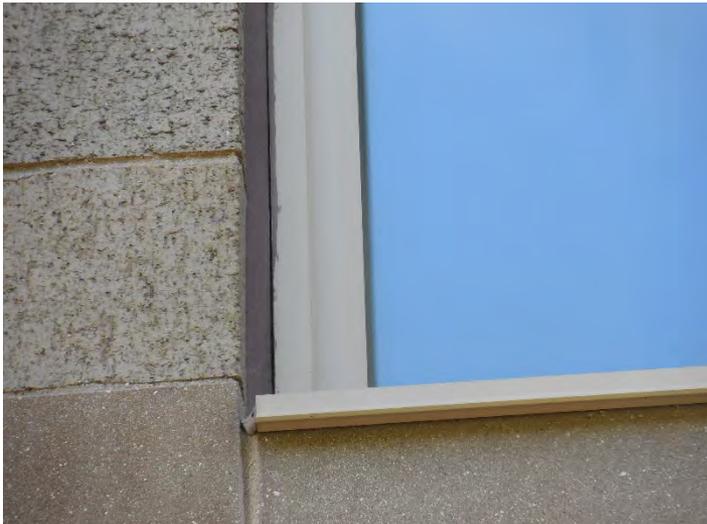
North Elevation, failed window perimeter sealant

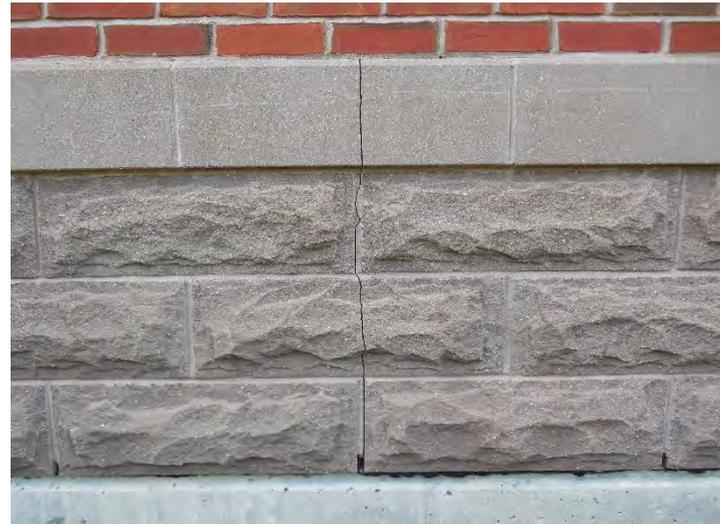
North Elevation, crack in masonry and mortar joints

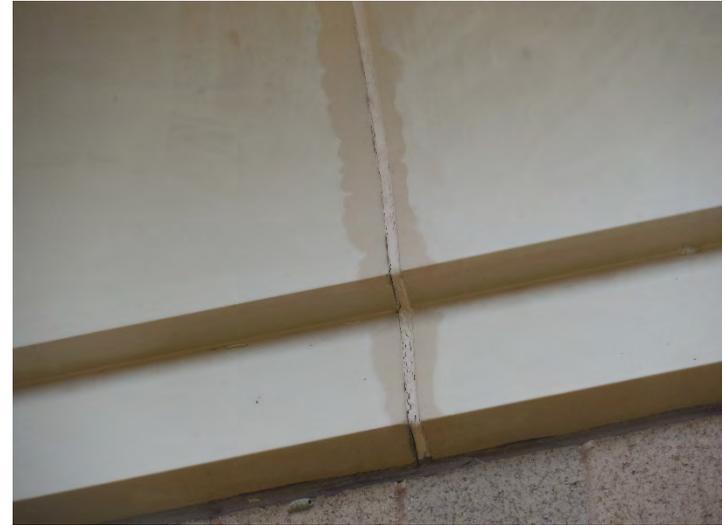
West Elevation, failed sealant at a joint in the trim

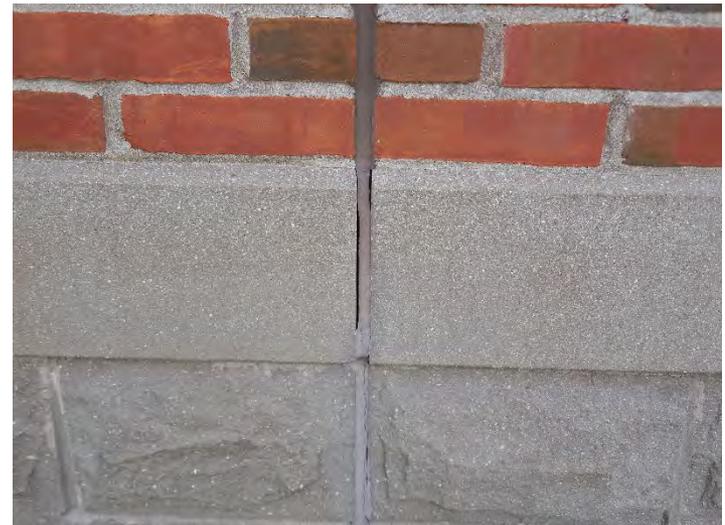
North Elevation, failed sealant at an expansion joint

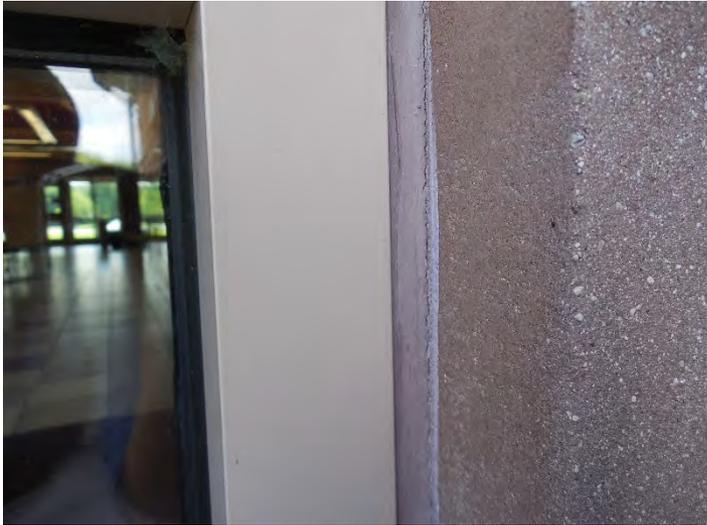
North Elevation, failed sidelight perimeter sealant

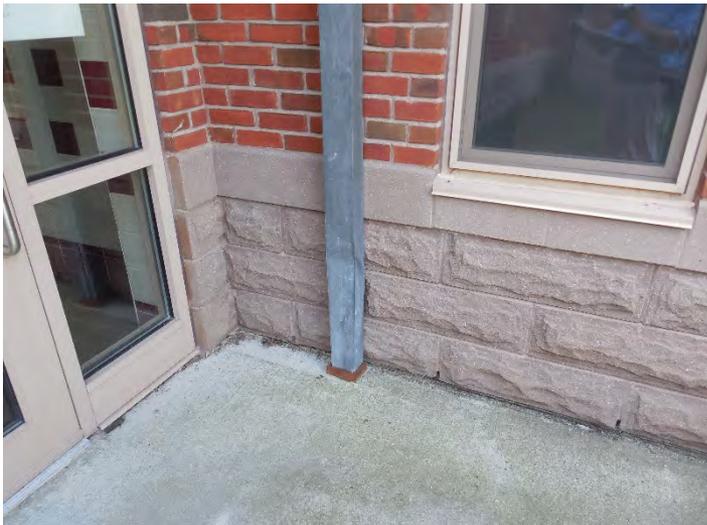
East Elevation, damaged downspout

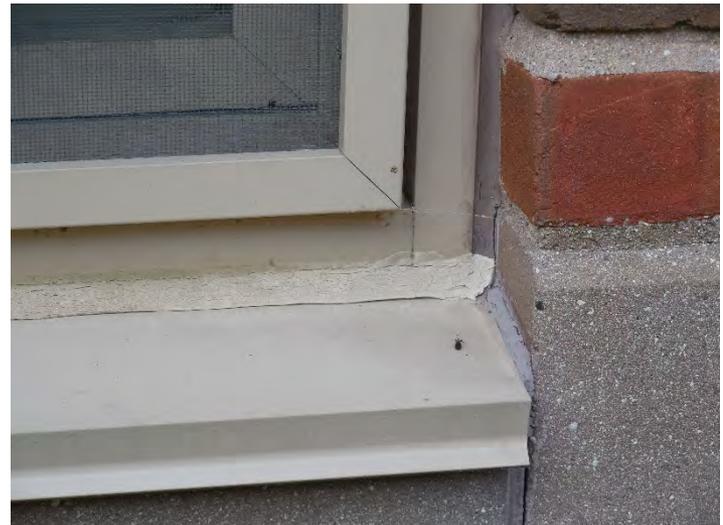
East Elevation, failed window perimeter sealant

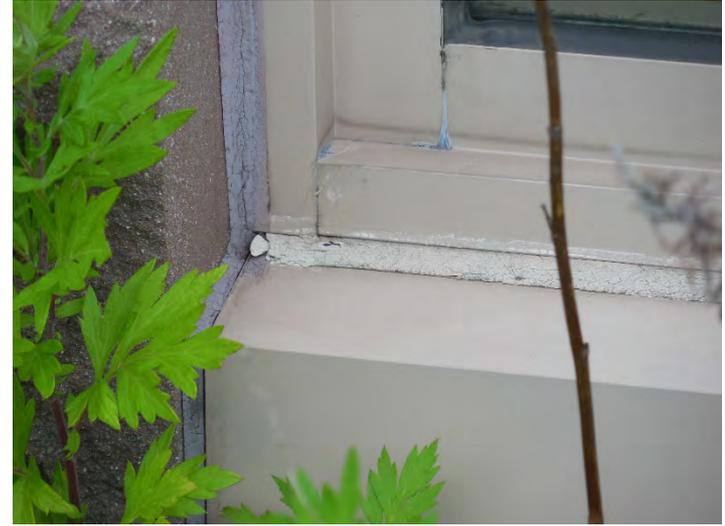
North Elevation, failed window perimeter sealant

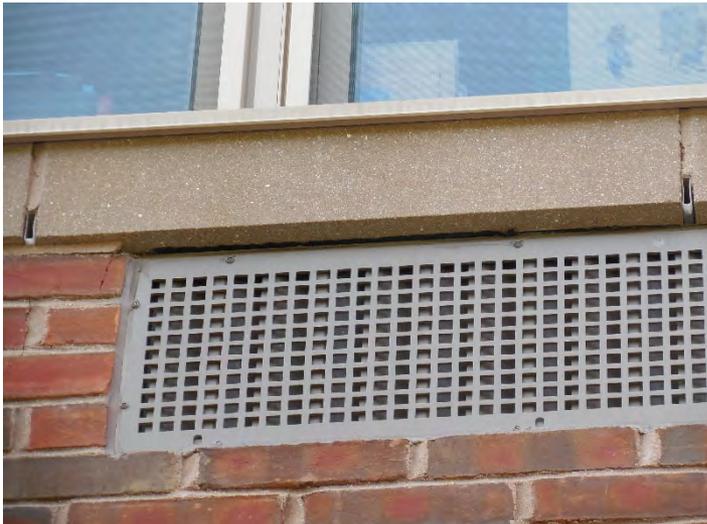
East Elevation, cracks in masonry and mortar, and gap between stone sill and vent screen

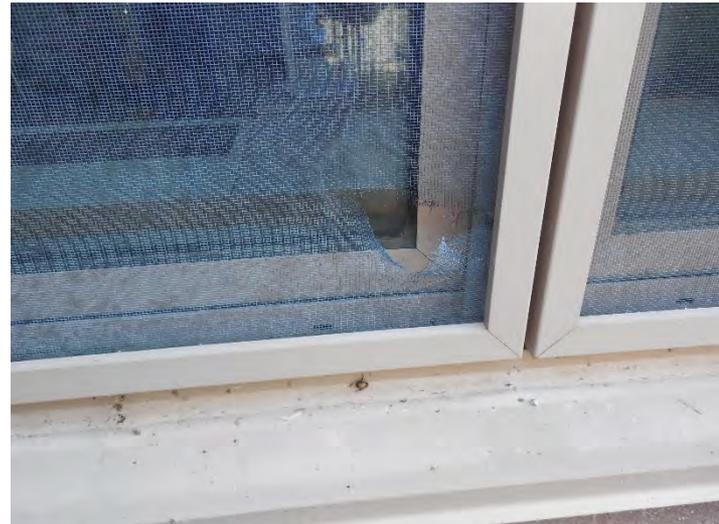
East Elevation, damaged window screen

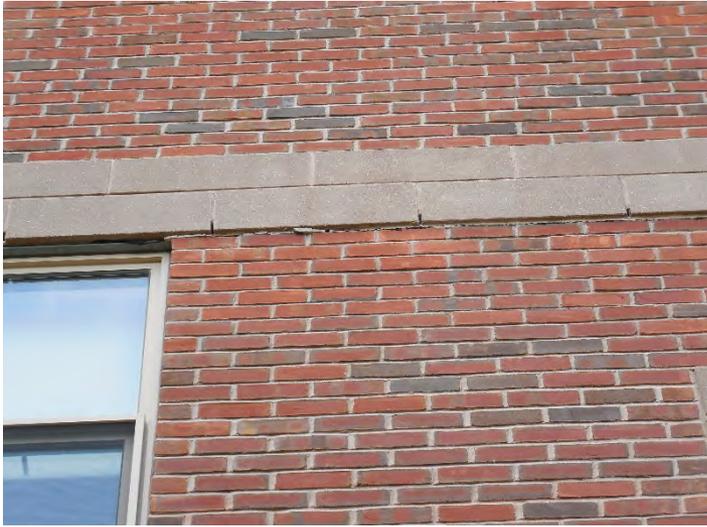
East Elevation, loose and deteriorated mortar at a lintel

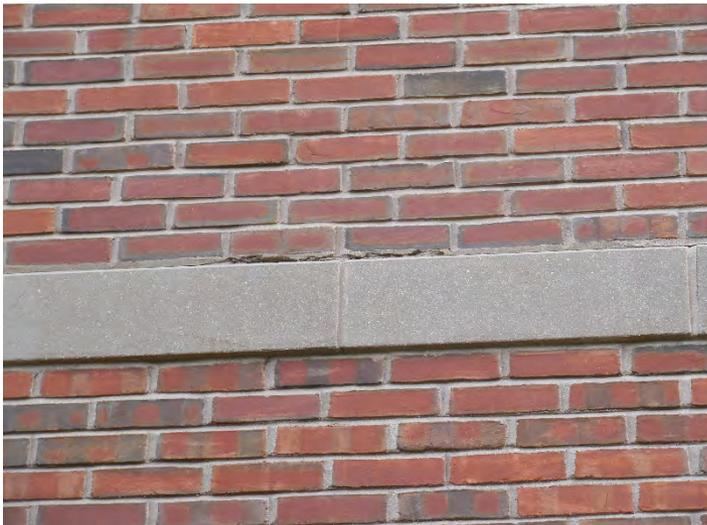
North Elevation, cracked and deteriorated mortar

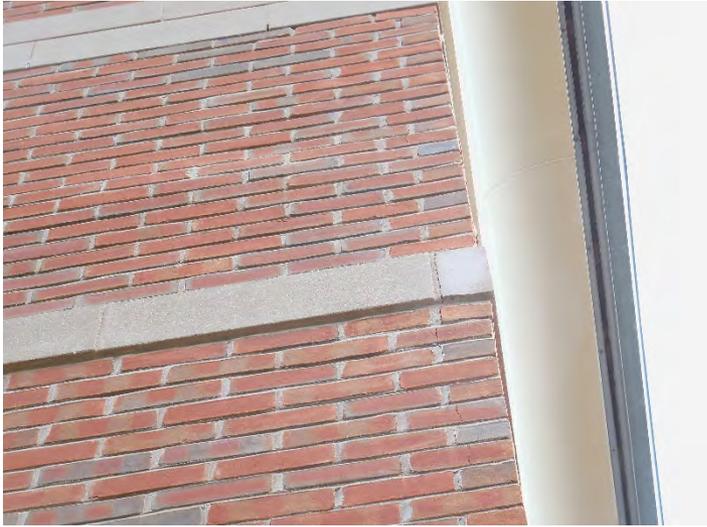
North Elevation at Northwest Corner, crack through masonry and mortar, and masonry is displaced

- iii. Investigate cracked and displaced masonry to determine the cause of cracking and movement. Remove any loose masonry as an interim measure. Repair cracks by routing and sealing (moving cracks) or pointing (static cracks). Secure masonry to backup structure with restoration anchors as required.

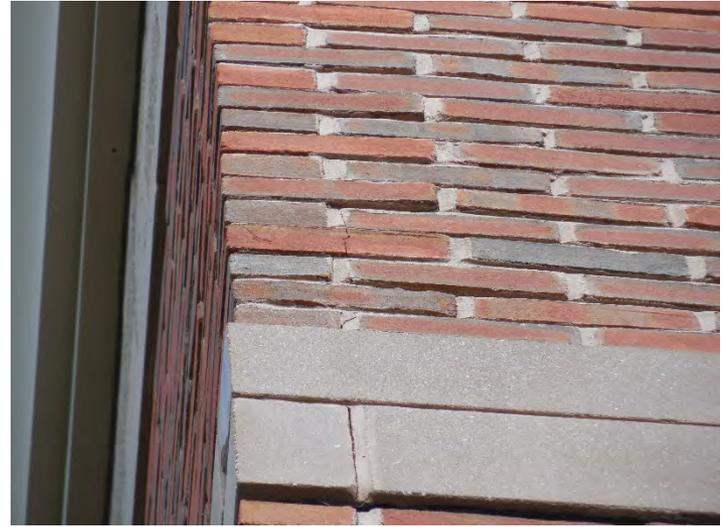
West Elevation at Northwest Corner, crack through masonry and mortar, and masonry is displaced

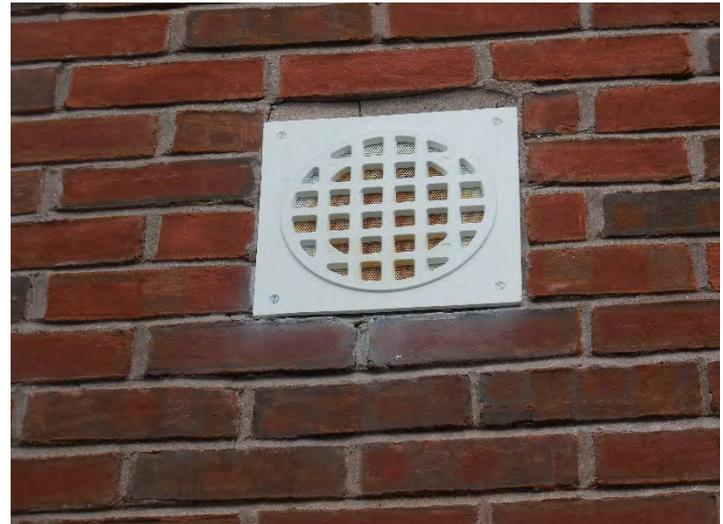
West Elevation, cracked and deteriorated mortar and stained masonry around a vent

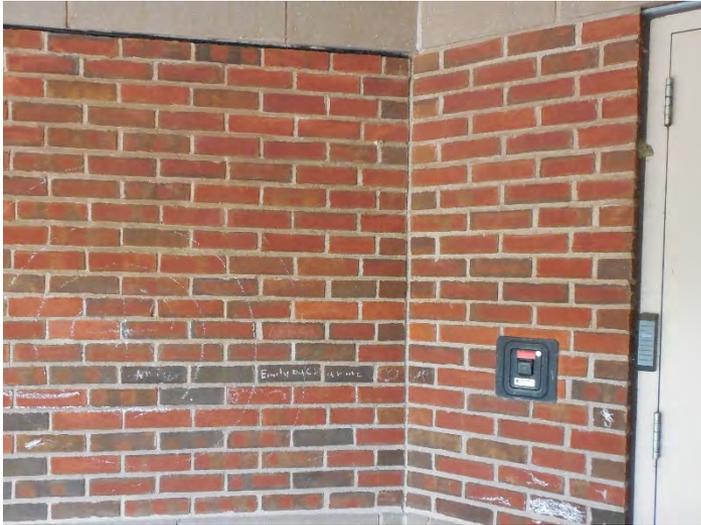
West Elevation at entry, cracked and deteriorated mortar joint

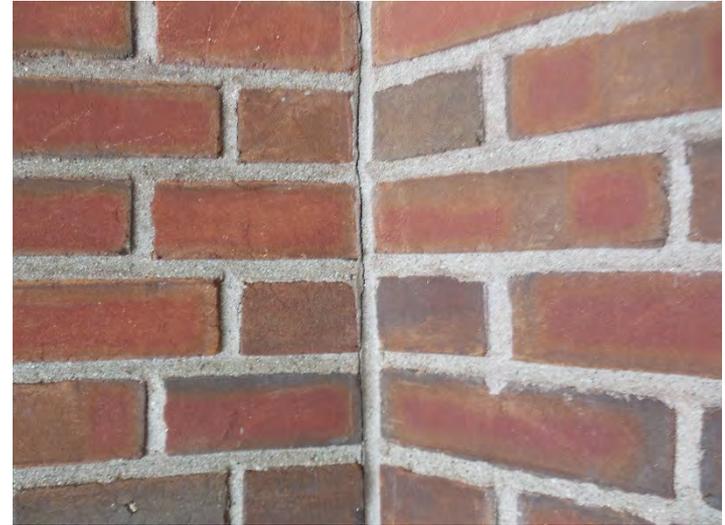
West Elevation at entry, crack in mortar joint

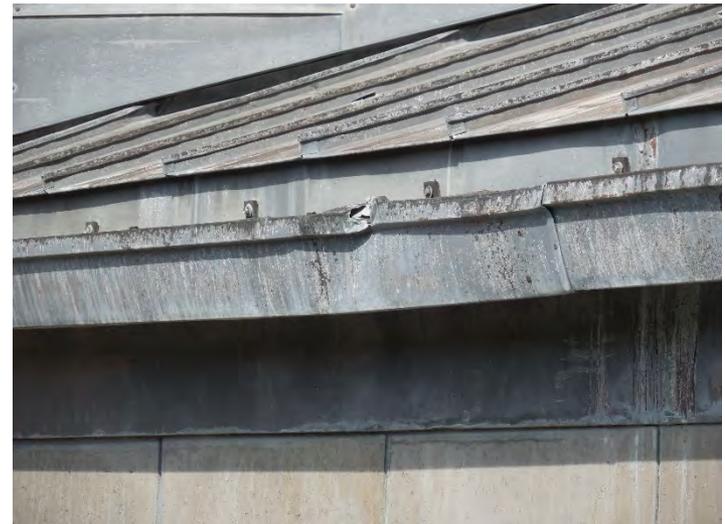
Northwest entry, damaged gutter

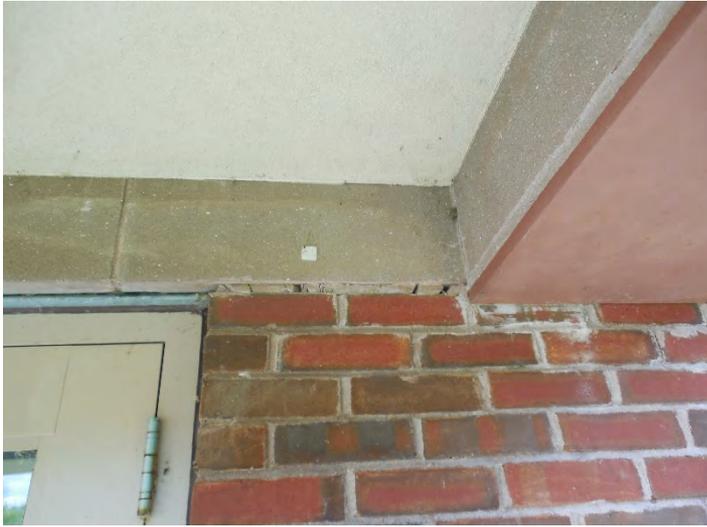
North Elevation at entry, cracked and deteriorated mortar

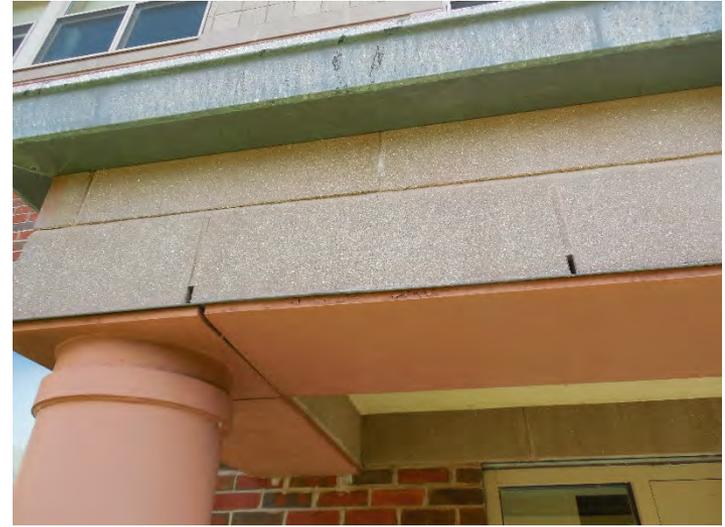
North Elevation at entry, peeling paint and crack in mortar joint

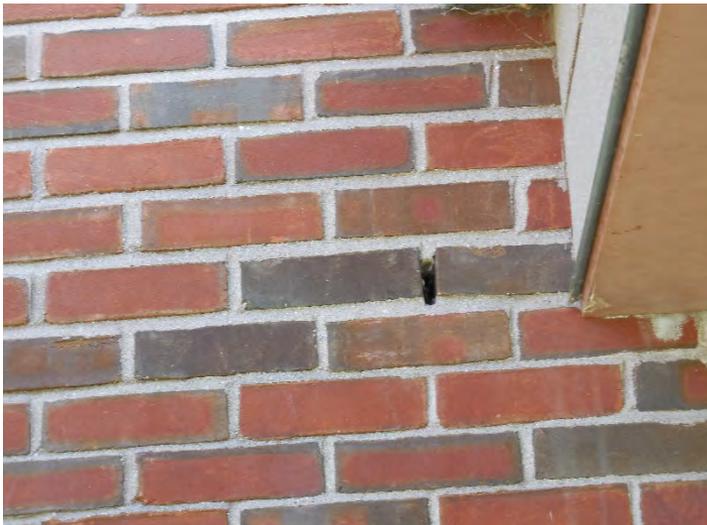
North Elevation at entry, section of mortar missing

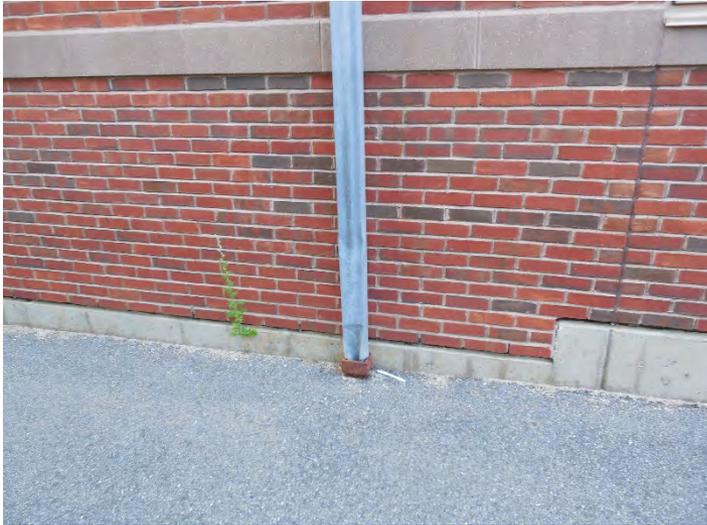
West Elevation, damaged downspout

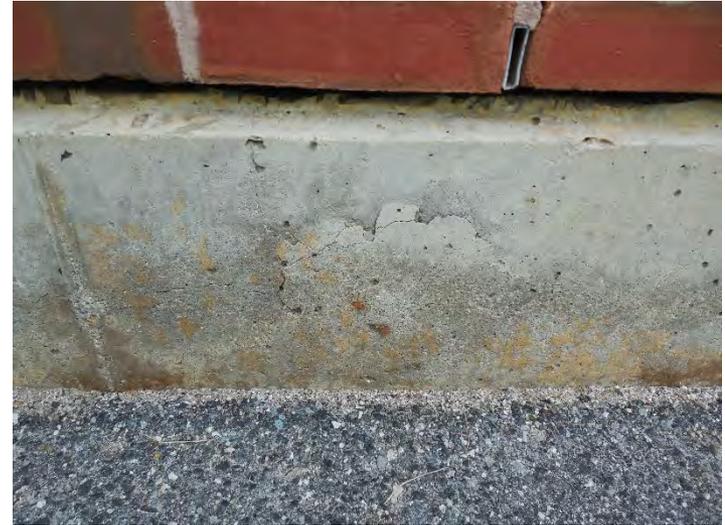
West Elevation, spalled and cracked concrete

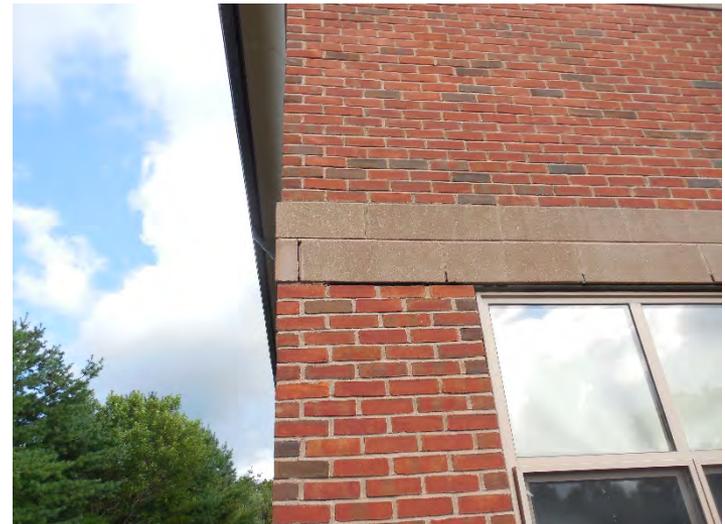
South Elevation, displaced masonry and cracked and deteriorated mortar joints

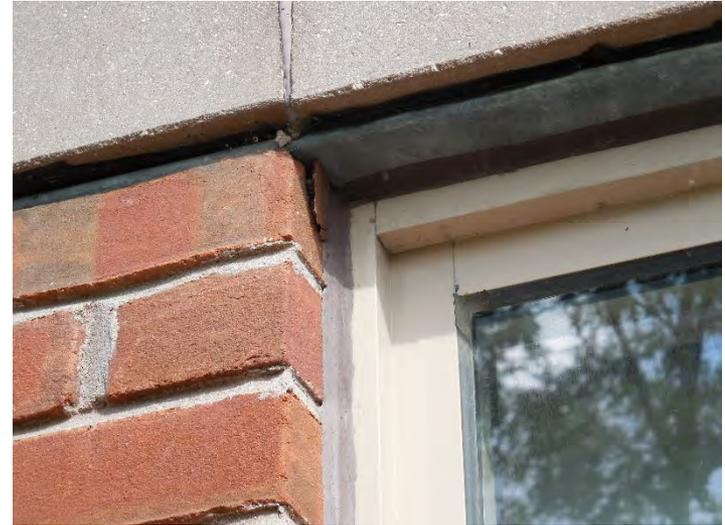
South Elevation, spalled brick under a lintel

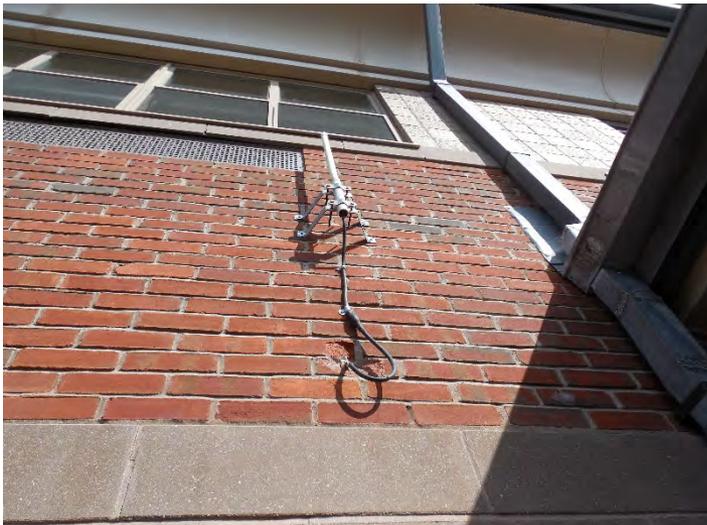
South Elevation, partially sealed wire penetration

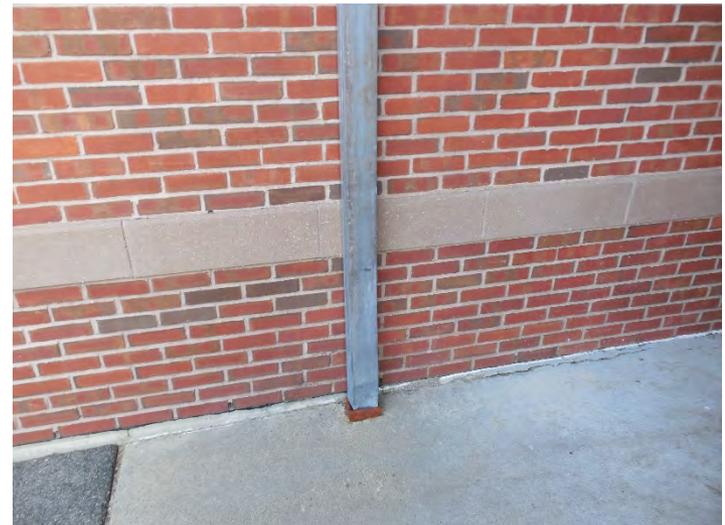
South Elevation, damaged downspout

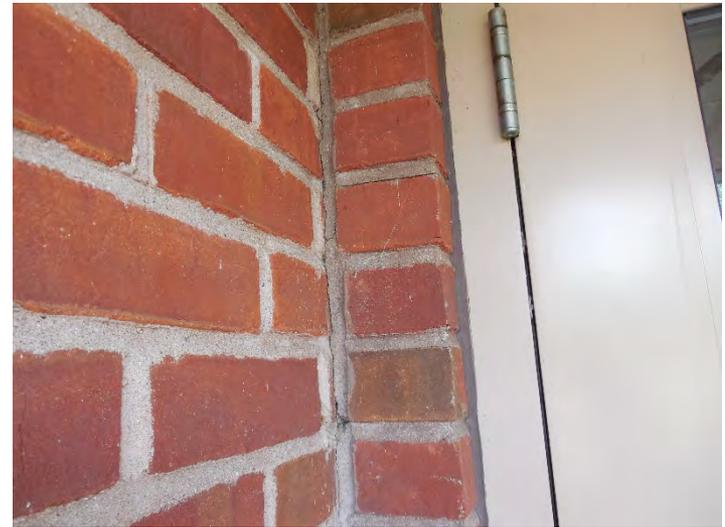
West Elevation crack in mortar joint

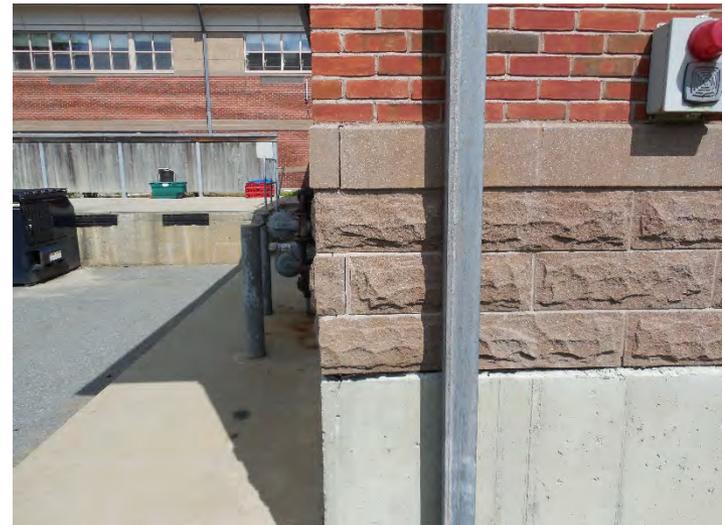
South Elevation, crack in mortar joint

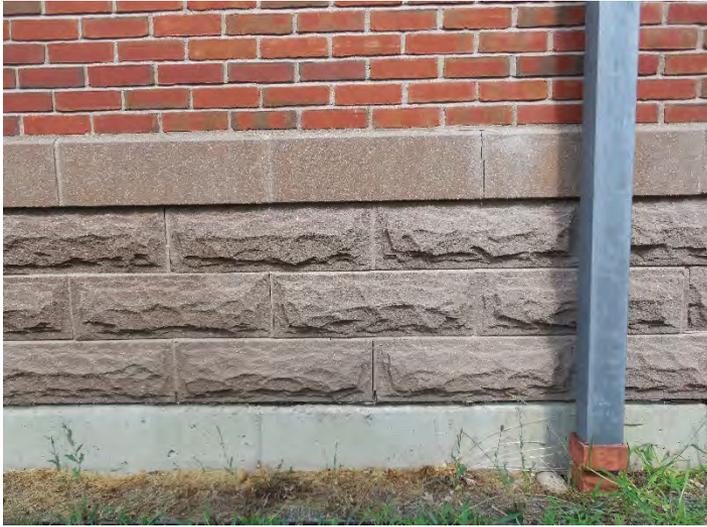
South Elevation, cracks in mortar joints

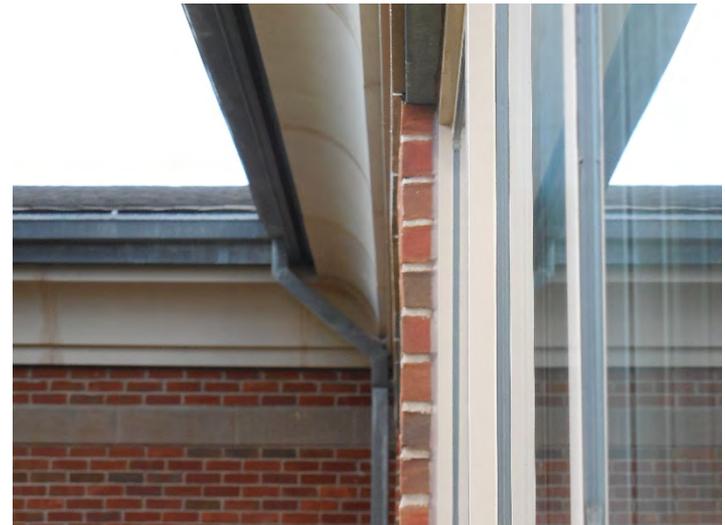
South Elevation, brick bulges out at top of wall

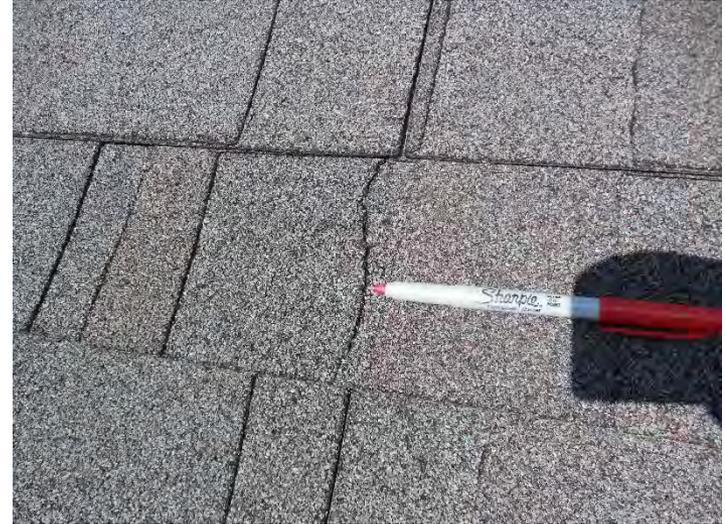
Crack through a shingle

- i. Repair isolated damage as soon as possible.
- ii. Plan to replace 100% of roofing between 2022 and 2026.

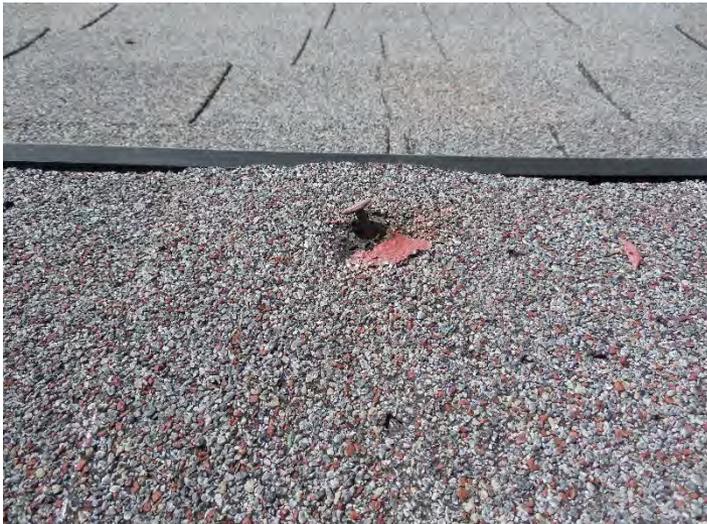
Roofing nail protruding through shingle

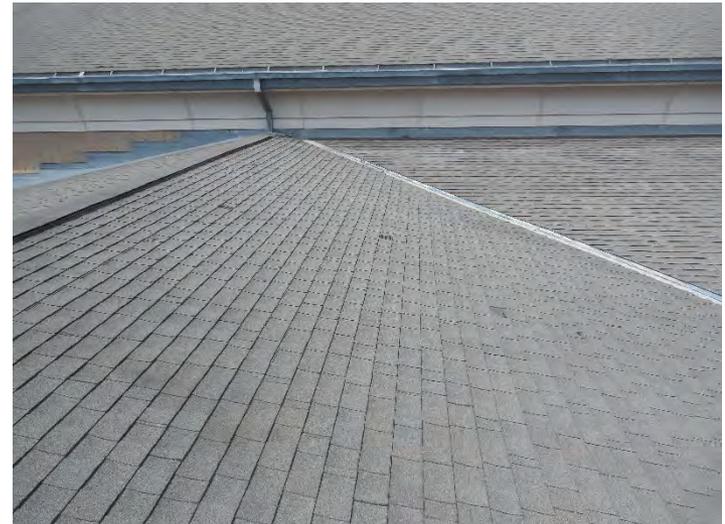
Partial view of roof with several broken shingle tabs

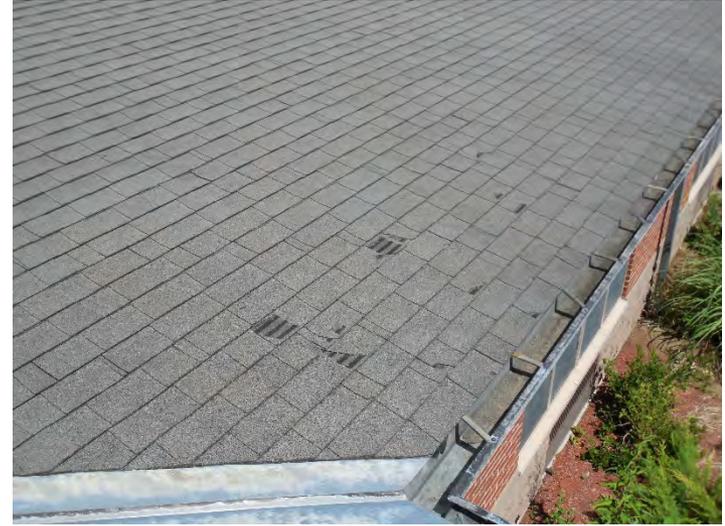
Partial view of roof with several broken shingle tabs

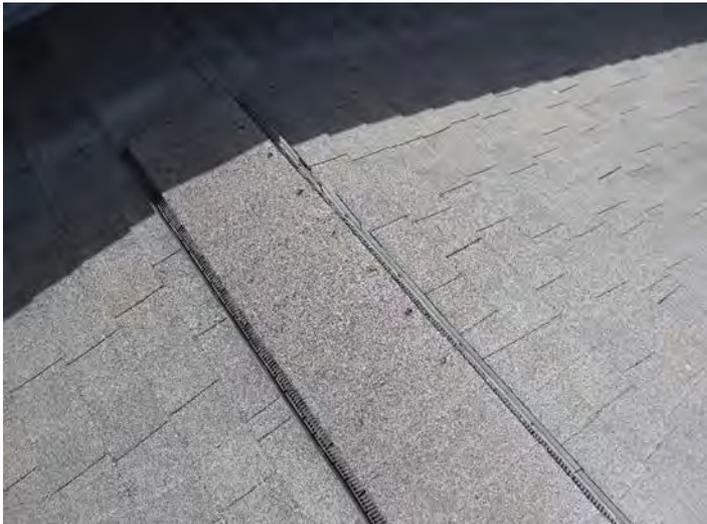
Ridge vent, holes at face nails

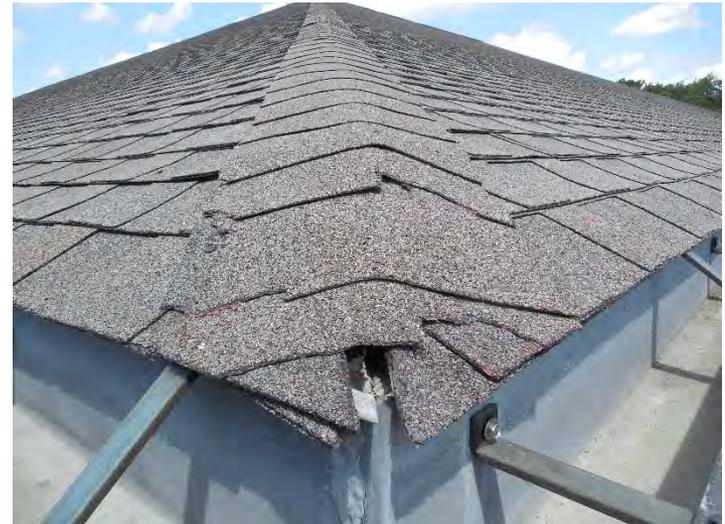
Southwest corner of upper roof, gap in roofing materials with exposed wood structure

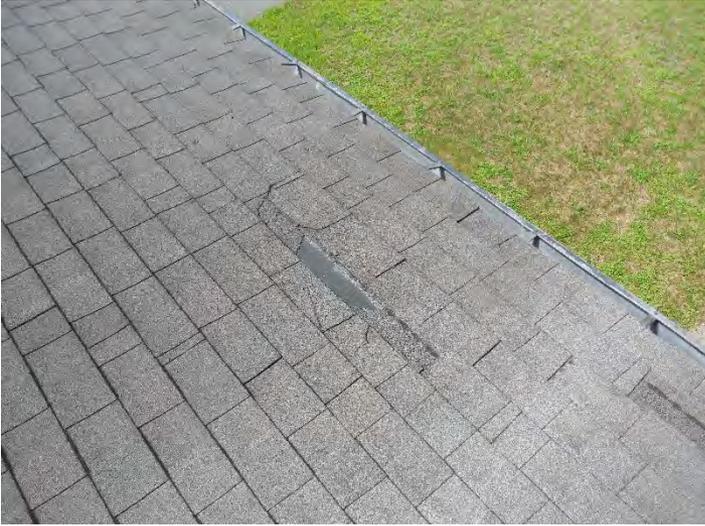
Partial view of roof at North side, area of exposed self-adhered membrane underlay
