TOWN OF SHREWSBURY
FACILITIES CONDITION ASSESSMENT OF
TOWN BUILDINGS

FINAL REPORT

June 01, 2016

**Shrewsbury
Police Station**

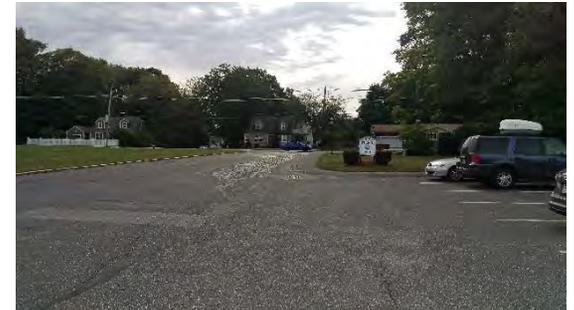
SPS E1

- i. The pavement condition of the vehicular entrances and interior circulation system ranges from good to fair throughout the site.

- i. Implement a program of replacing damaged or worn pavement throughout the site.

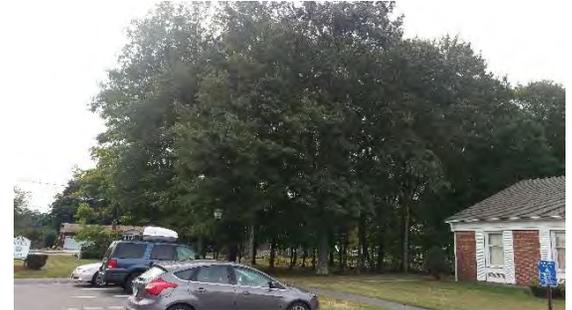
SPS E2

- i. The pavement condition of the parking areas mirrors that of the vehicular entrances, ranging from good to fair to poor throughout the site, with little evidence of recent repairs.

- i. Implement a program of replacing damaged or worn pavement throughout the site.

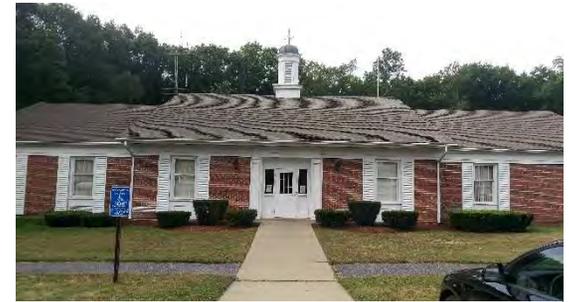
SPS E4

- i. The condition of the pavement on the site ranges from fair to poor throughout.

- i. Implement a program of replacing damaged or worn pavement throughout the site.
- ii. Implement a program to review accessible pedestrian routes throughout the site for safety and compliance with current MAAB standards.

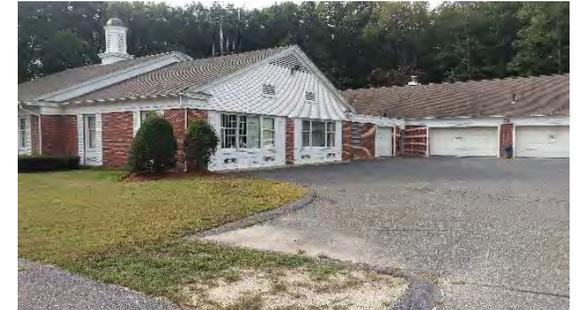
SPS E5

- i. The pavement in the loading area, and concrete aprons into the garage doors all appear in good to fair condition.
- ii. Confirm that loading area meets current needs of the building.

- i. Maintain condition of loading area.

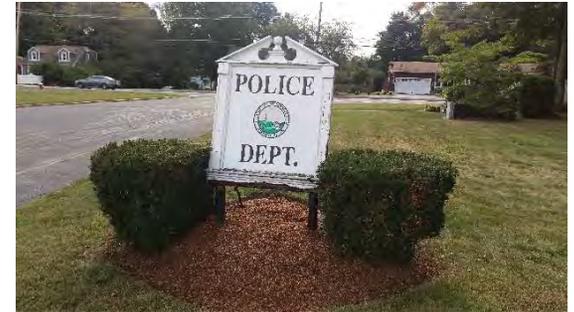
SPS E7

- i. The sign appears to be in poor condition and is not visible from Maple Ave.

- i. Develop a signage identity program for the campus to improve visibility from Maple Street.

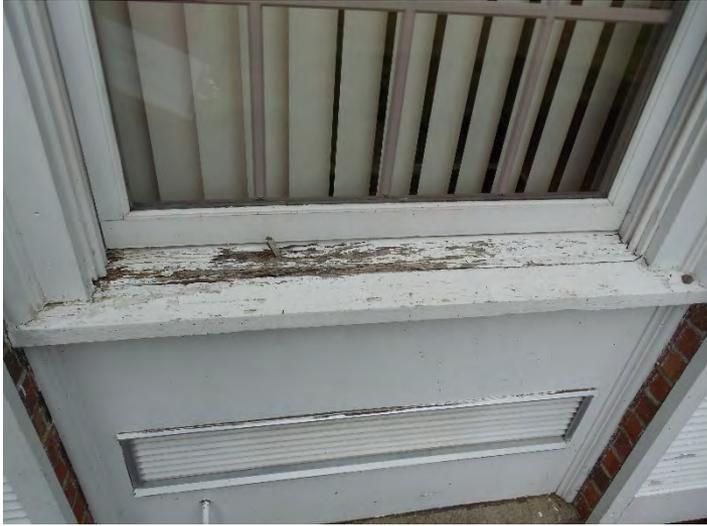
Northeast Elevation, rotted windowsill

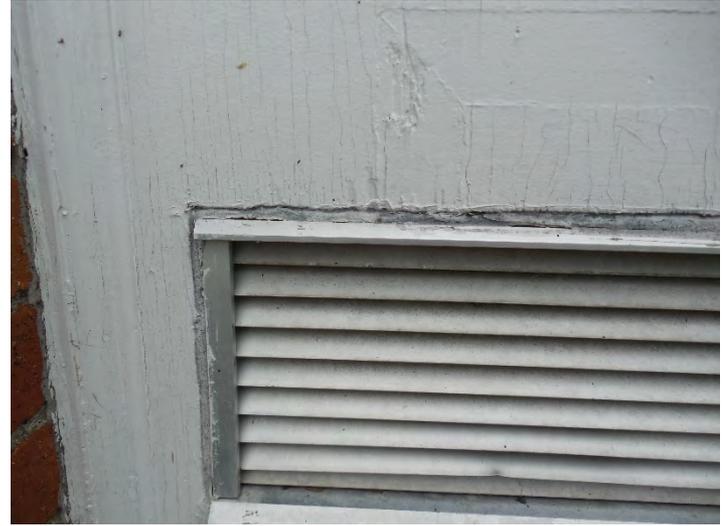
Northeast Elevation, failed sealant around louver

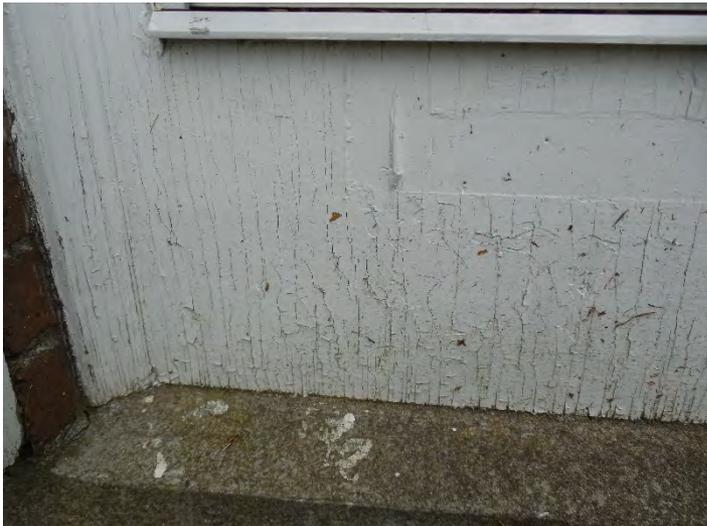
Northeast Elevation, peeling paint below a window

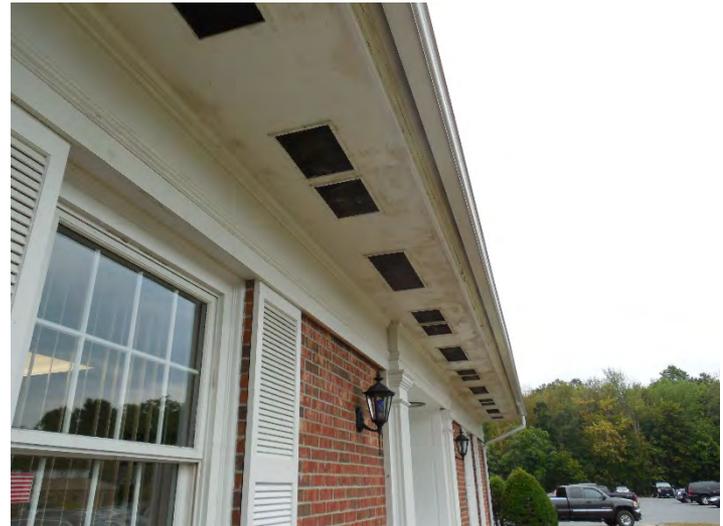
Northeast Elevation, soffit intake vents

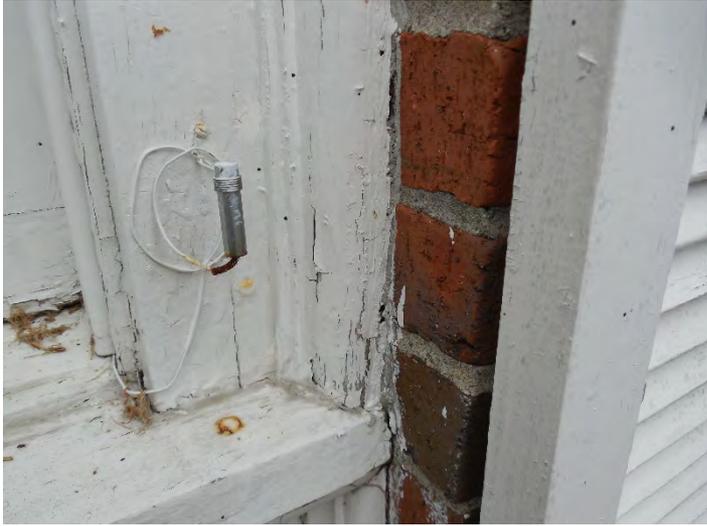
Northeast Elevation, window perimeter sealant failure

- i. Replace failed sealants; plan ongoing replacement approximately every 5-10 years.

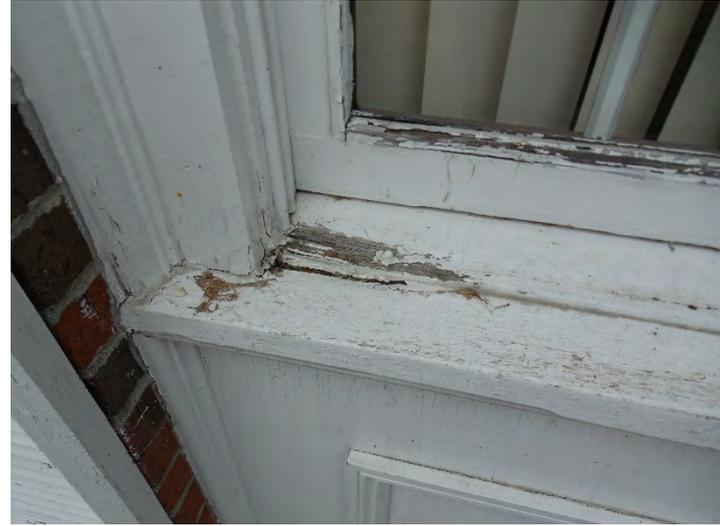
Northeast Elevation, rotted windowsill

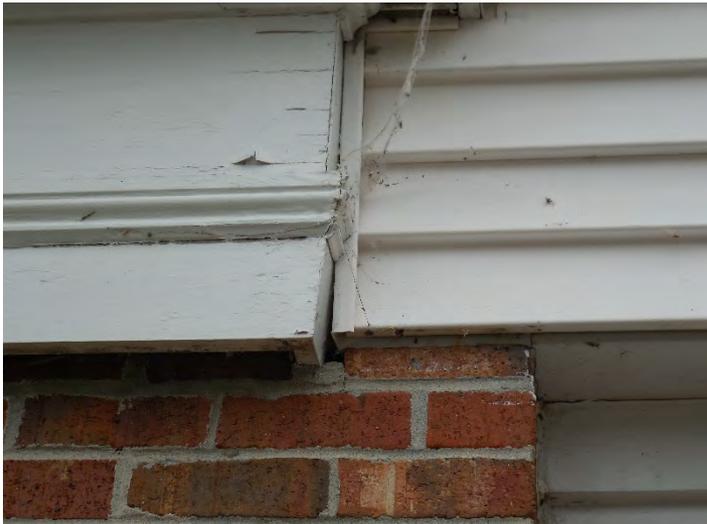
Northwest Elevation, peeling paint and an open joint

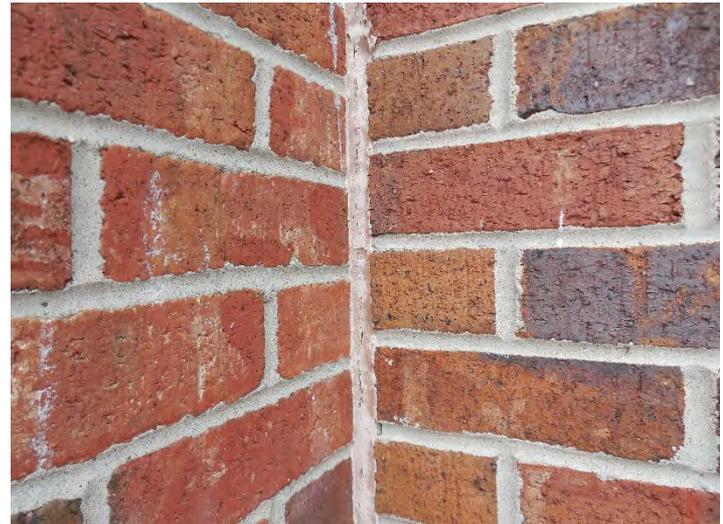
Northwest Elevation, sealant failure at an expansion joint

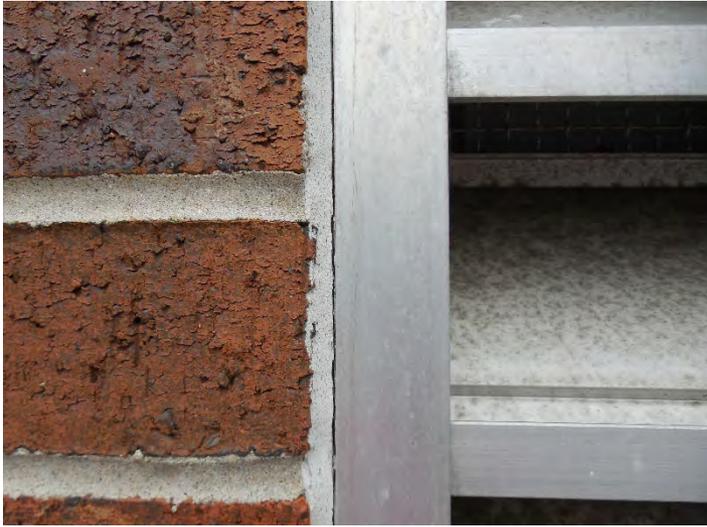
Northwest Elevation, sealant failure around a louver

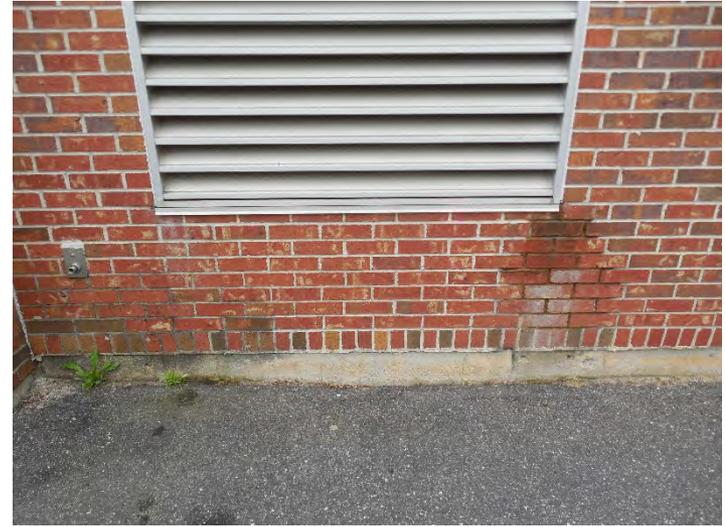
Northwest Elevation, staining and mortar deterioration under a louver

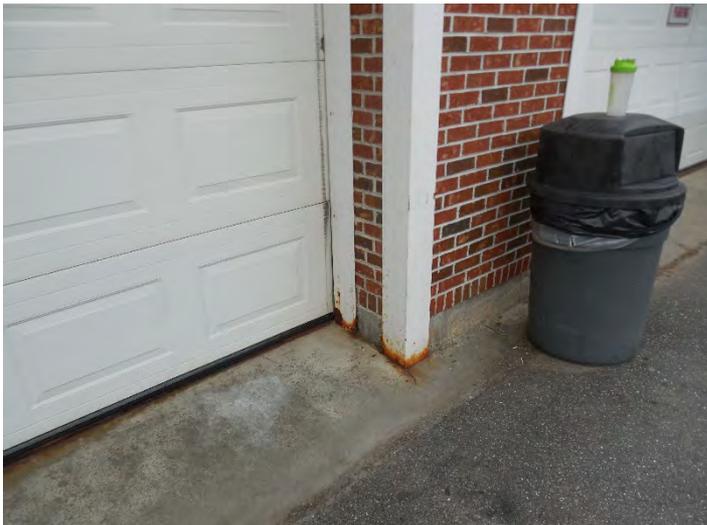
Northeast Elevation, corroded corner guards

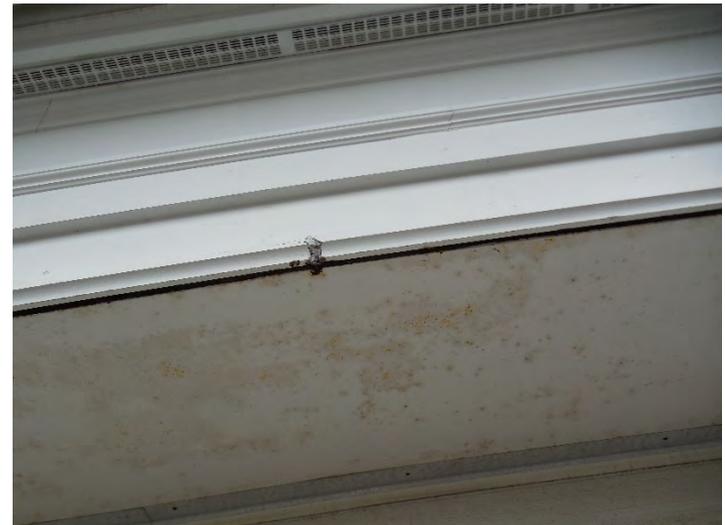
Northeast Elevation, damaged trim

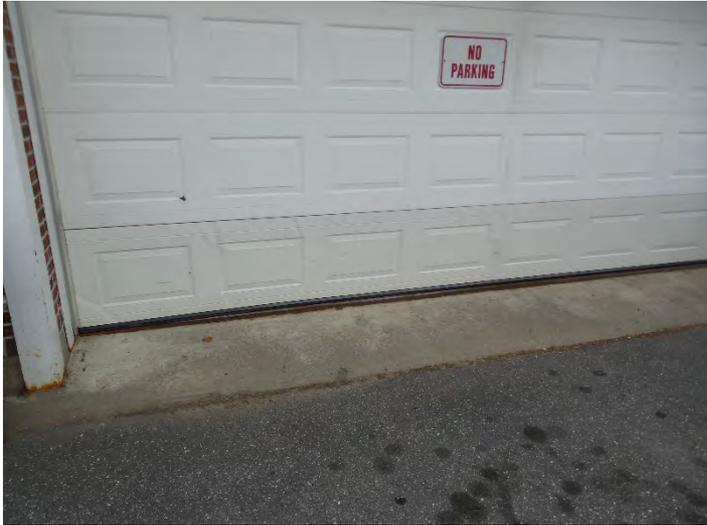
Northeast Elevation, damaged overhead door

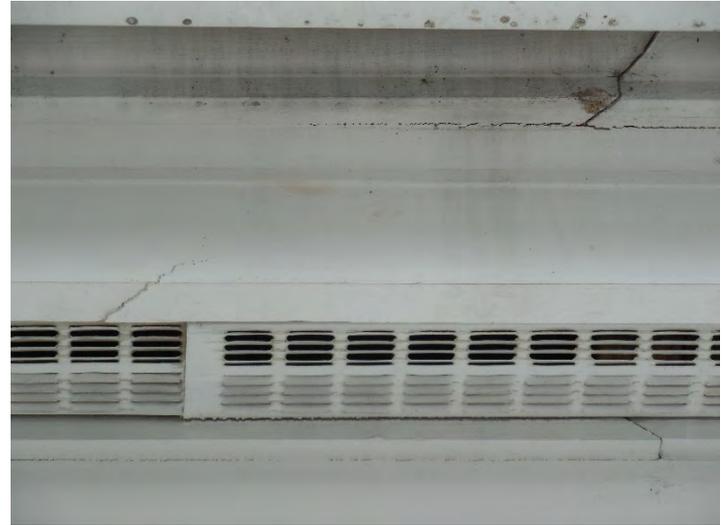
Northeast Elevation, damaged trim

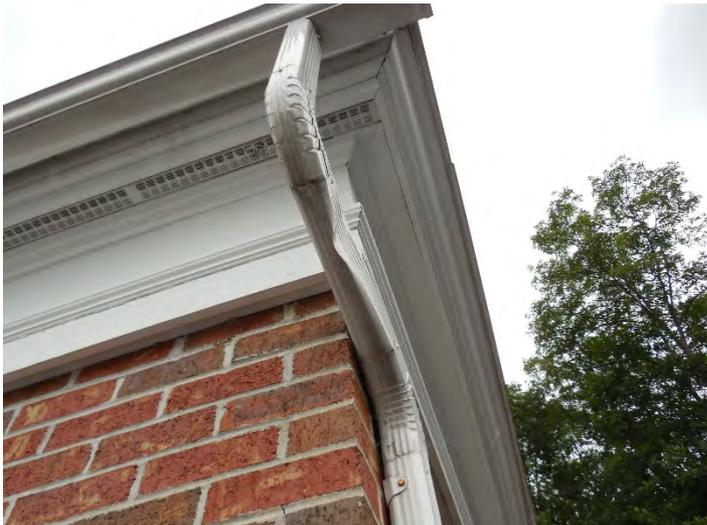
Northwest Elevation, damaged downspout

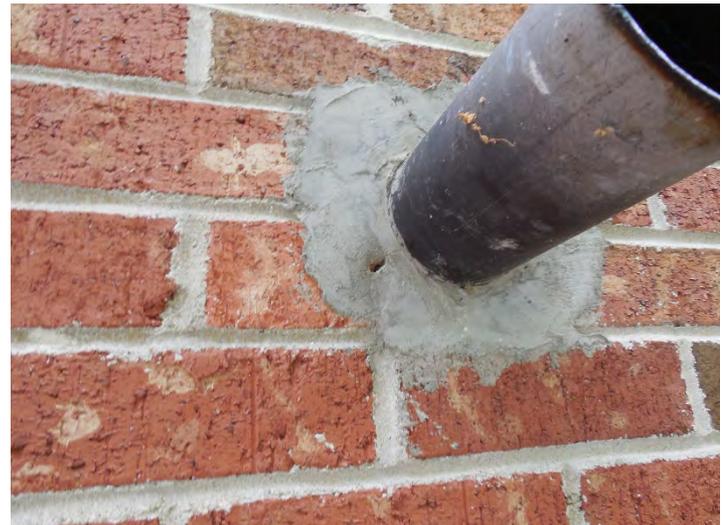
Southwest Elevation, gap in pipe penetration sealant

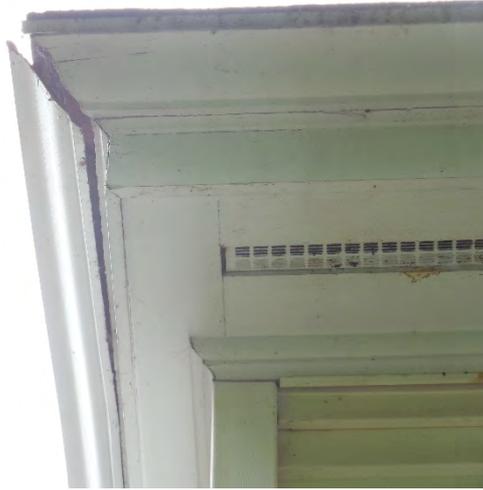
Southwest Elevation, damaged trim

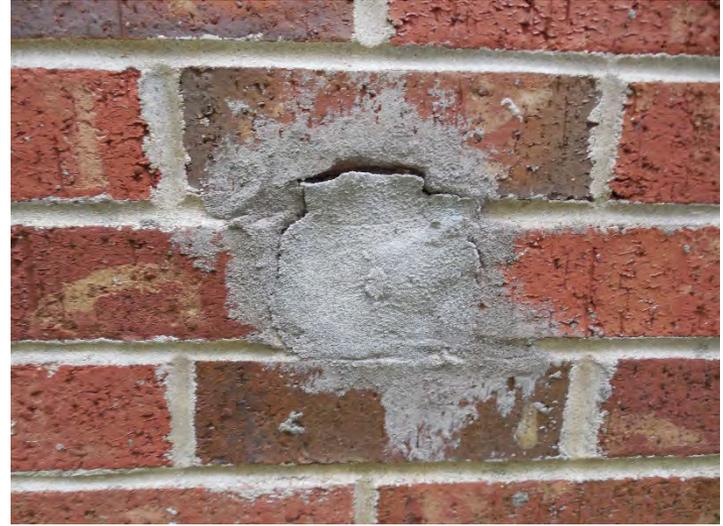
Southwest Elevation, failed patch

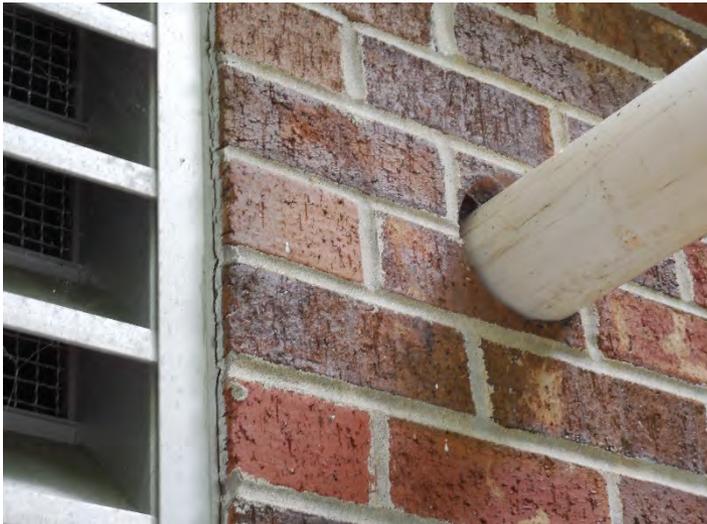
Southwest Elevation, open pipe penetration and failed perimeter sealant at a louver

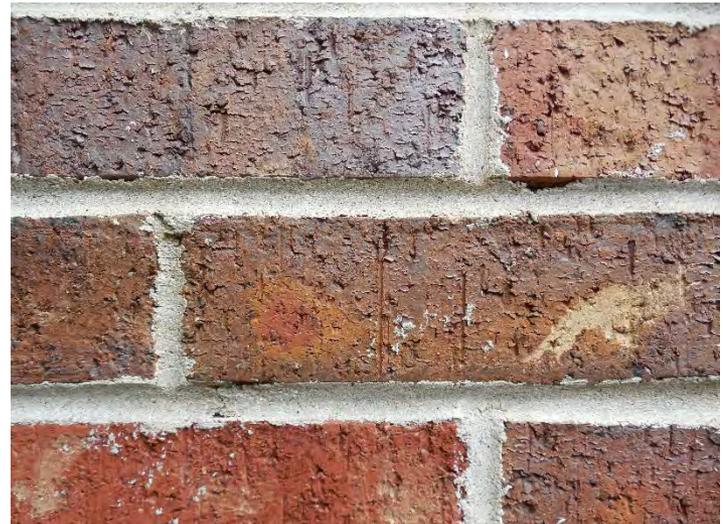
Southeast Elevation, hole in mortar

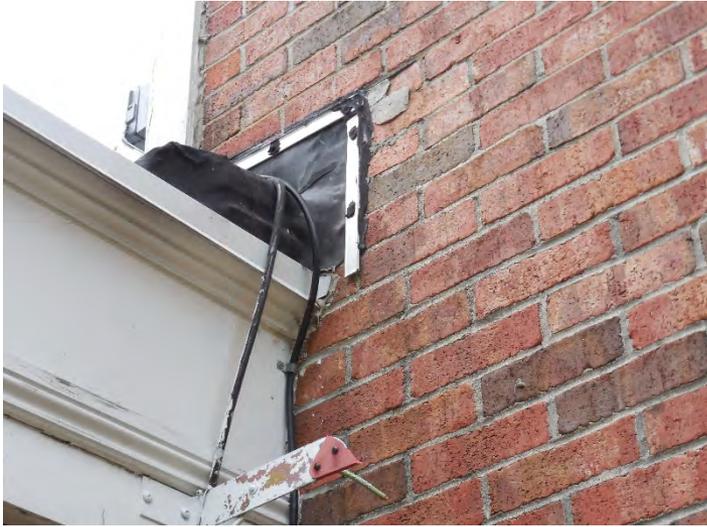
Southeast Elevation, open edges at roof corner flashing

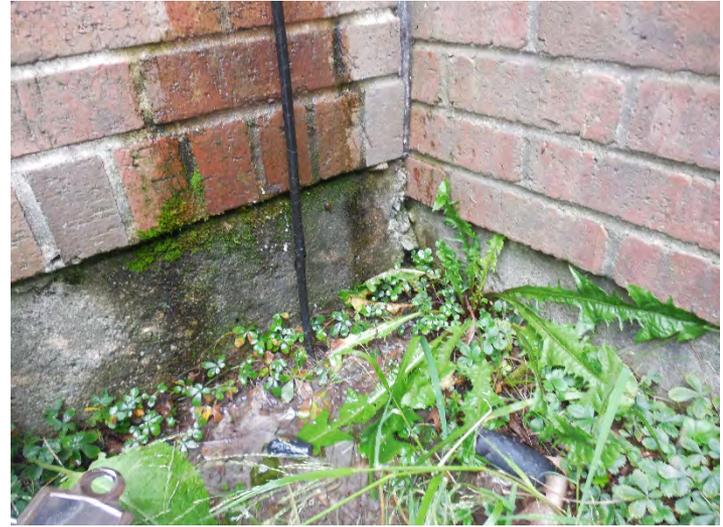
Southeast Elevation, open joint in concrete foundation

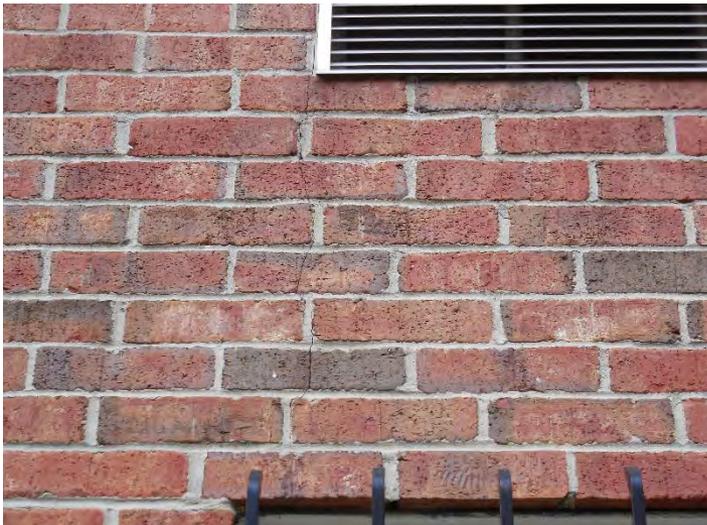
Southwest Elevation, crack through brick and mortar joints

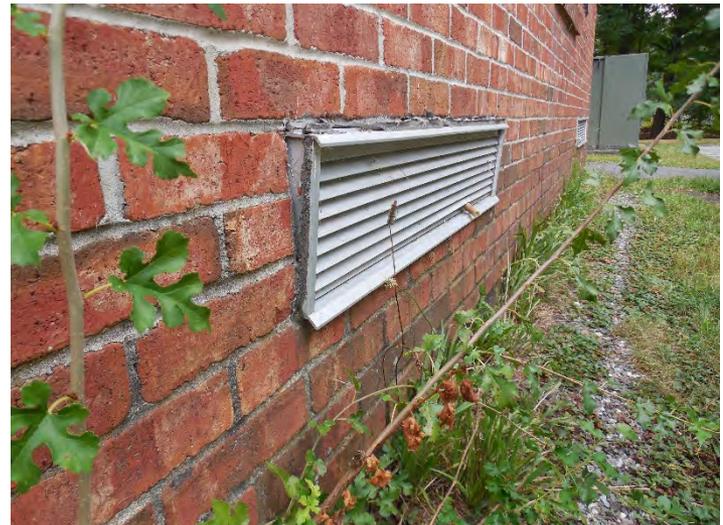
Southwest Elevation, failed sealant and displaced louver

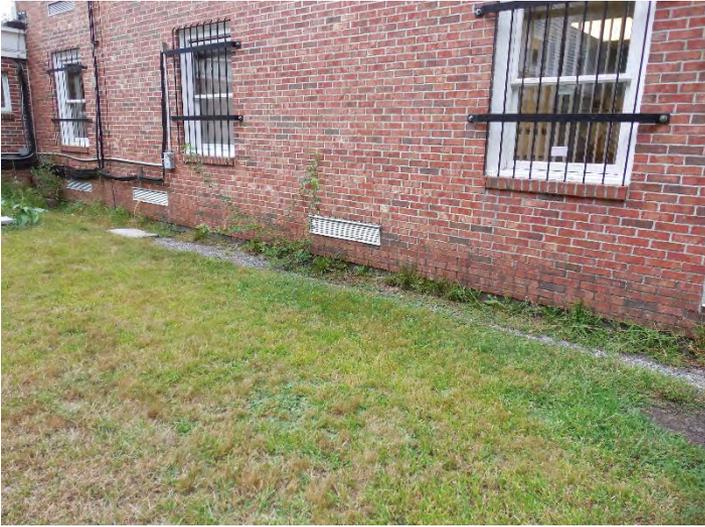
Southwest Elevation, staining along base of wall

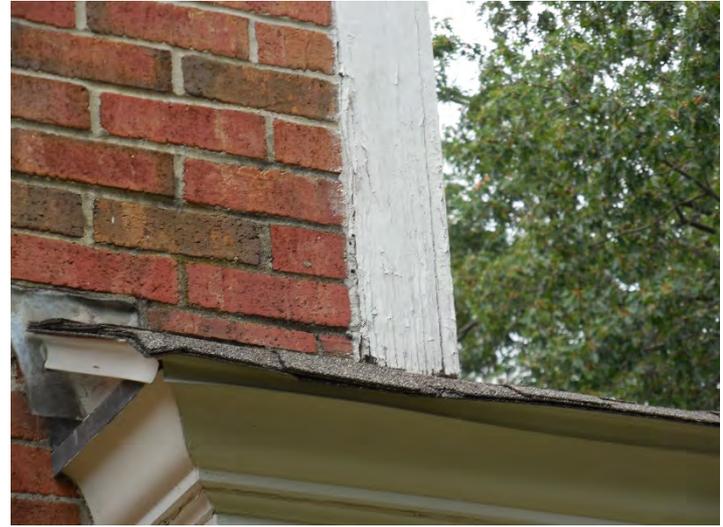
Southwest Elevation, deteriorated trim

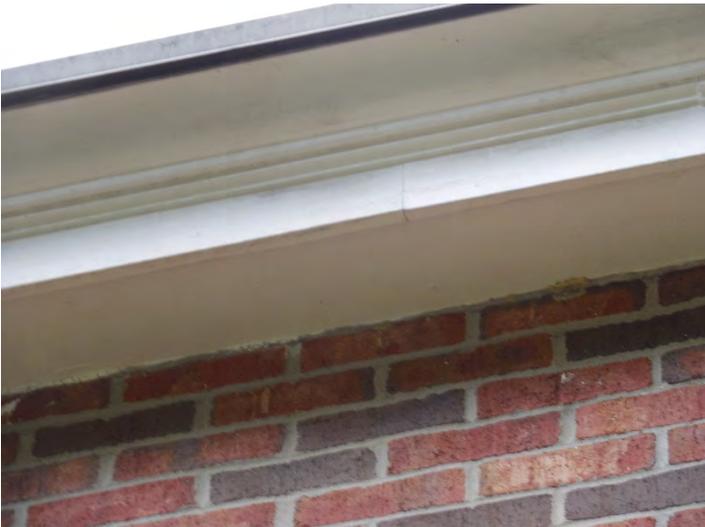
Southwest Elevation, no soffit intake vents

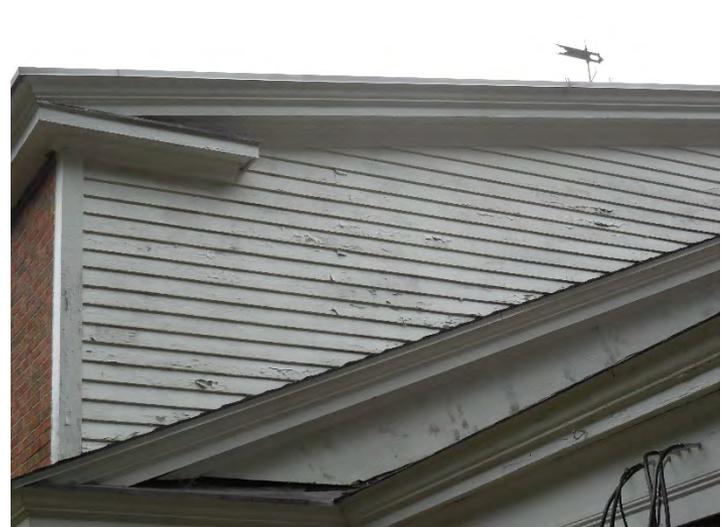
Southwest Elevation, peeling paint

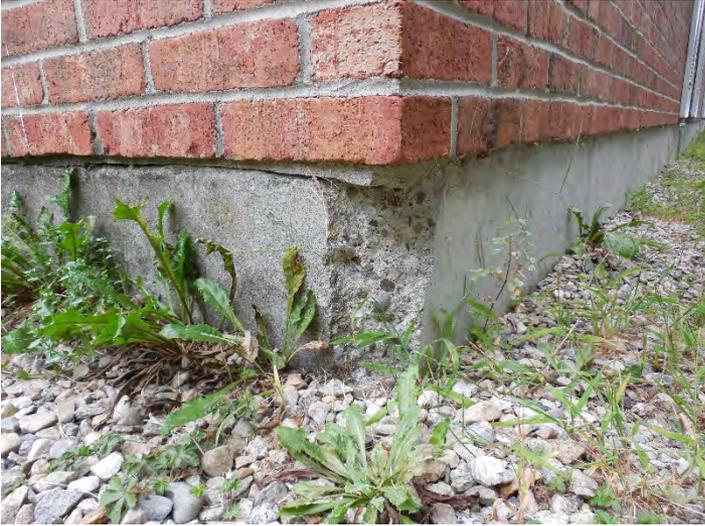
Southwest Elevation, deteriorated concrete foundation

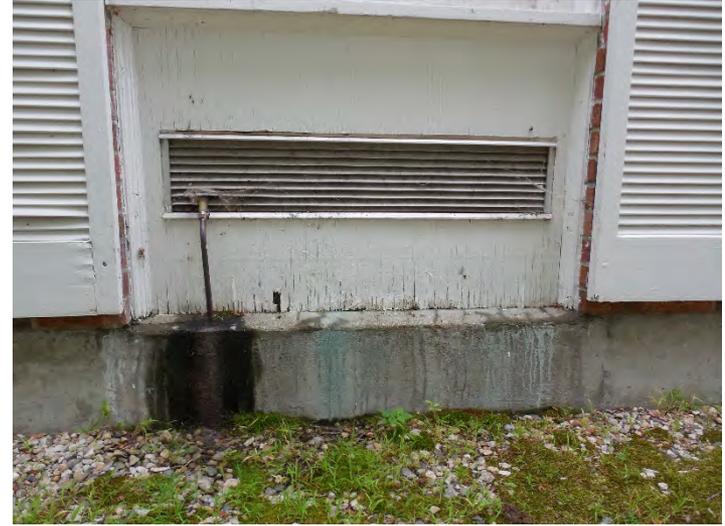
Southeast Elevation, stained and cracked concrete, deteriorated trim, dripping condensate line

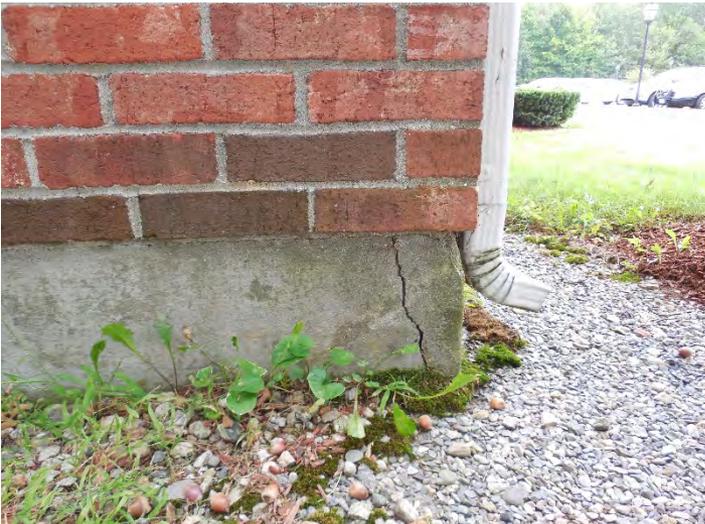
Southeast Elevation, crack in concrete

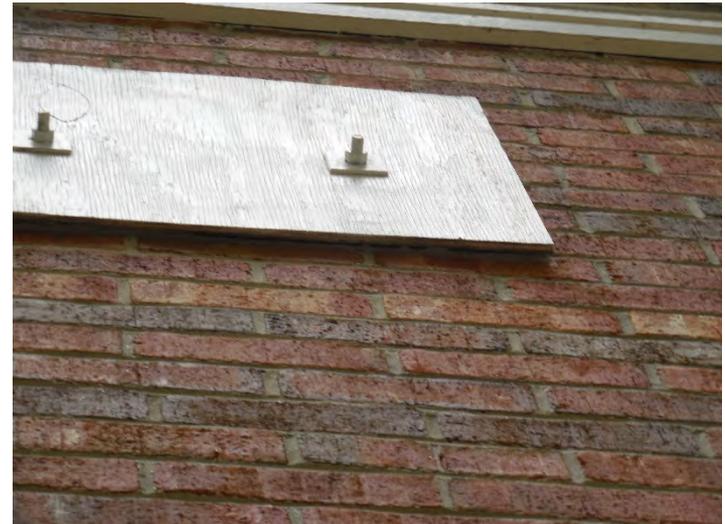
Southeast Elevation, failed perimeter sealant

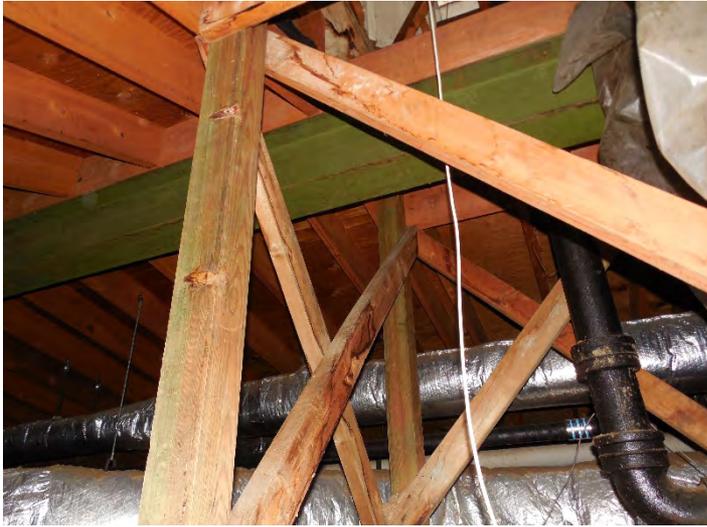
Attic, water staining on interior framing

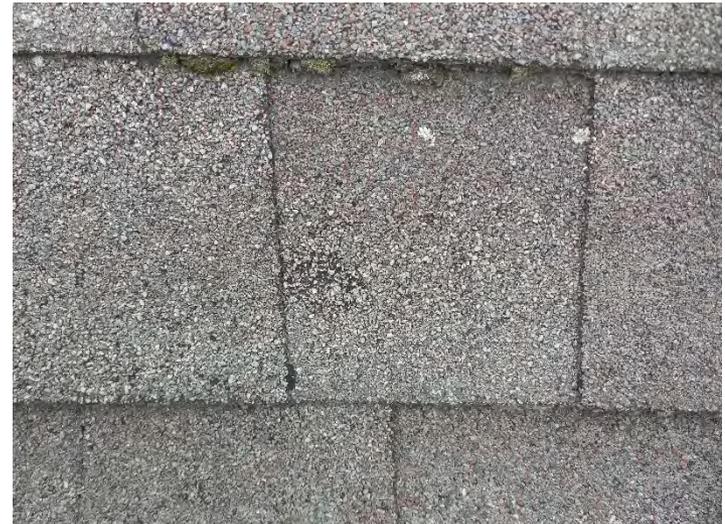
Typical roof shingles with granule loss and algae growth

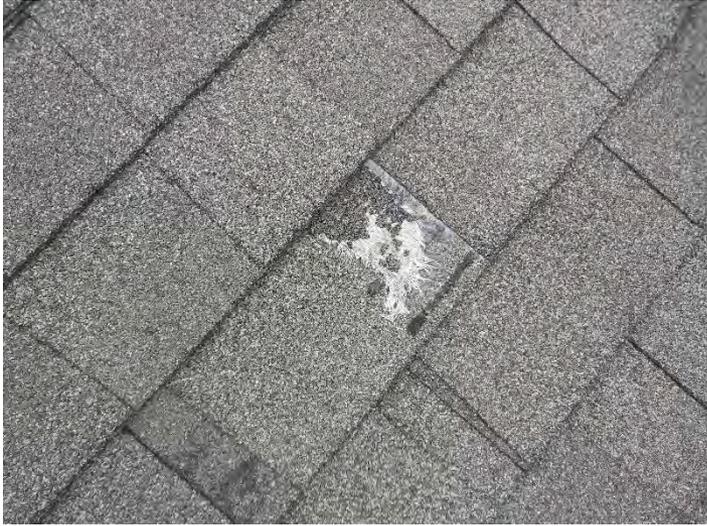
Broken shingle tab

- i. Repair isolated damage as soon as possible. Implement a program of annual inspections.
- ii. Plan to replace asphalt shingle roofing in 2022 to 2026.

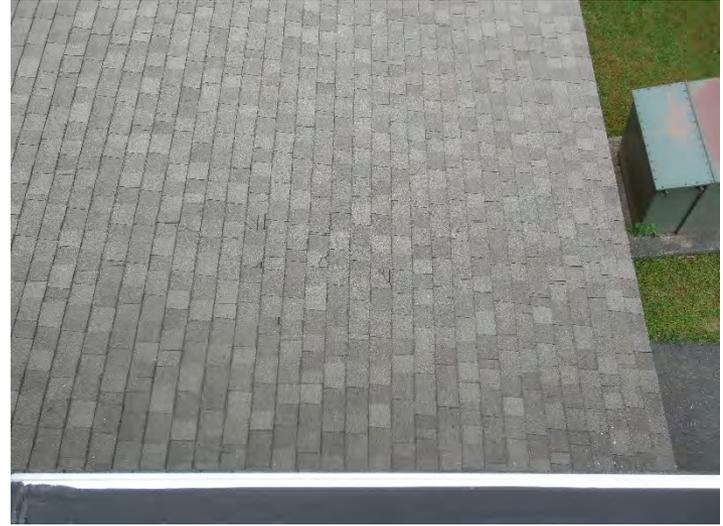
Broken shingle tabs

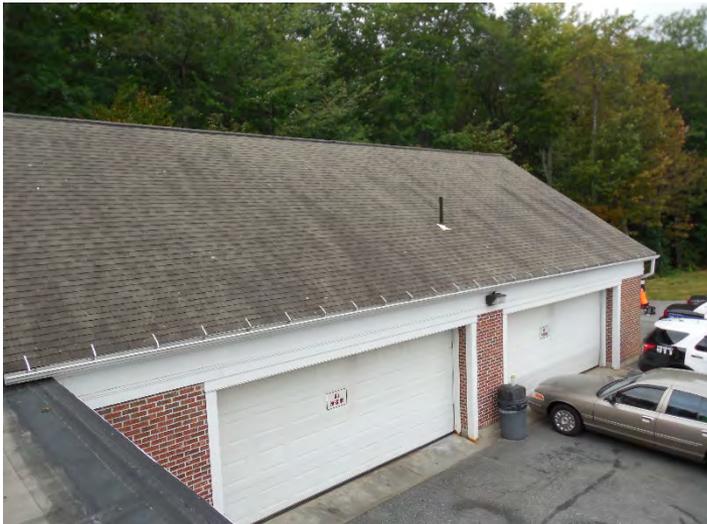
Deteriorated and stained shingles; several spots of algae

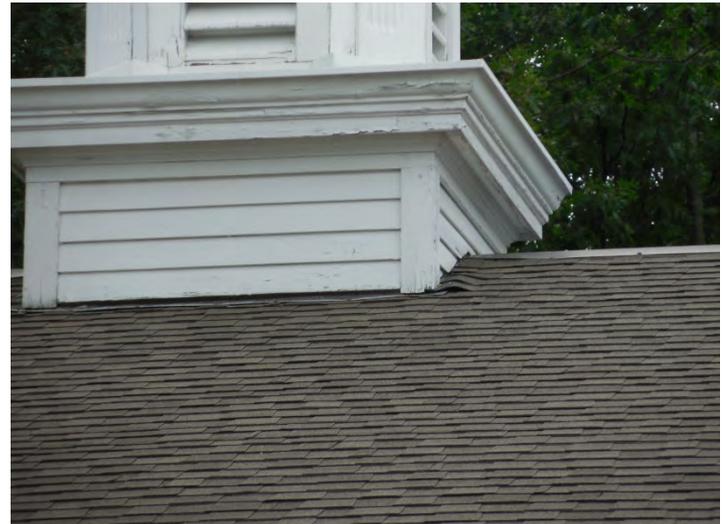
Buckled shingles around the cupola

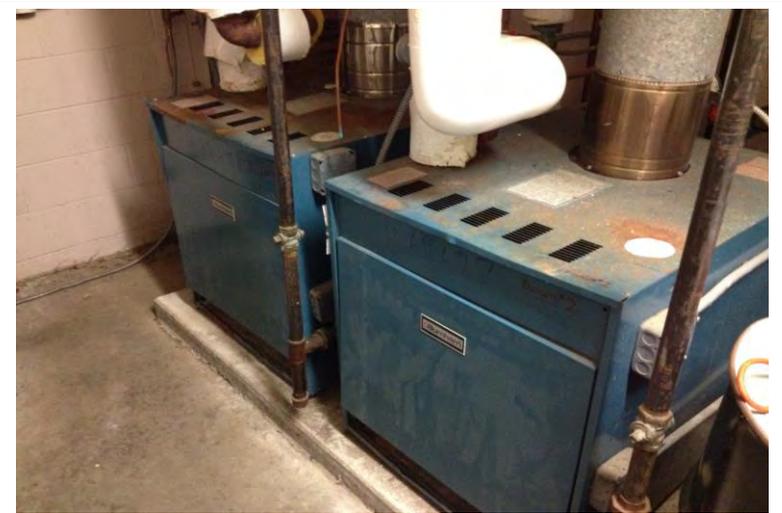
SPS M1 Boilers B-1 & B-2

- Boilers: The existing gas fired hot water boilers are Burnham model 807B-WI each with a net output of 275 MBH. Both have a dedicated boilers pump and are natural draft. Upon visual inspection the burners appeared to be in good condition although the outer shell is showing signs of rusting. The boilers appear to be original to the 1995 renovation. The boilers are controlled by a Tekmar Boiler Control system. The two combustion air dampers for the boiler room are not functioning. The high damper is closed and not opening and the lower damper is stuck open.

- i. Suspect water system quality issues. Check heating and cooling system water/glycol mixture and quality for proper chemistry.
- ii. Replace boilers with high efficiency condensing boilers.
- iii. Repair/Replace combustion air dampers and actuators.
- iv. Replace existing Hot Water Pumps.
- v. Replace existing perimeter FCU's.
- vi. Replace existing BMS System
- vii. Replace existing air cooled chiller.
- viii. Replace existing chilled water pumps.

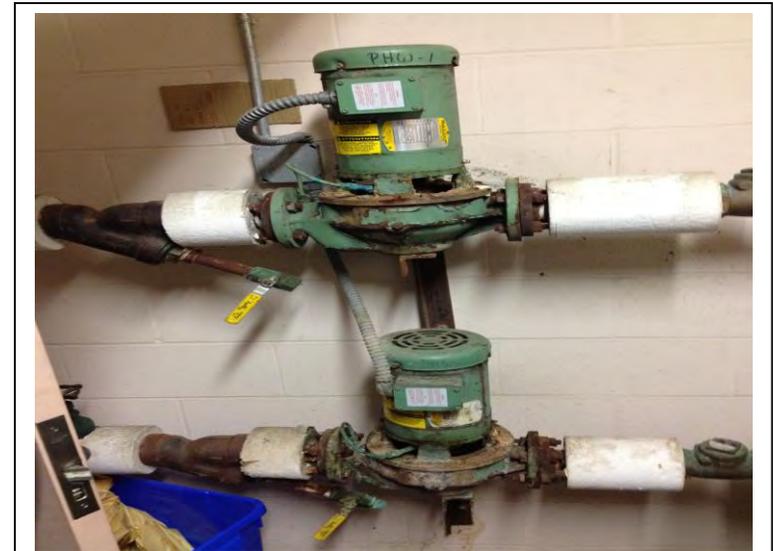
SPS M3 – Hot Water Pumps

- Hot Water Pumps: The existing inline constant volume hot water pumps are original to the 1995 renovation and are in poor condition. Upon visual inspection it was noticed that the glands are showing signs of leaking and there is significant signs of corrosion. The Hot water pump labeled PHW-2 is extremely noisy.

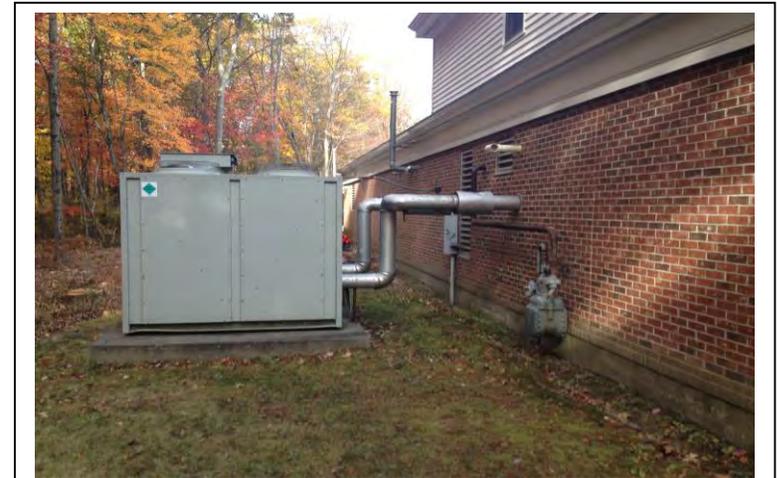
SPS M5 – Air Cooled Chiller

- The existing air cooled chiller is a Trane model CGAEC30 and is original to a 1995 renovation. The unit is a nominal 30 Ton single circuit unit and has R-12 as its refrigerant. It is located outside on grade. Upon visual inspection of the unit the compressors and condenser coils appeared to be in good condition but the condenser coils are dirty.
- Chilled Water Pumps: The existing inline constant volume chilled water pumps are original to a 1995 renovation and are in poor condition. Upon inspection it was noticed that there are significant signs of corrosion.
- The existing ductless split systems are newer are appeared to be in good condition. Most of the units are in the ton to 1.5 ton range.
