**TOWN OF SHREWSBURY**  
FACILITIES CONDITION ASSESSMENT OF  
TOWN BUILDINGS

**FINAL REPORT**

June 01, 2016

**Shrewsbury  
Town Hall**

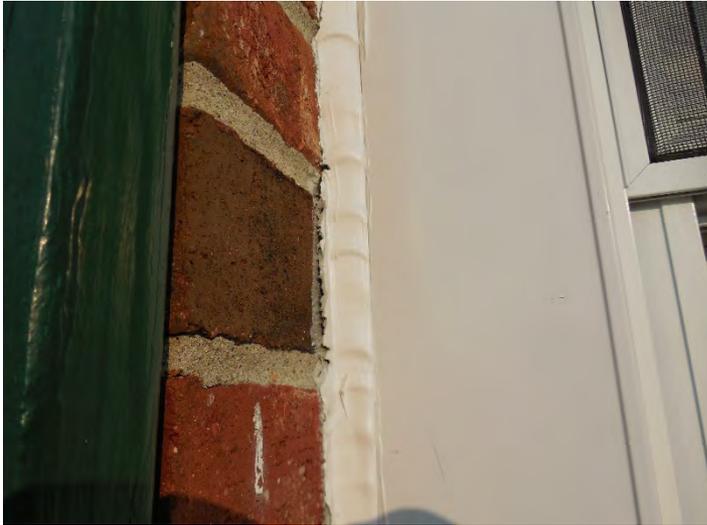
Southeast Elevation, failed window perimeter sealant

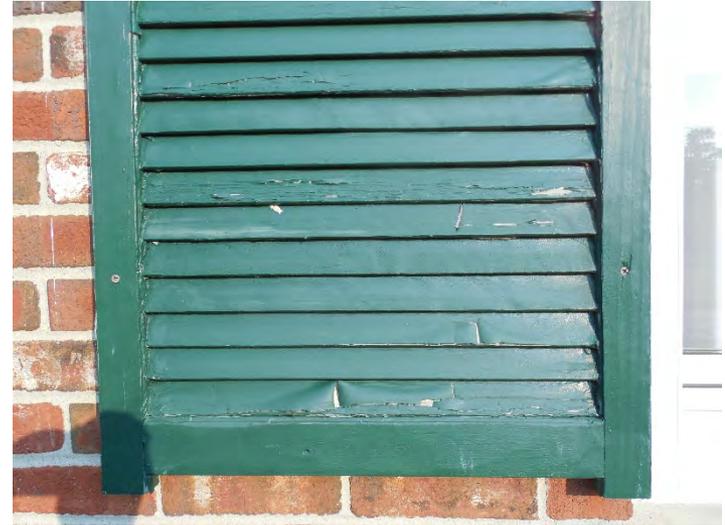
Southeast Elevation, peeling paint on a shutter

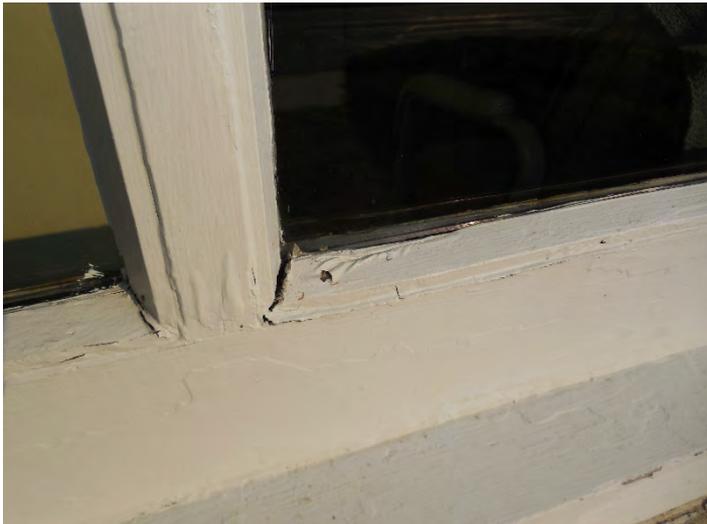
Southeast Elevation, broken glazing stop

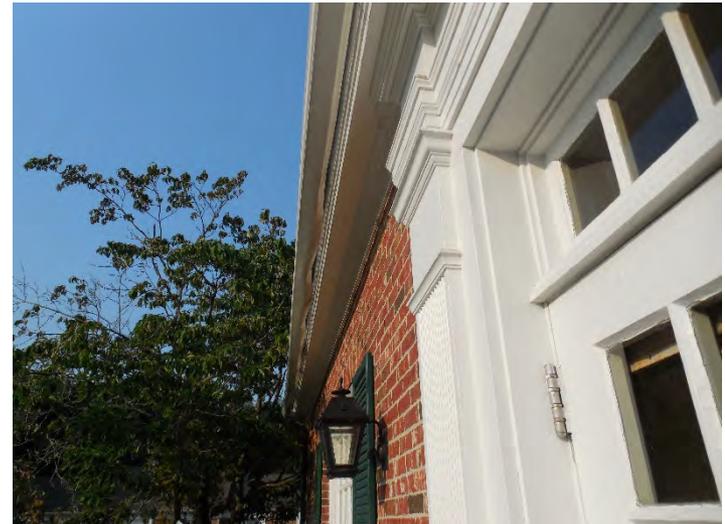
Southeast Elevation, twisted and bent section of gutter, and paint is peeling at fascia

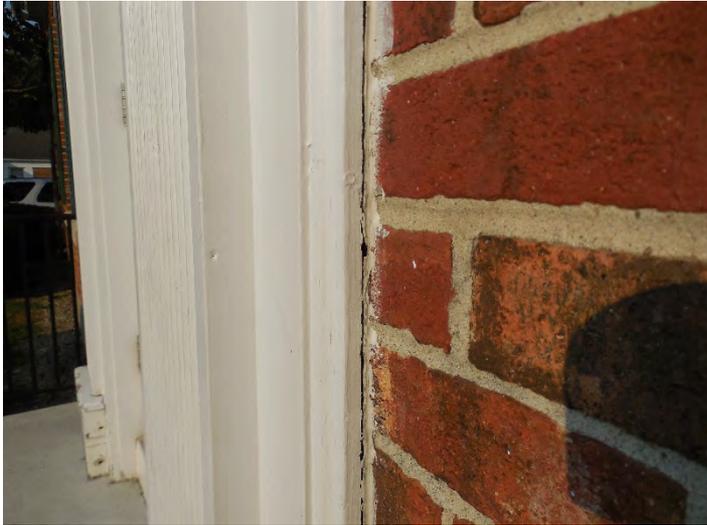
Southeast Elevation, failed door perimeter sealant

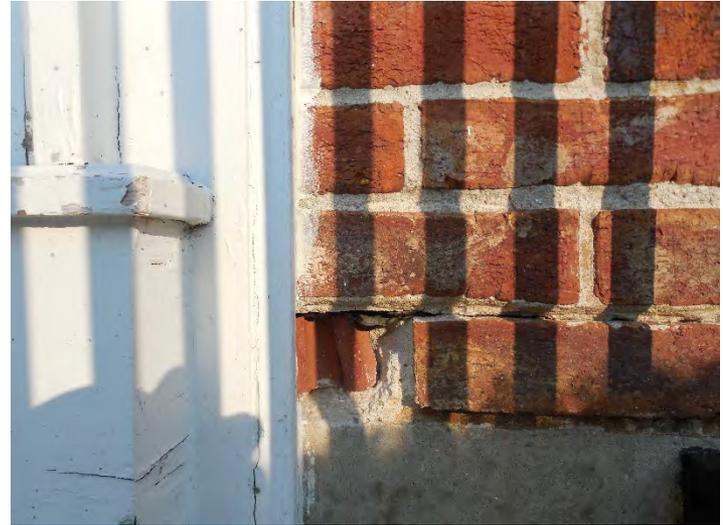
Southeast Elevation, missing brick

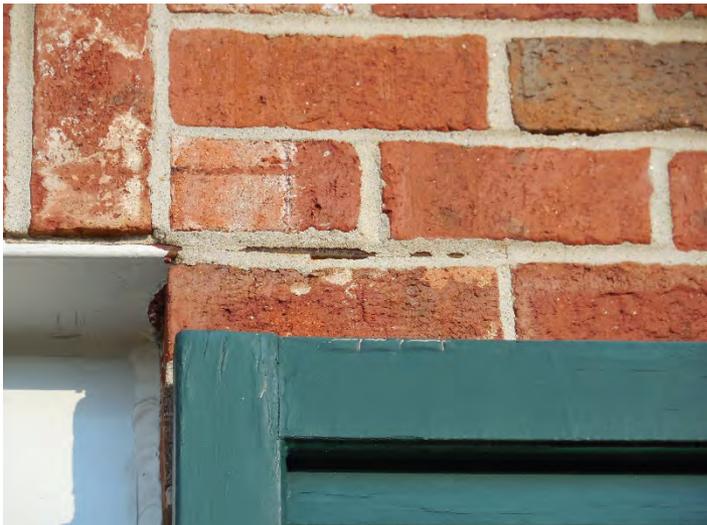
- i. Sealants require frequent replacement and should be considered an ongoing maintenance item.
- ii. Corroded lintels expand, causing surrounding brick to crack. Deteriorated masonry and continued lintel corrosion may present a falling hazard.

Southeast Elevation, corroded lintel above a window

- i. Replace failed sealants; plan ongoing replacement approximately every 5-10 years.
- ii. Replace deteriorated wood trim.
- iii. Replace corroded lintels with new galvanized lintels, and repair surrounding brick masonry.

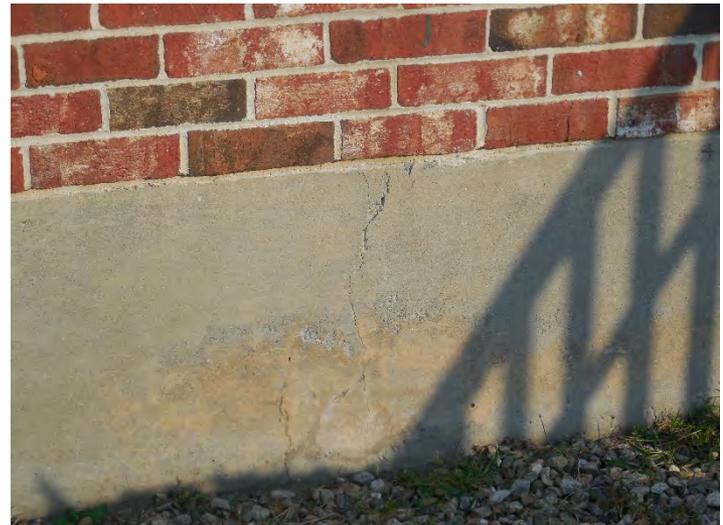
Southeast Elevation, crack at foundation

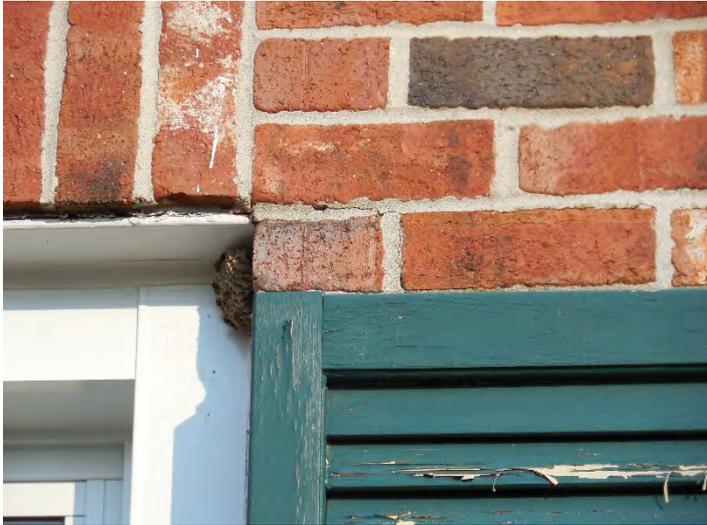
Southeast Elevation, corroded lintel above a window, and peeling paint on a shutter

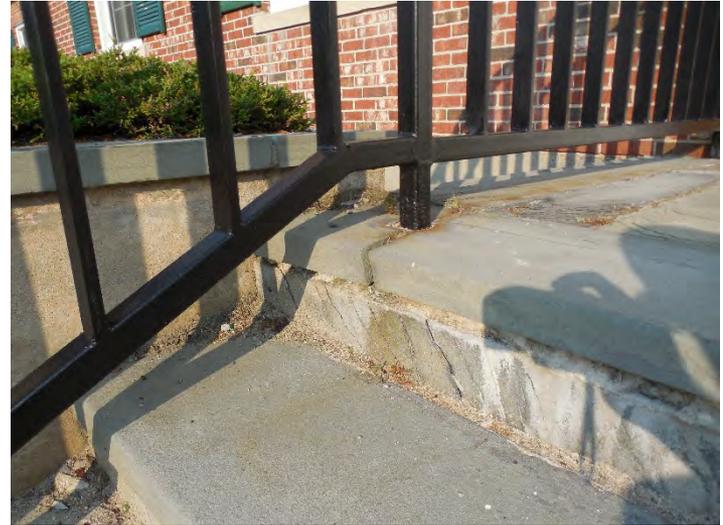
Southeast Elevation, deteriorated front entry steps

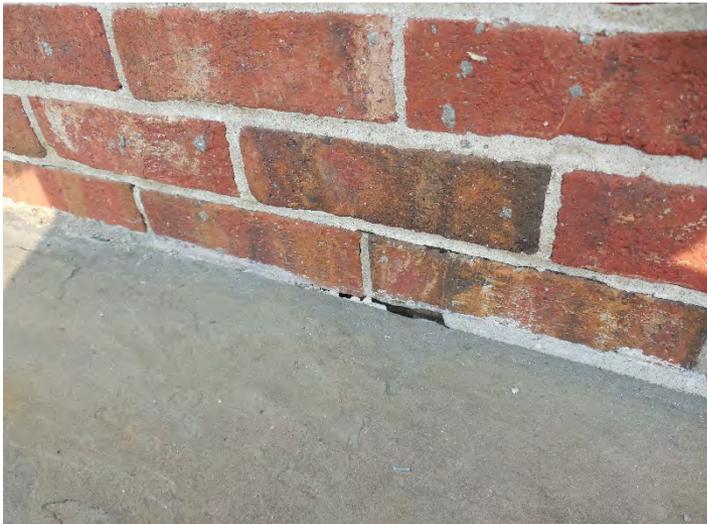
Southeast Elevation, deteriorated mortar at base of brick-to-ramp

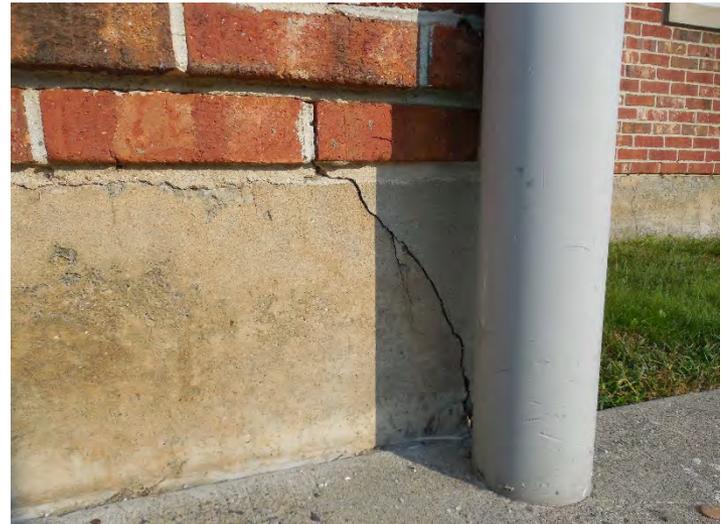
Southeast Elevation, crack through concrete foundation and brick mortar joint

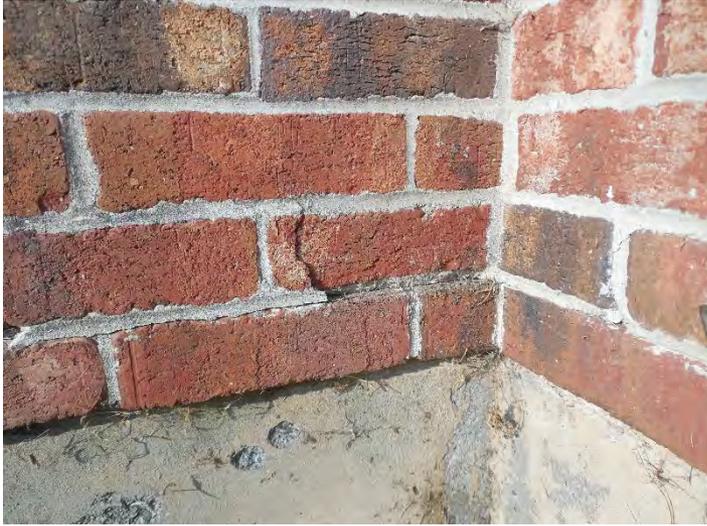
Southeast Elevation, spalled brick and scaling concrete

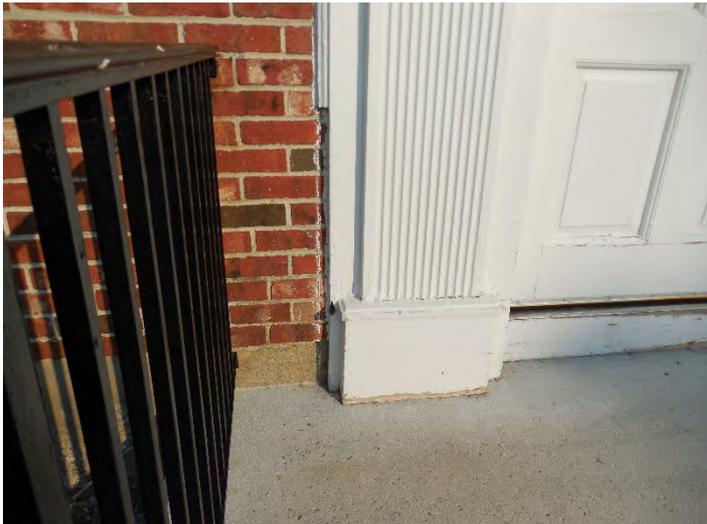
Southeast Elevation, missing section of door trim

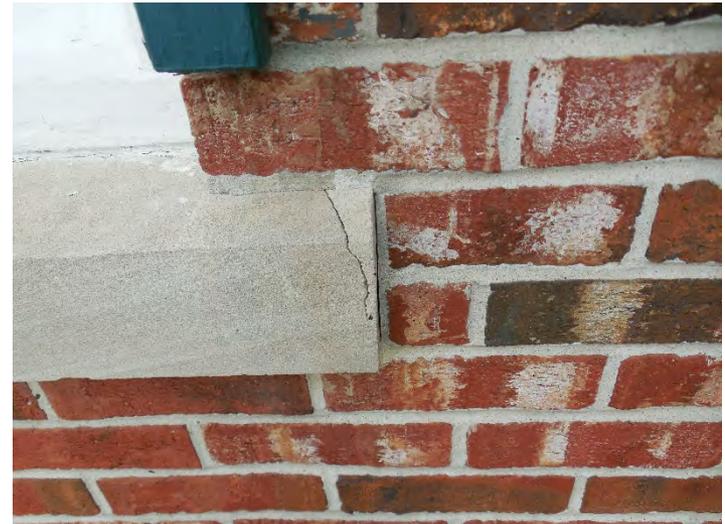
Southeast Elevation, crack at windowsill and failed sealant joints

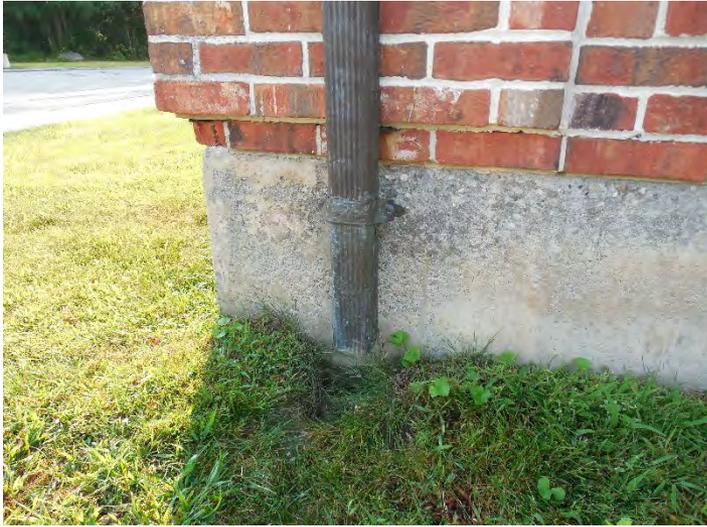
Northwest Elevation, missing storm water connection at grade, scaled concrete behind downspout

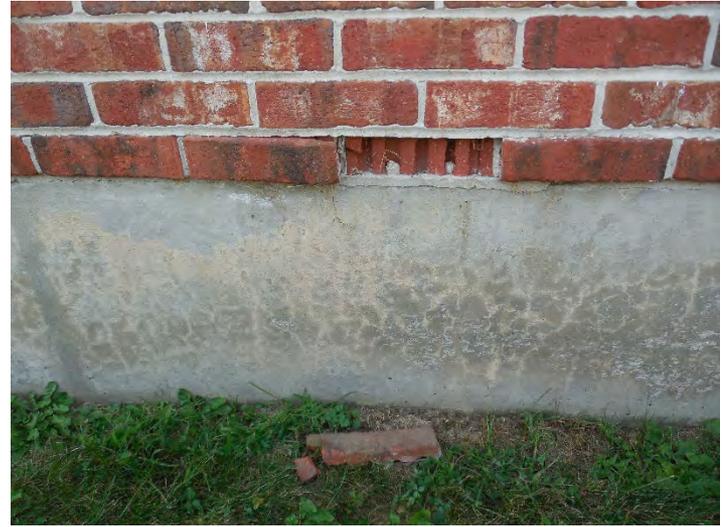
Northwest Elevation, spalled brick

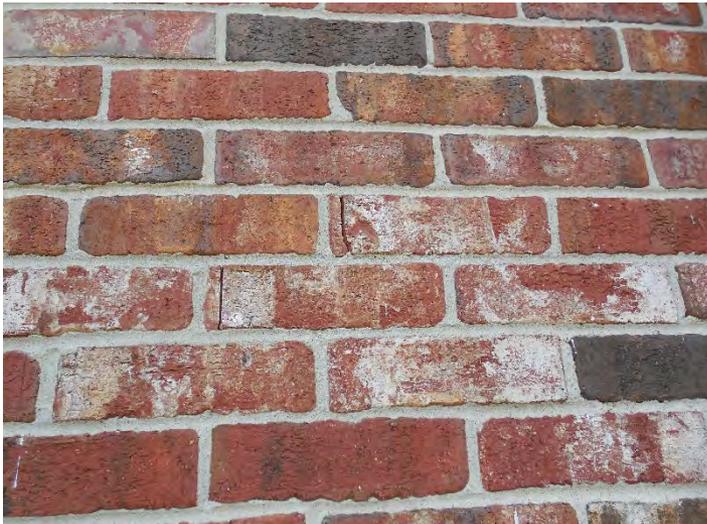
Northwest Elevation, cracked and stained bricks

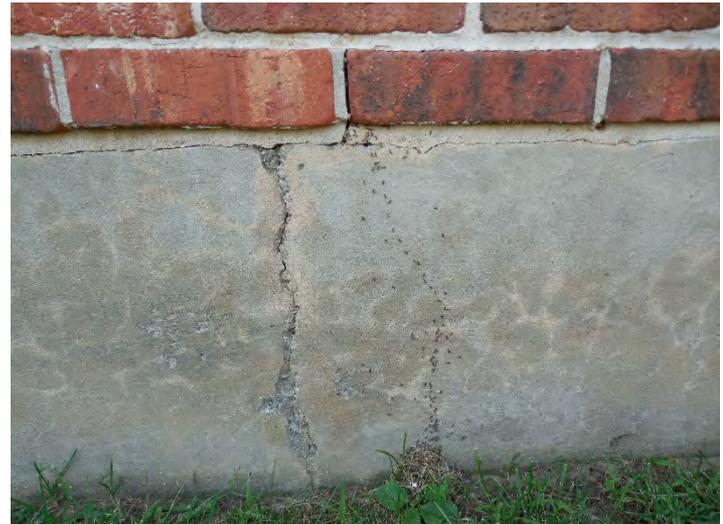
Northwest Elevation, cracked mortar and concrete, with insect activity

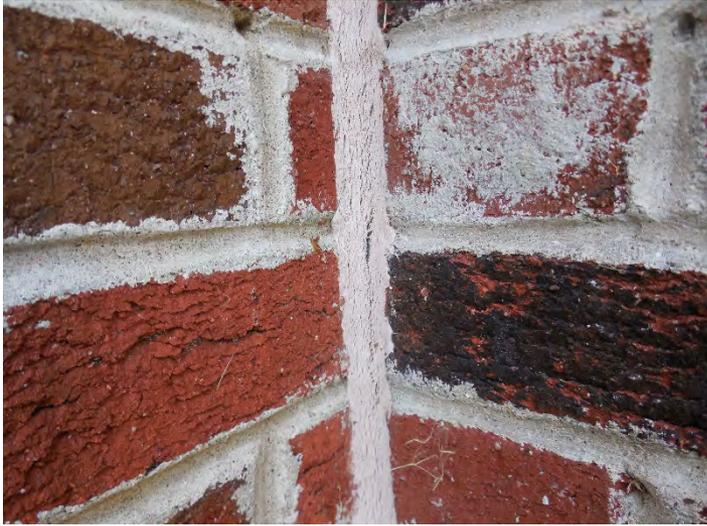
Northwest Elevation, failed sealant at an expansion joint

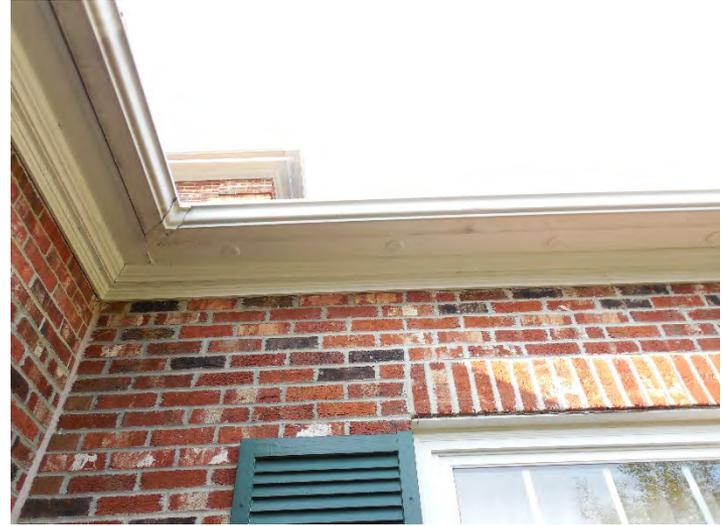
Northeast Elevation, round soffit vents, but no ridge vent; and Northwest Elevations, no soffit intake vents

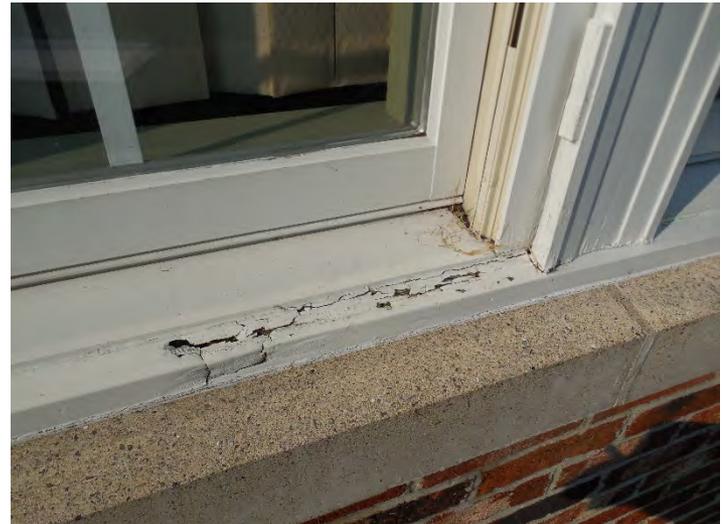
Northeast Elevation, rotted wood window trim

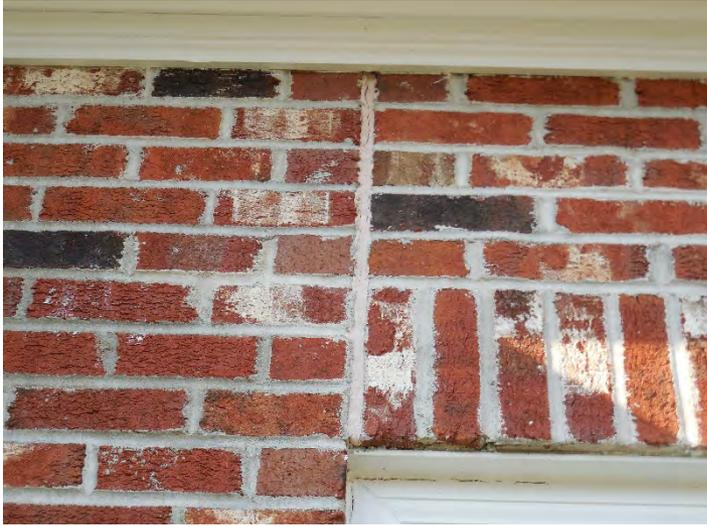
Northeast Elevation, sealant failure at an expansion joint

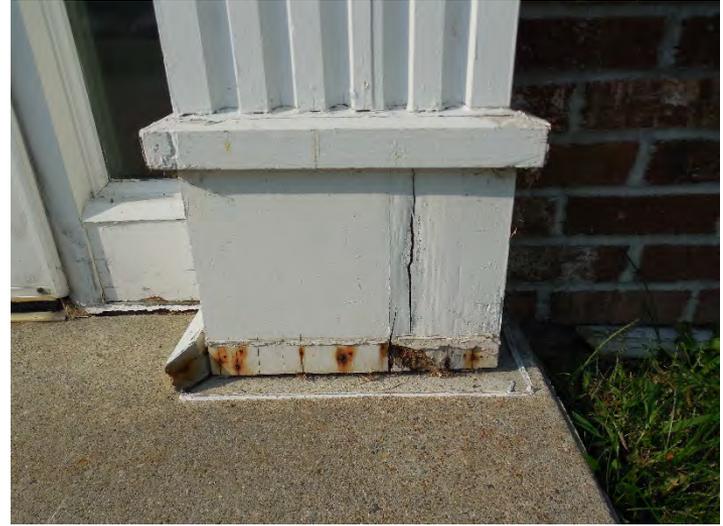
Northeast Elevation, missing, deteriorated, and cracked trim

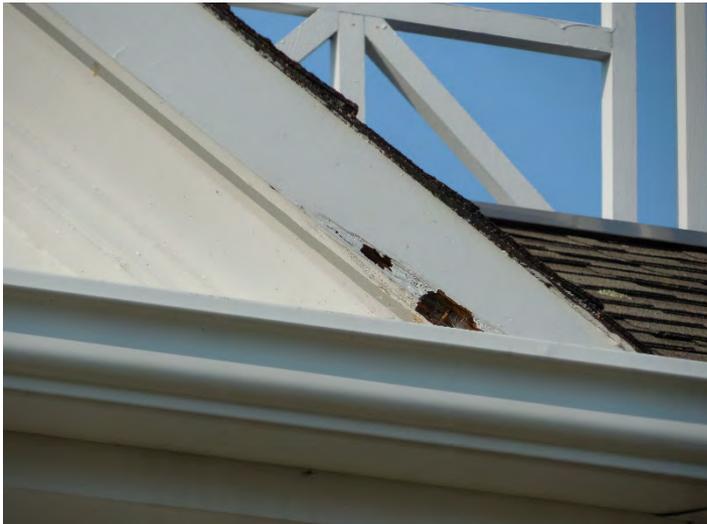
Northeast Elevation, rotted wood trim

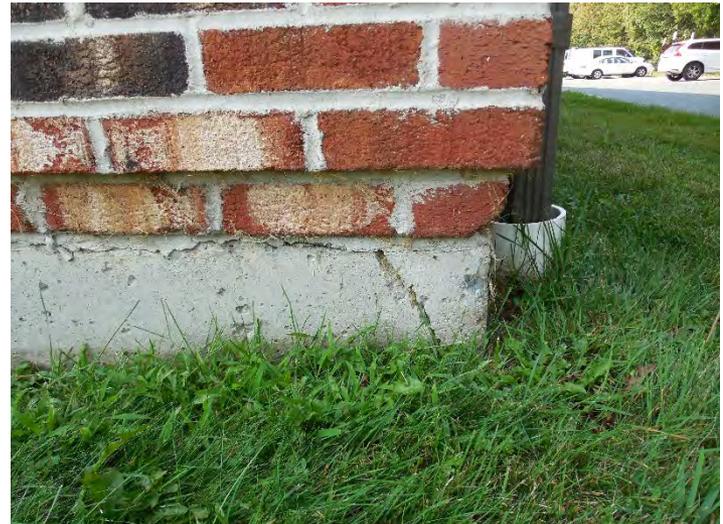
Northwest Elevation, crack in concrete foundation

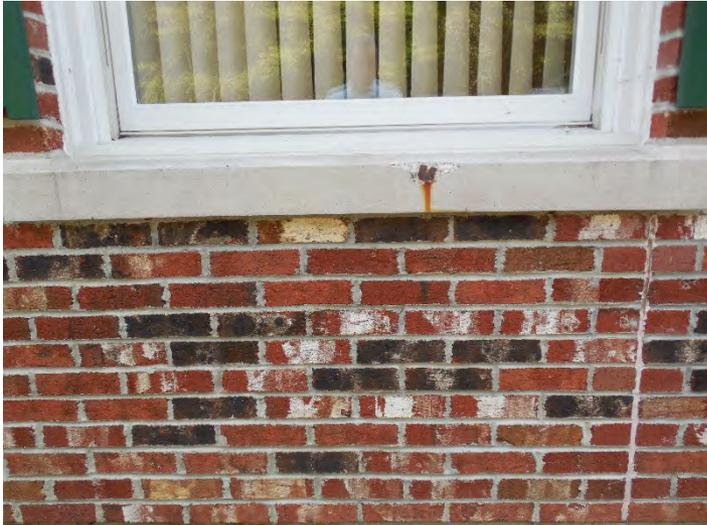
Northwest Elevation, concrete spall at embedded metal

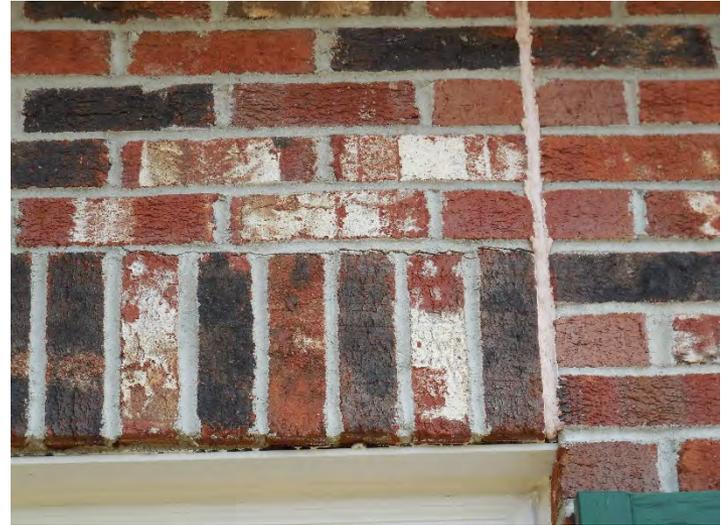
Southwest Elevation, crack in mortar joint above a window

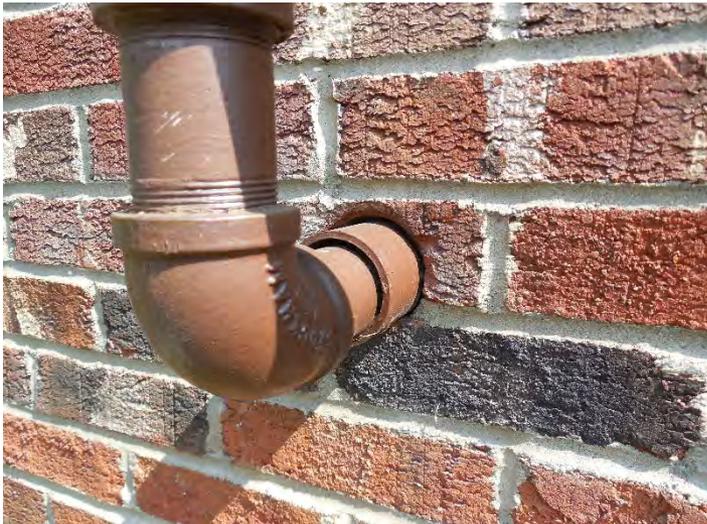
Southwest Elevation, open pipe penetration

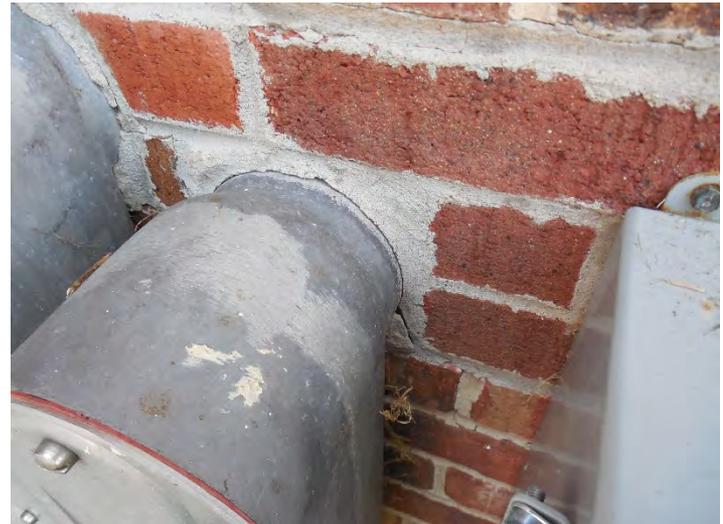
Northwest Elevation, gap around pipe penetration

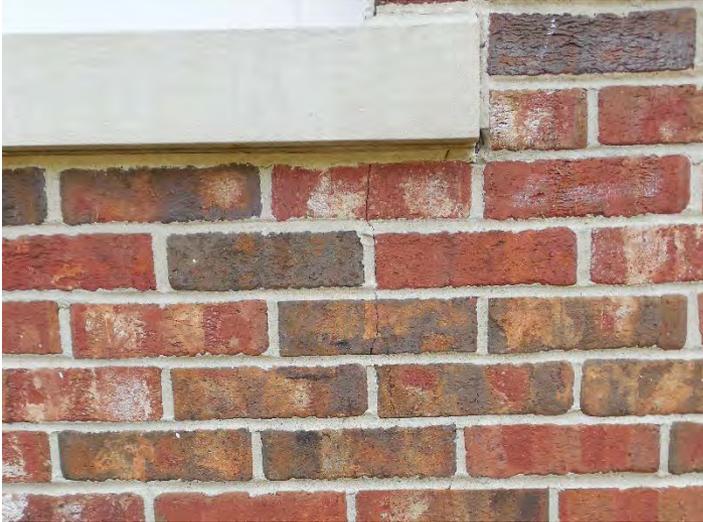
Northwest Elevation, crack in masonry and mortar below a window

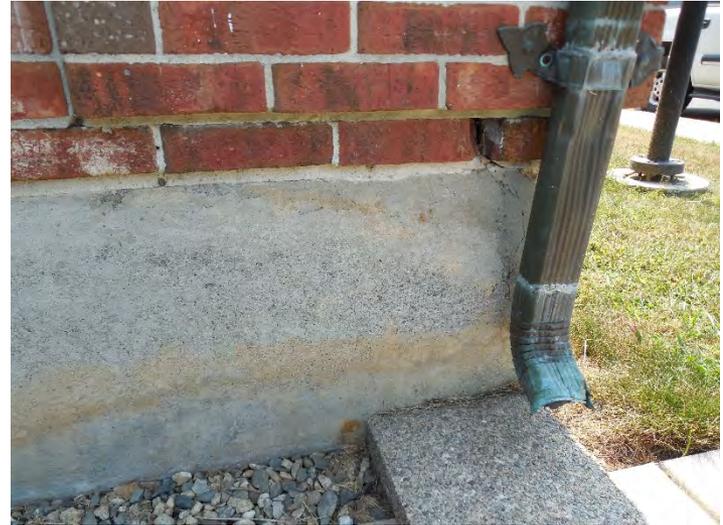
Northwest Elevation, cracked and spalled concrete, deteriorated mortar, and section of concrete missing, leaving the brick unsupported. There is also insect activity.

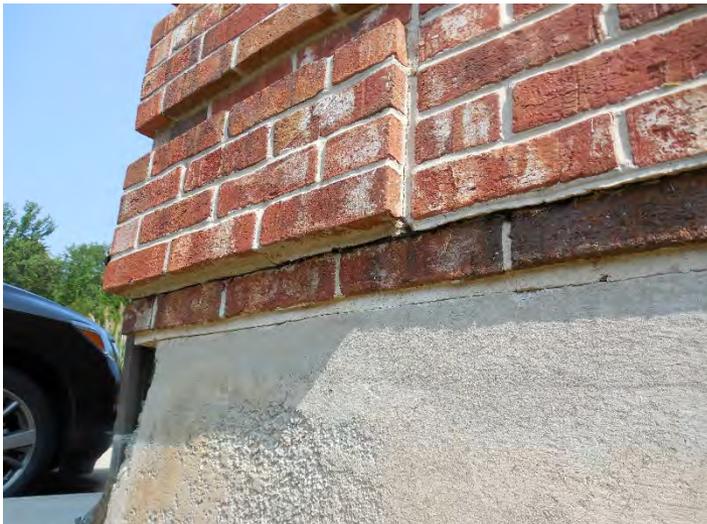
Southwest Elevation, second course of bricks is displaced

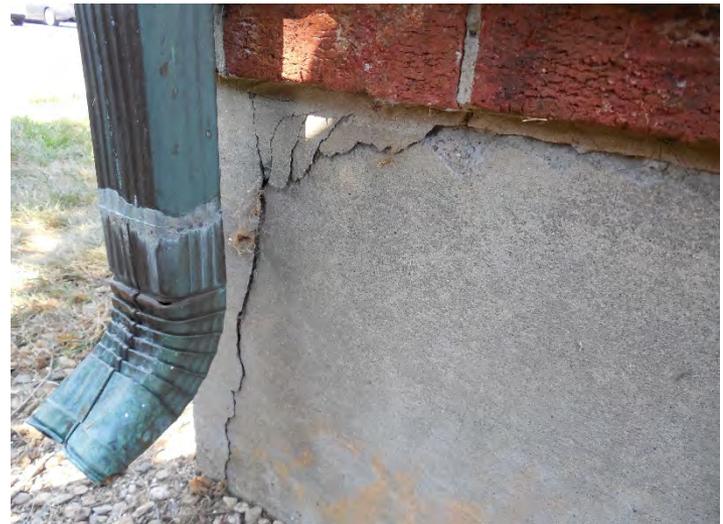
South Corner, crack in concrete and mortar

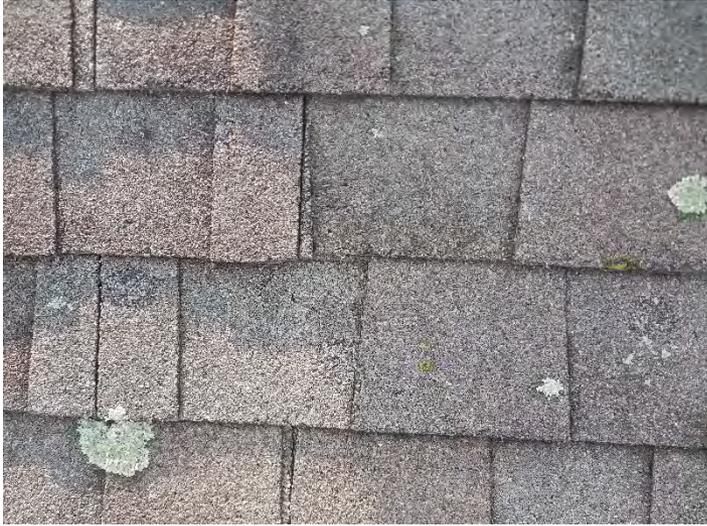
Northeast Wing roof, granule loss, cracks in shingles, and lichen growth

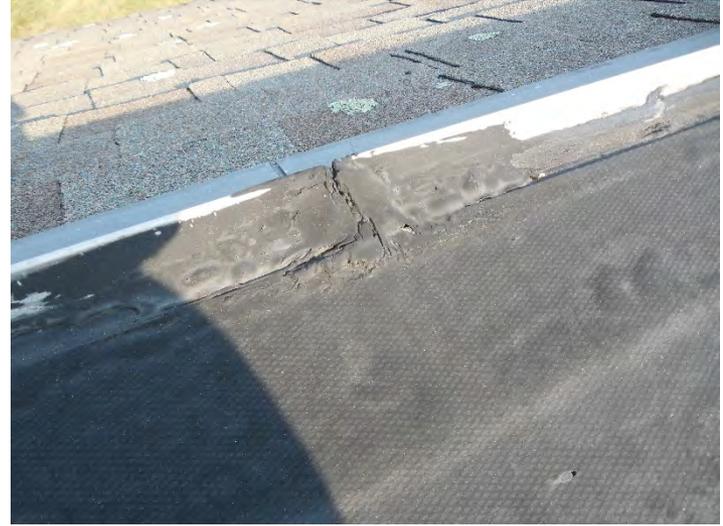
Northeast Wing EPDM-to-shingle transition, crack at edge metal joint

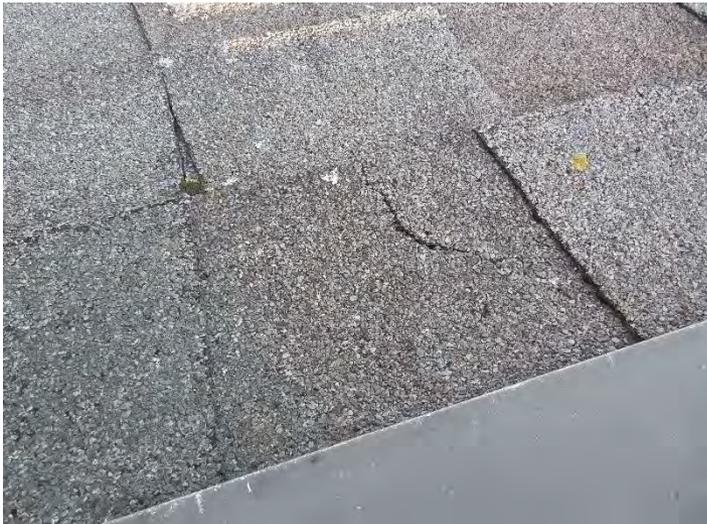
Shingled roof at Northwest side, broken shingle

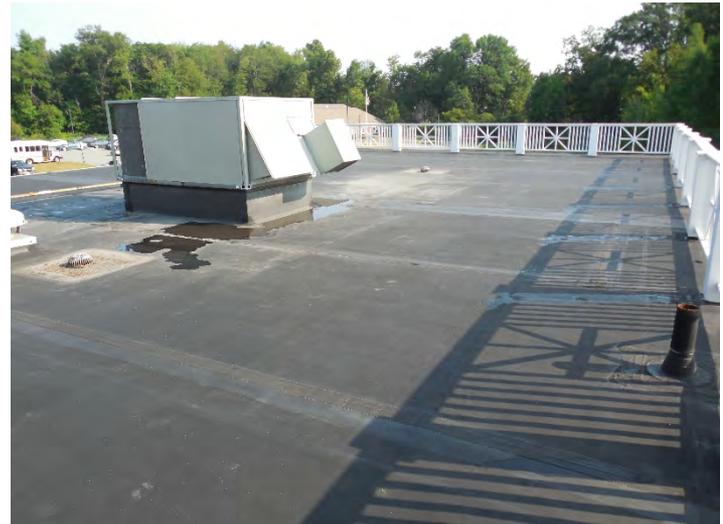
Northeast Wing roof, partial view facing South, with ponded water

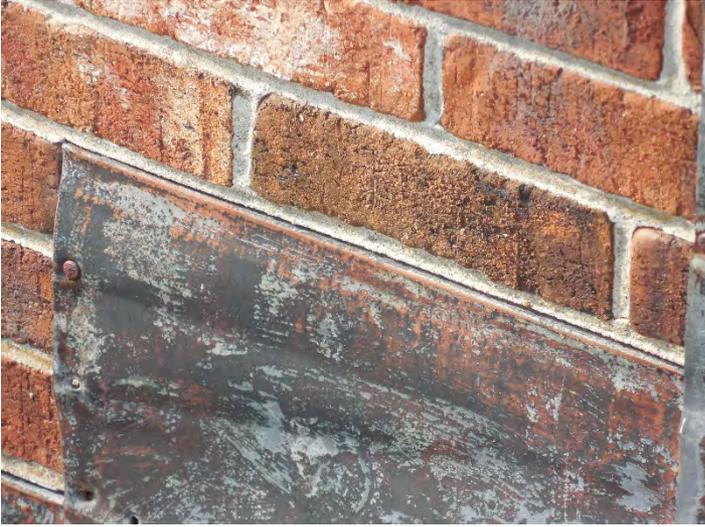
Northeast Wing roof at cheek wall, open joints at step flashing

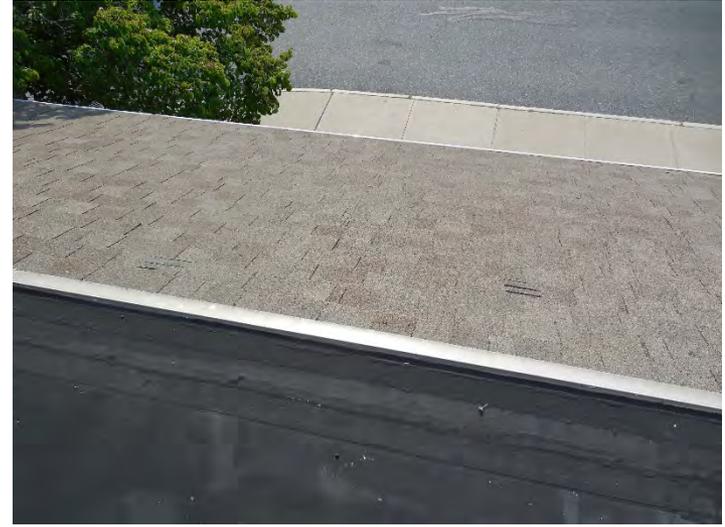
Northeast Wing roof, missing shingles

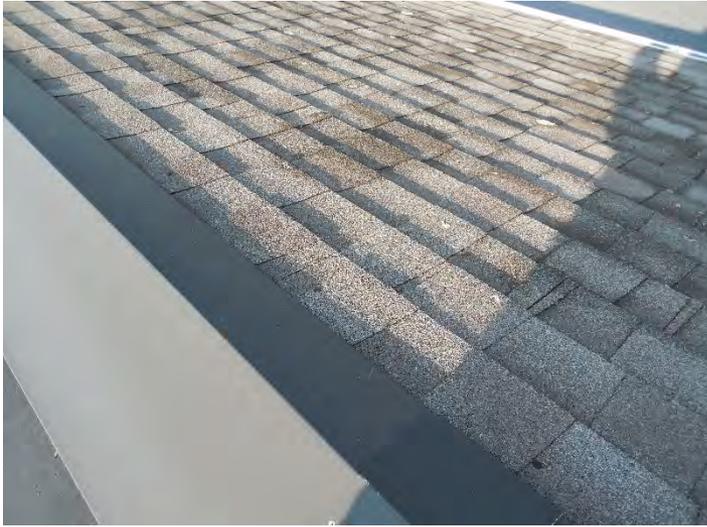
Northwest Wing, exposed shingle fasteners

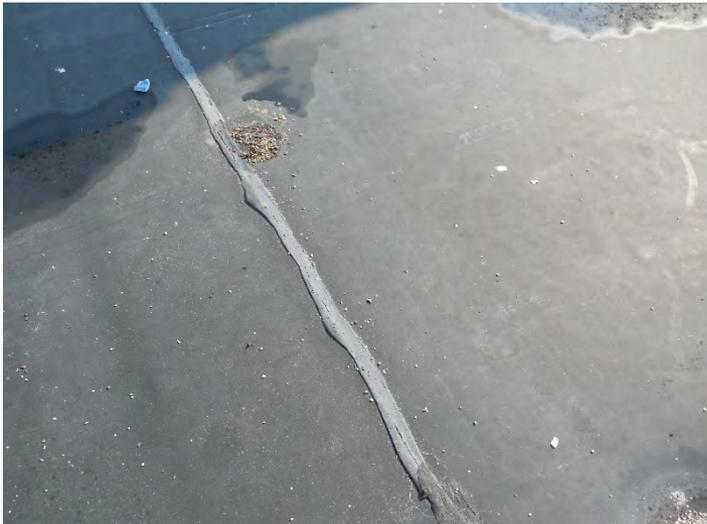
Northwest Wing, failing lap seal

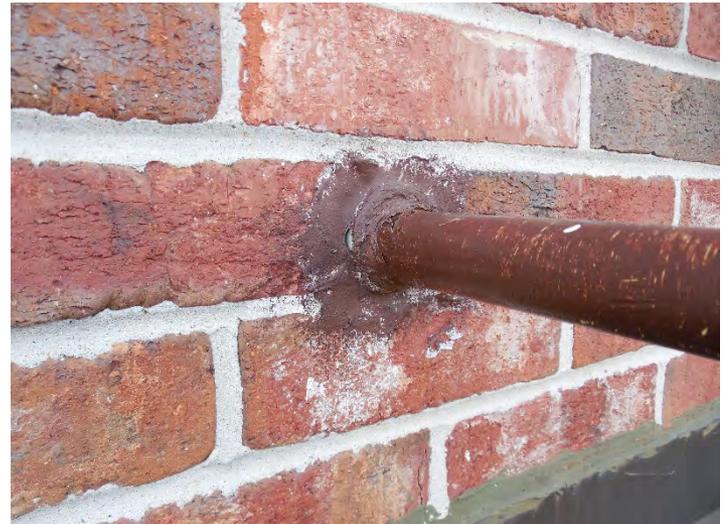
Northwest Wing at main building wall, failed sealant at gas line penetration

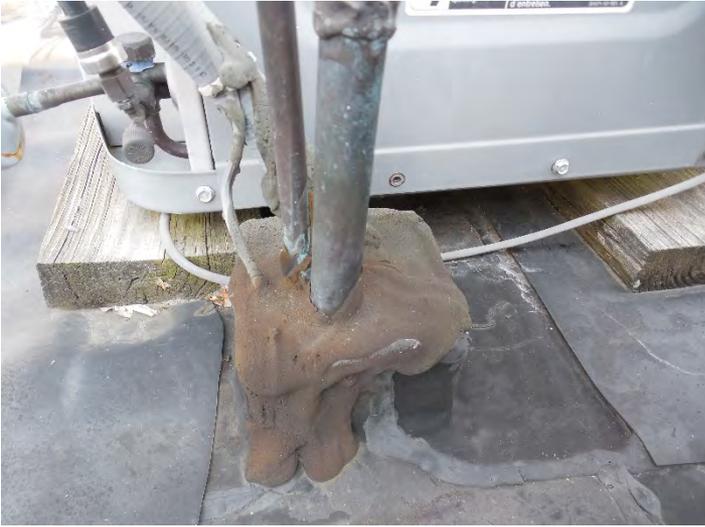
Northwest Wing, failed sealant at a pitch pocket

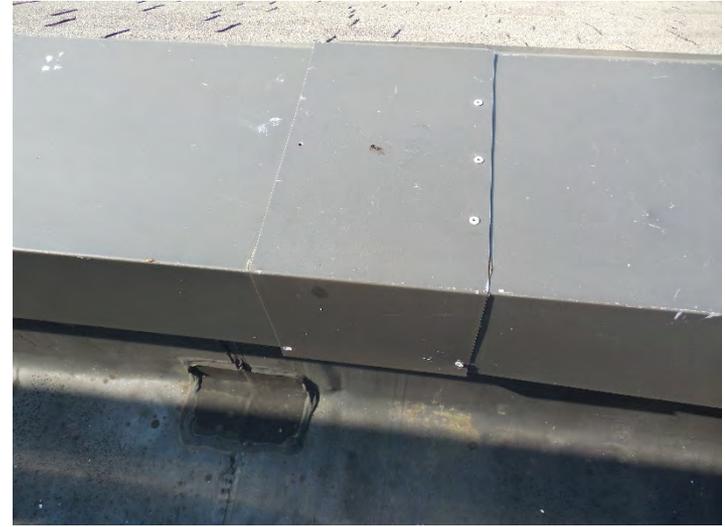
Northwest Wing, fasteners missing at metal coping

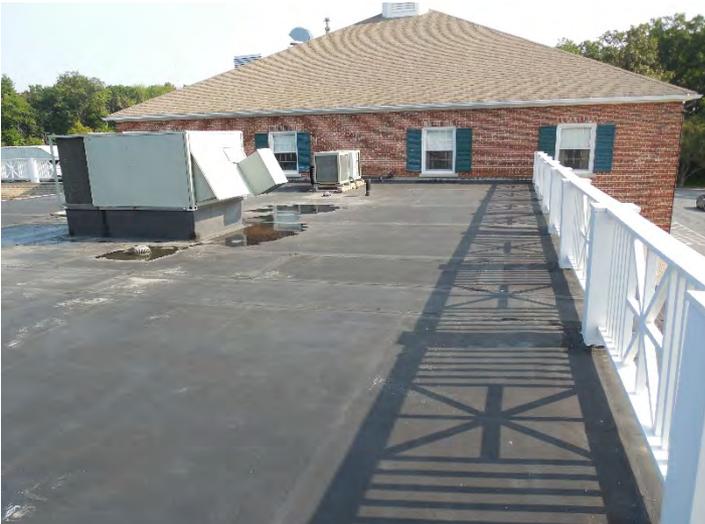
Southwest Wing, partial view facing Northeast, with ponded water

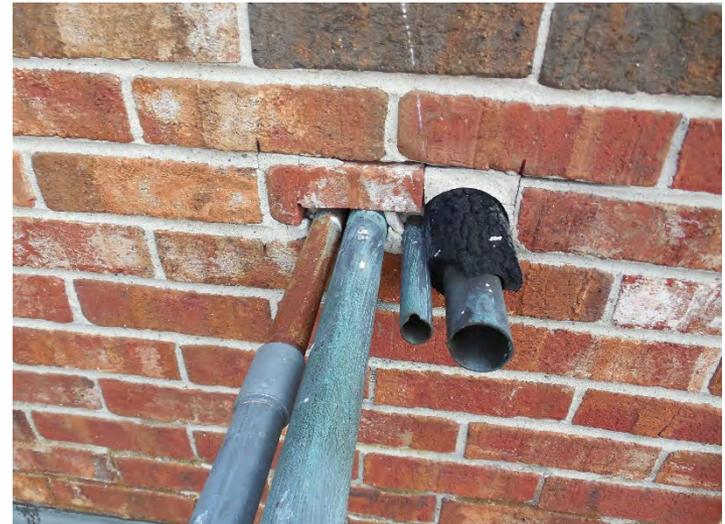
Southwest Wing at main building wall, open pipe penetrations

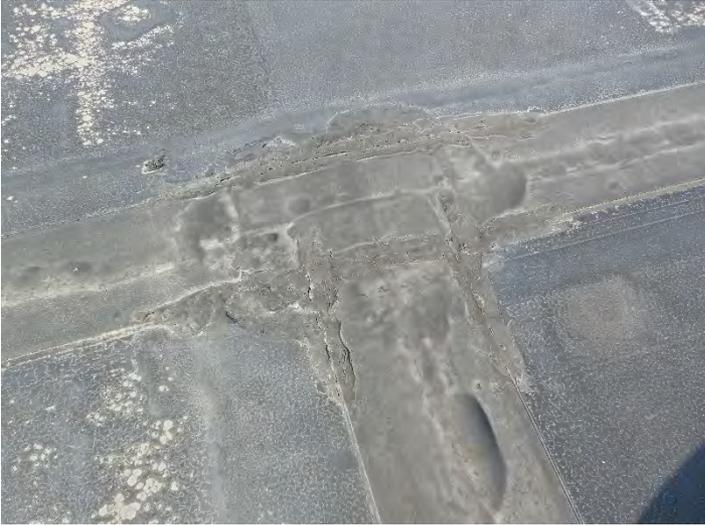
Southwest Wing, cracked lap sealant

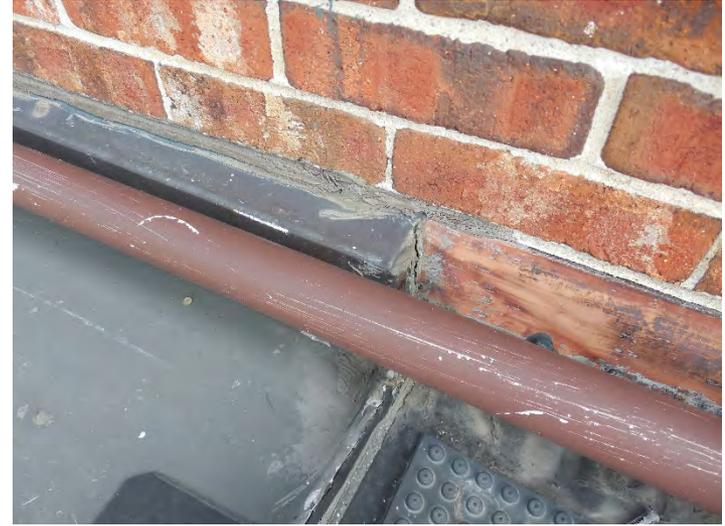
Southwest Wing at main building wall, deteriorated and cracked sealant at counter-flashing

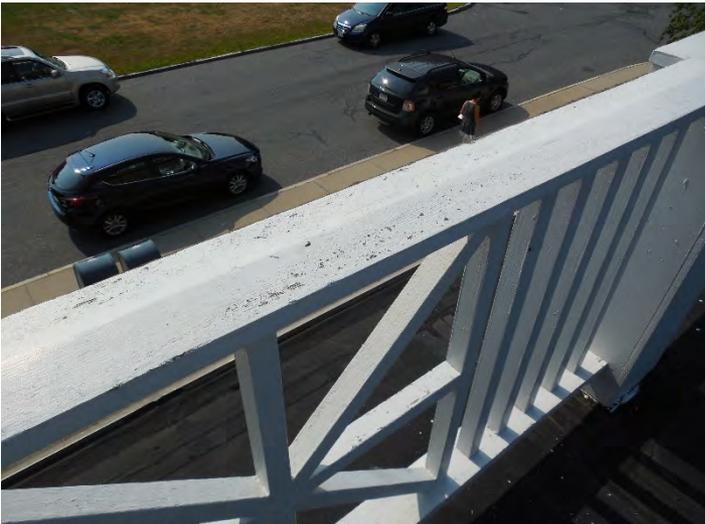
Southwest Wing, peeling paint on rail

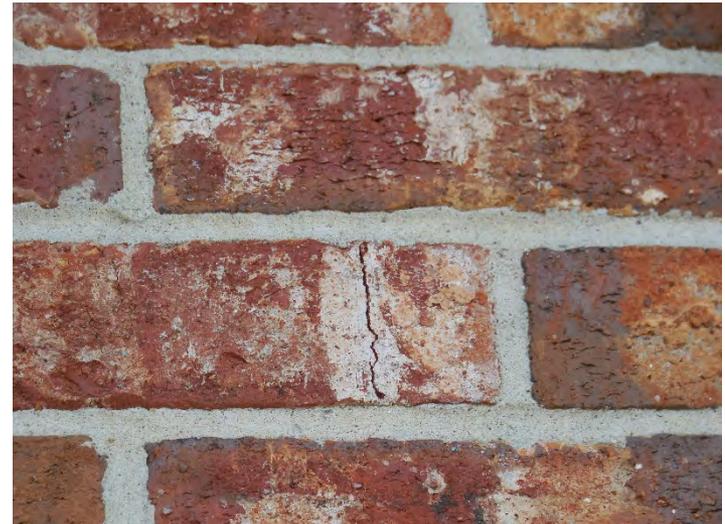
Northwest Wing at main building wall, crack through a brick

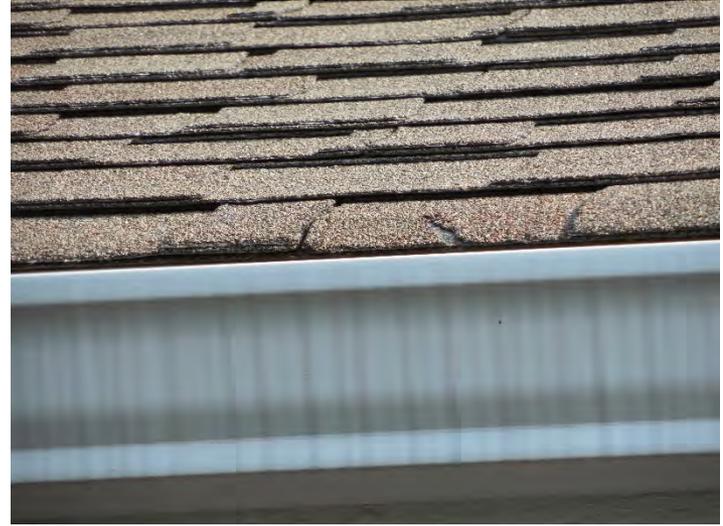
Southwest upper roof, damaged shingle

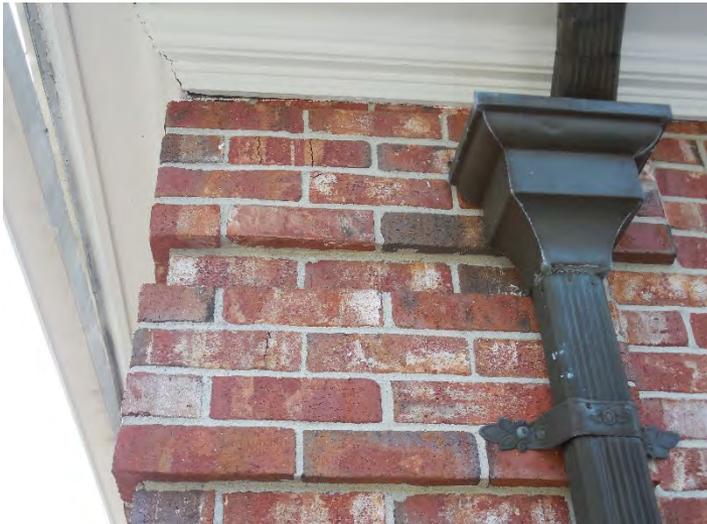
North Corner of upper portion of main building, cracked bricks

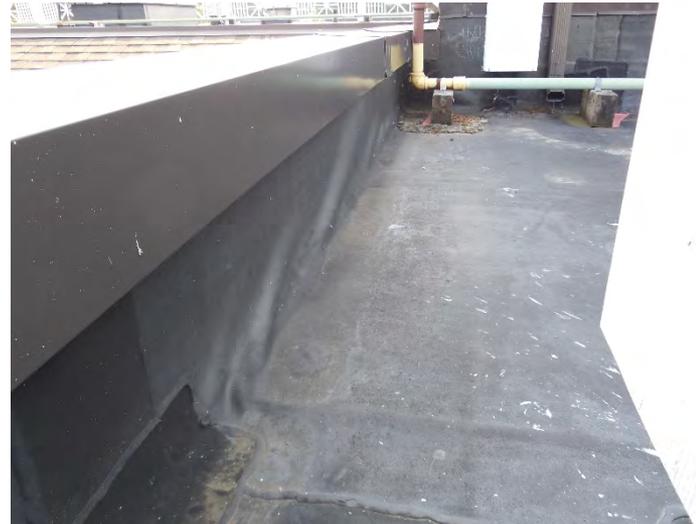
Northwest Wing parapet, EPDM membrane not adhered

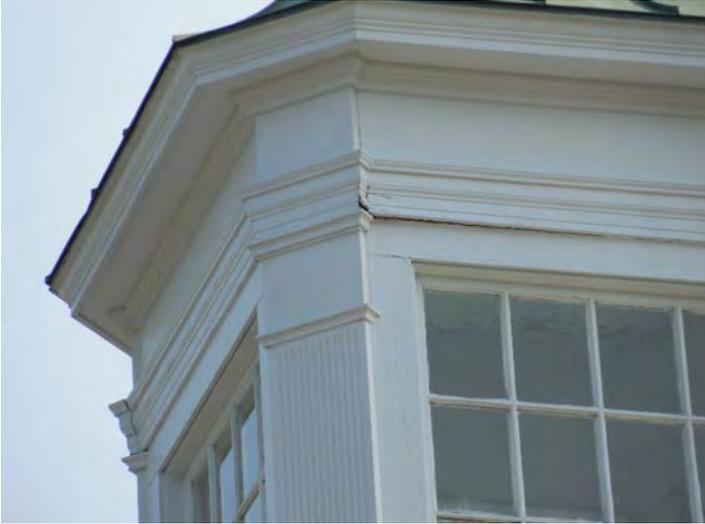
Cupola, peeling paint and deteriorated trim

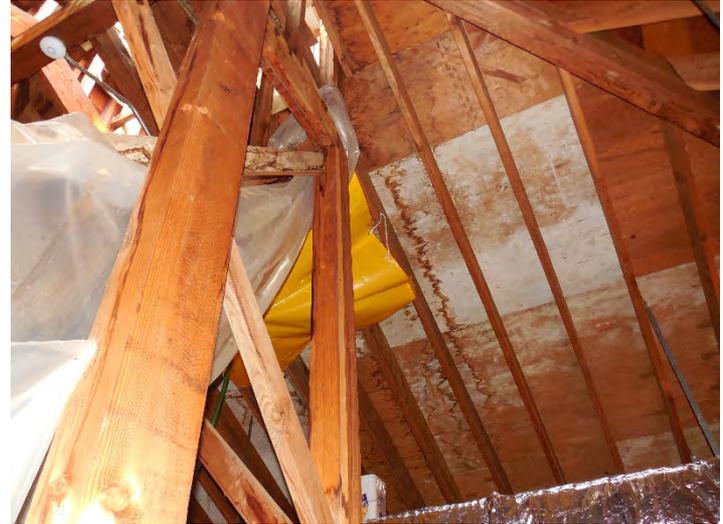
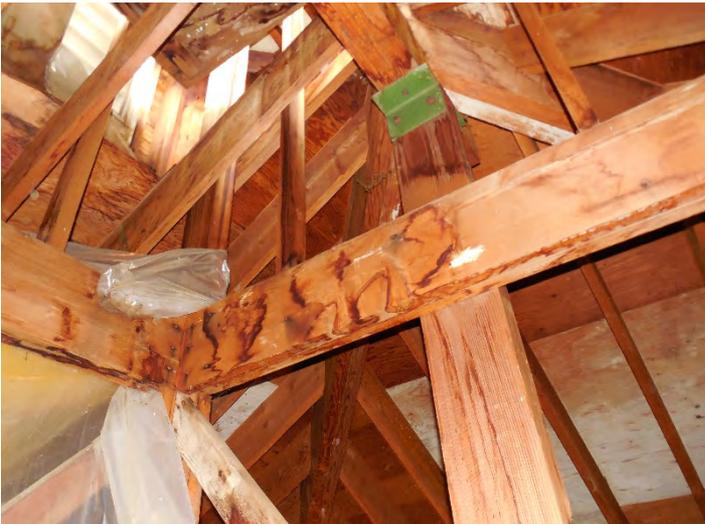
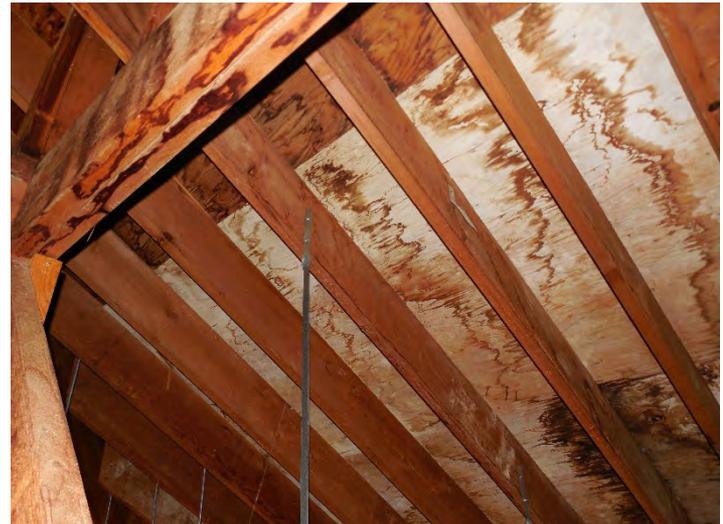
- x. At the cupola, there is water staining on the underside of the plywood roof sheathing and on wood framing members.
- xi. Town representatives report ice dam related leakage.

Cupola interior, water staining on plywood roof deck

Cupola interior, water staining on wood framing members

Cupola interior, water staining on plywood roof deck and wood framing members

- i. Repair isolated damage as soon as possible.
- ii. Investigate cause of water staining at cupola.
- iii. Investigate roof ventilation to determine if it is sufficient.
- iv. Plan to replace 100% of asphalt shingle roofing between 2018 and 2022.
- v. Plan to replace 100% of EPDM roofing after 2026.
