**TOWN OF SHREWSBURY**  
FACILITIES CONDITION ASSESSMENT OF  
TOWN BUILDINGS

**FINAL REPORT**

June 01, 2016

**Shrewsbury  
Town Hall**

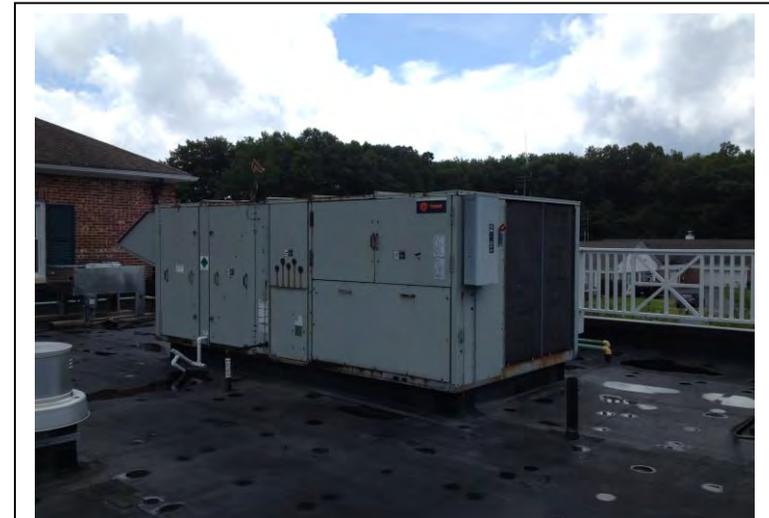
STM M1 - RTU-3

- c. Rear Wing (RTU-3): This existing RTU is a Trane Voyager model YCD330AELB2A6EH3B3H. The unit is a nominal 27.5 ton dual circuit down flow unit and has R-22 as its refrigerant. The unit was installed in 1997 and is approximately 19 years old. The unit

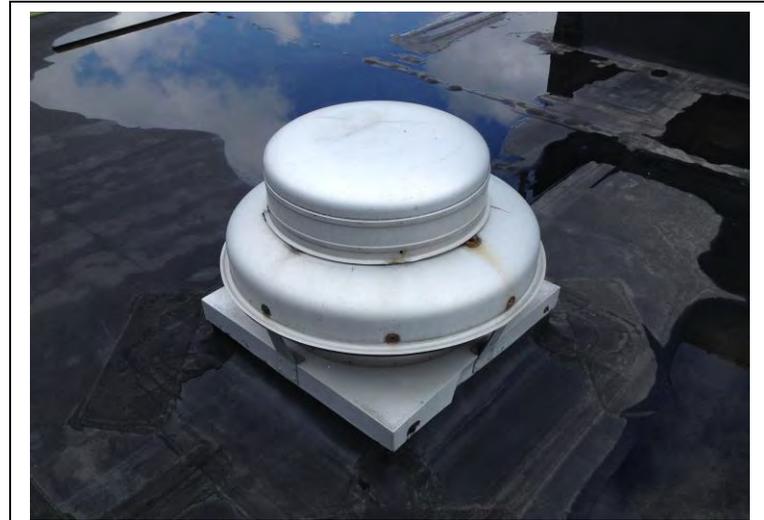
STH M2 – TEF-1 Exhaust Fan

- v. Toilet exhaust fans: There are three constant volume toilet exhaust fans serving the building each one dedicated to a wing of the town hall. TEF-1 which serves the west wing and TEF-2 which serves the east wing are both ACME model PRN-75. The age of both fans could not be determined but both fans showed slight signs of corrosion and both fans had missing screws. TEF-3 which serves the rear wing is an ACME model PRN. TEF-3 appeared to be original to 1997 construction of the rear wing and was in good condition.
