TOWN OF SHREWSBURY
FACILITIES CONDITION ASSESSMENT OF
TOWN BUILDINGS

FINAL REPORT

June 01, 2016

**Shrewsbury
Walter J. Paton
School**

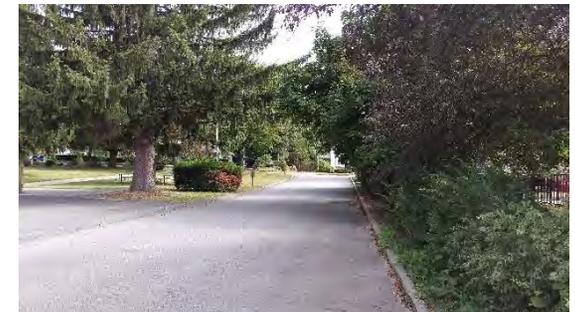
WPS E 1

- i. The pavement condition of the vehicular entrances and interior circulation system ranges from good to fair throughout the site. There is some evidence of recent repairs and improvements to the vehicular circulation.

- i. Implement a program of replacing damaged or worn pavement throughout the site.

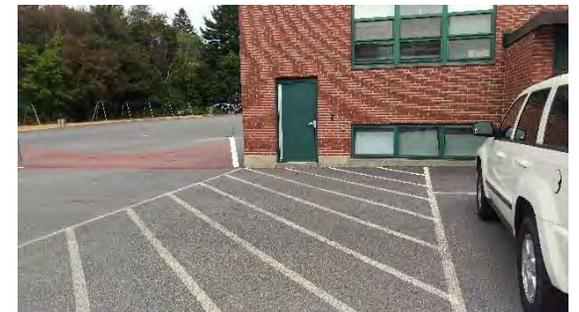
WPS E7

- i. There is one (1) service area located at the south side of the building. The loading dock services a bay door and is in fair condition. There is also a step up from grade into the building at the loading door.

- i. Confirm that loading dock meets current needs of the building.
- ii. The step up to the loading door does not provide an MAAB compliant accessible route into the building, and also makes deliveries with a hand truck difficult.

- i. Maintain pavement condition at loading area.
- ii. Implement a program to improve ease of access that brings the service door into compliance with current MAAB standards.

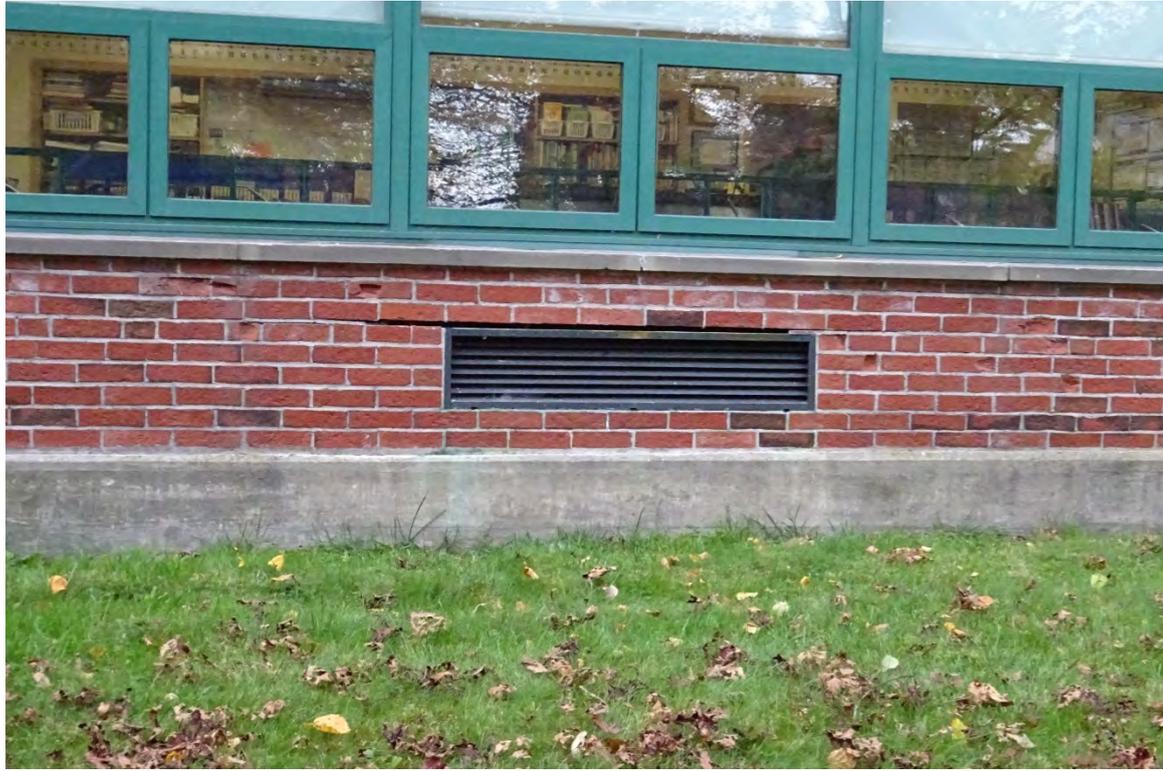
- i. The brickwork is shifted and cracked because of rusting steel lintels. (See Photo 1)
- ii. The brickwork is shifted and cracked brickwork because of rusting steel beams. (See Photo 3)
- iii. The mortar joints are eroded.
- iv. The areas of damaged concrete is caused by rusting railing anchors. (See Photo 4)

Photo 1: Rust Jacking Vent Lintel (See S-4)

- i. Replace all rusting embedded steel lintels.
- ii. Exposed, clean and painted rusted beam ends.
- iii. Cut and point eroded mortar joints with a compatible mortar.
- iv. Clean and paint, or replaced rusted anchors and repair concrete.

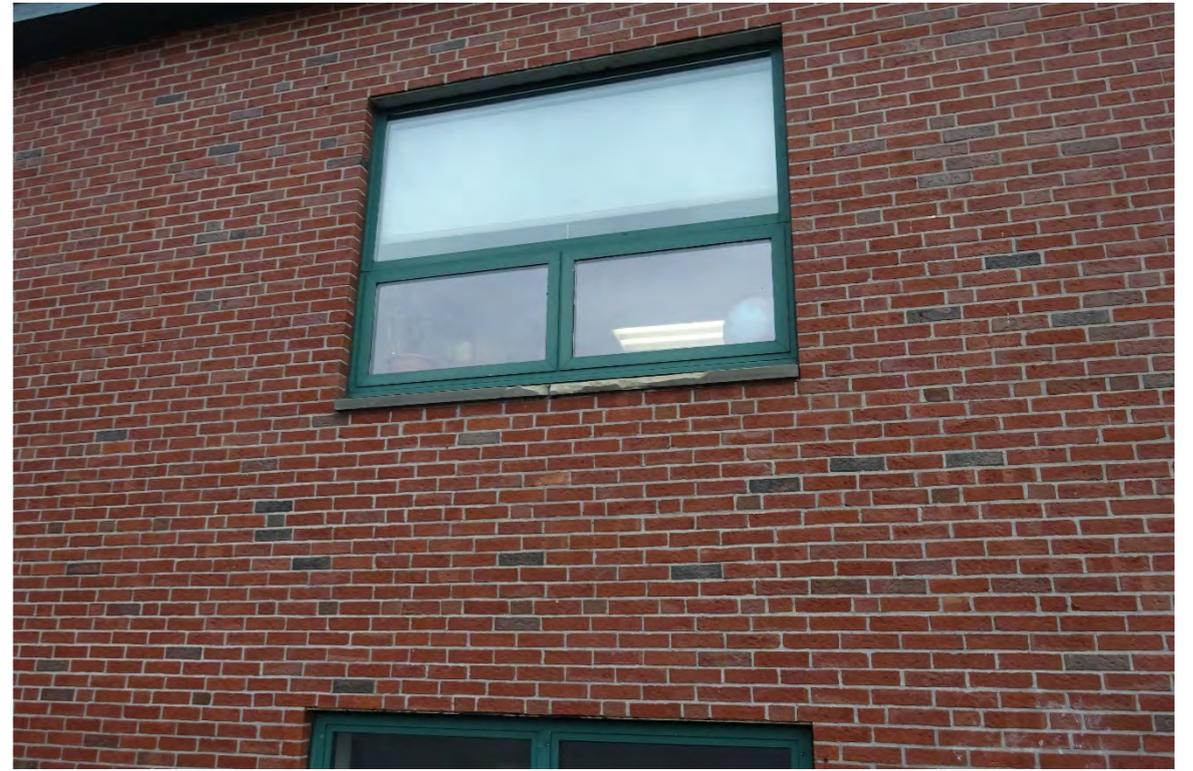
Photo 2: Damaged Stone Window Sill (See S-10 and S-19)

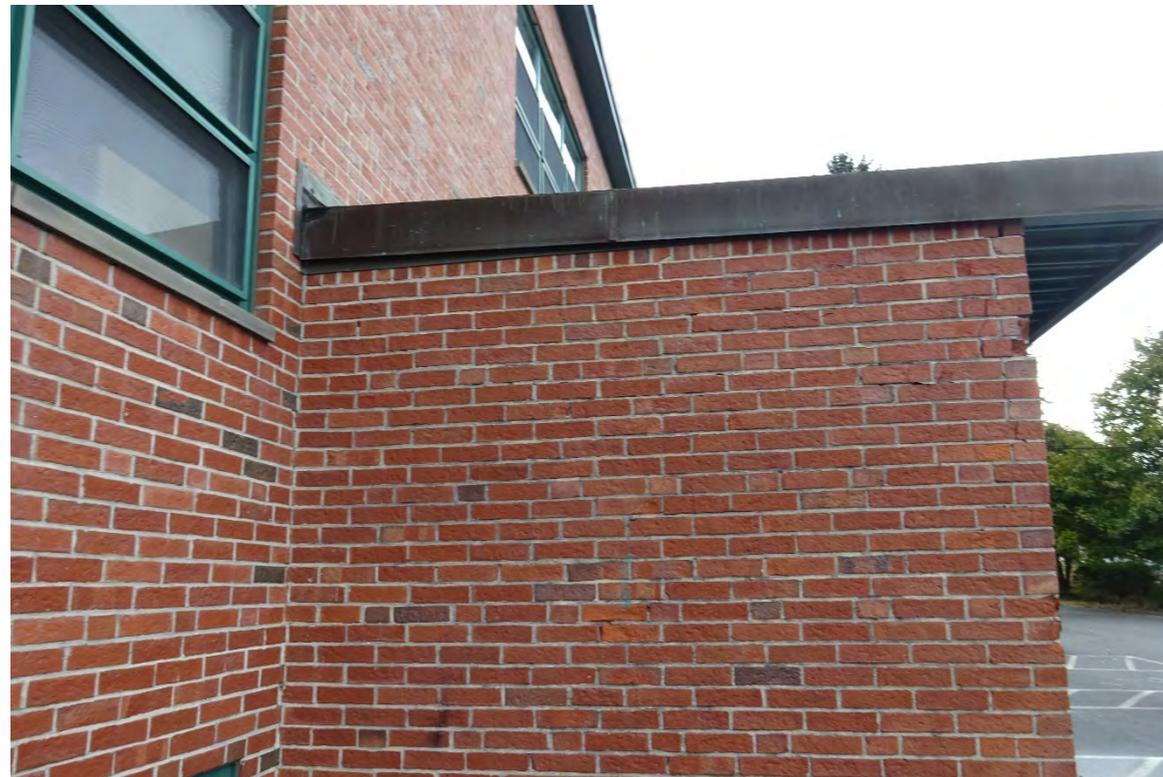
Photo 3: Damaged Brick Masonry from Embedded Steel (See S-13)

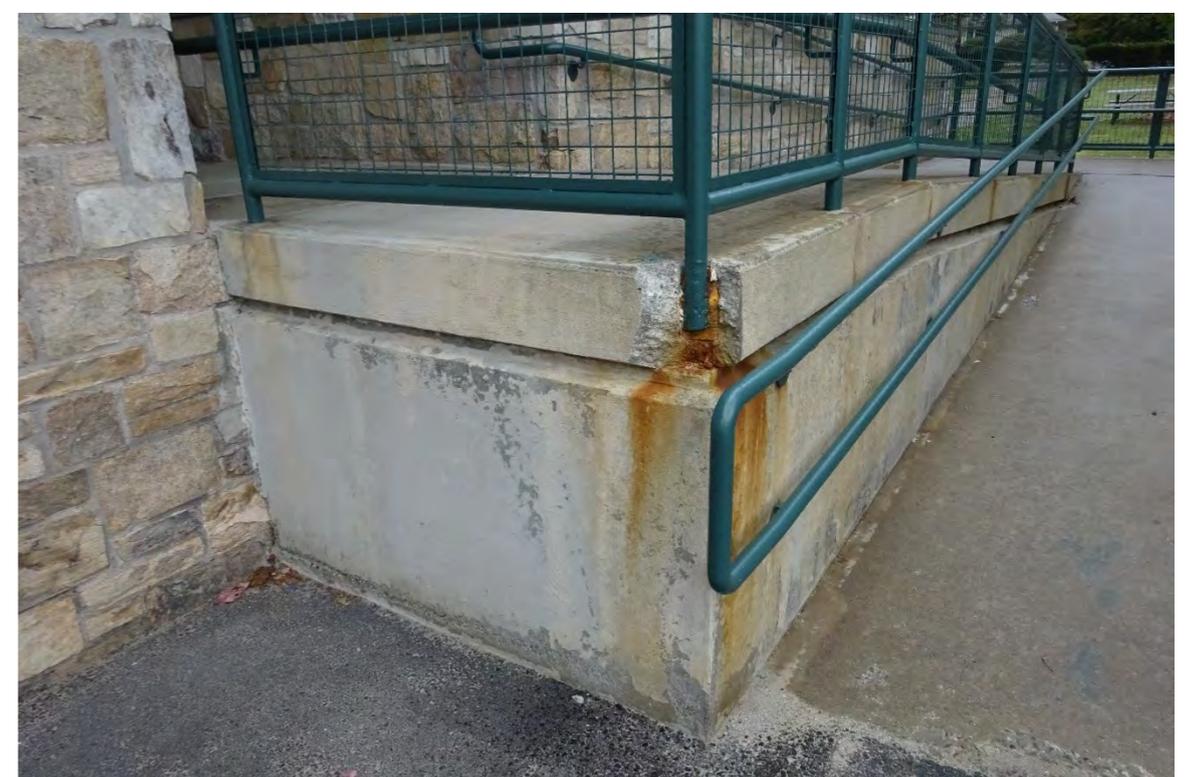
Photo 4: Damaged Concrete Ramp (See S-24)

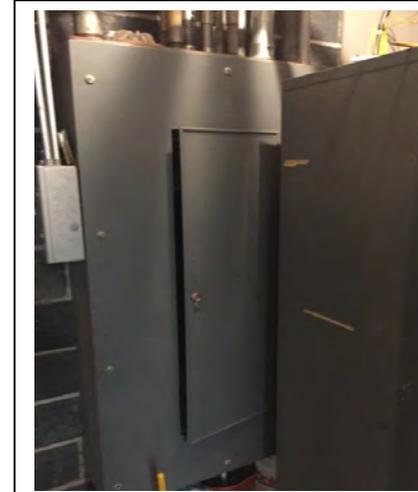
- i. Main service is 400A at 208/120V, 3-phase, 4-wire. (The main service is currently being upgraded as part of the HVAC upgrades to the school)

WJP E1 Main Electric Service

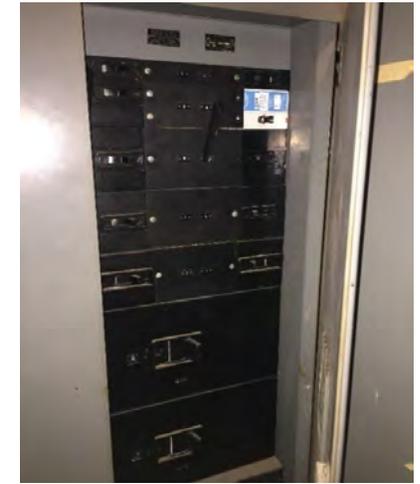
WJP E2 Distribution Equipment

There are a number of electrical panels located throughout the facility that are fed from the distribution panelboard. The panel boards do not have spare circuit breakers available for new circuits to be added, or include the space to add new circuit breakers. The panelboards are in fair to poor condition.

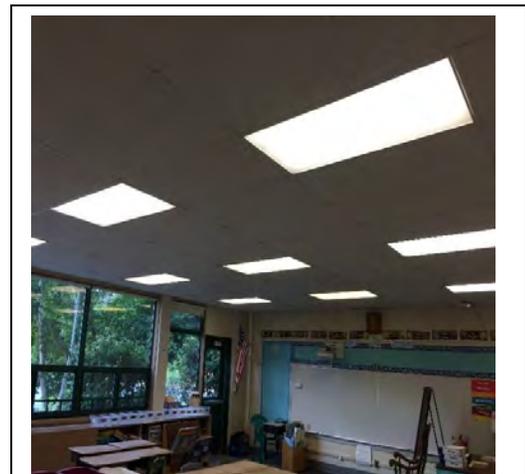
WJP E4 Recessed Fluorescent Lighting

- i. Replace all fluorescent fixtures with new LED fixtures for energy savings
- ii. Replace (8) existing manual fire alarm pull stations with new.
- iii. Replace all existing manual lighting controls with new automatic lighting controls to meet current energy codes
- iv. Replace all power distribution equipment. Including the main distribution panel and the 5 panelboards located throughout the school.
- v. Main electric room is in code violation. The main electric room is currently also being used for storage and does not have the minimum code required clearance of 3' in front of all electrical panelboards and equipment.

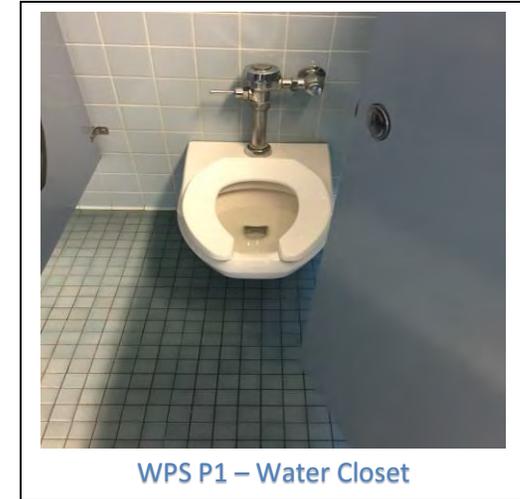
WPS P1 – Water Closet

- #### i.
- Replace existing water closets flush valves with automatic flush valves.
- #### ii.
- Replace existing urinals flush valves with automatic flush valves.
- #### iii.
- Replace existing lavatories faucets with automatic faucets

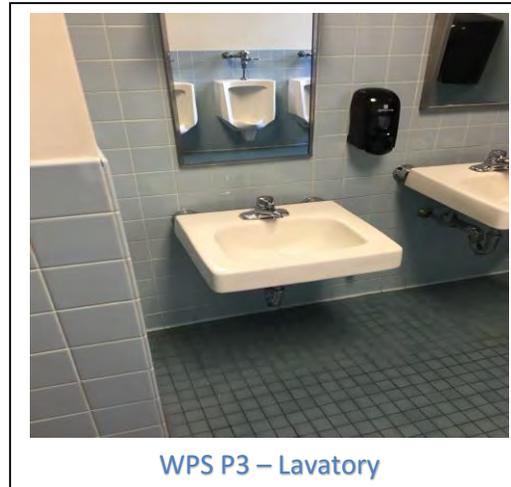
WPS P3 – Lavatory

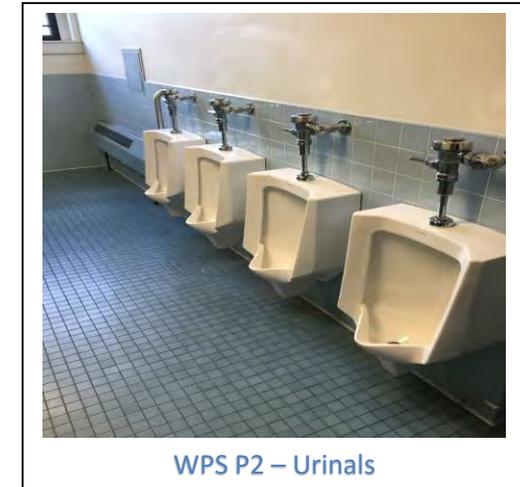
WPS P2 – Urinals
