**TOWN OF SHREWSBURY**  
FACILITIES CONDITION ASSESSMENT OF  
TOWN BUILDINGS

**FINAL REPORT**

June 1, 2016

**Shrewsbury  
Calvin Coolidge  
Elementary School**

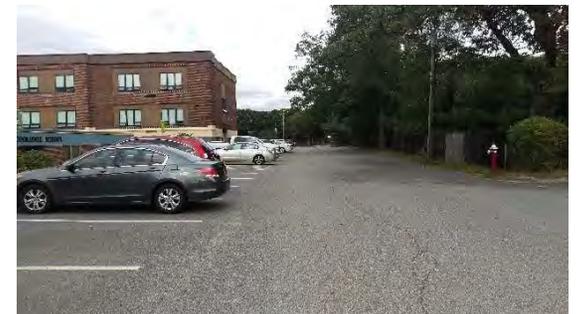
CCS E1

- i. The pavement condition of the vehicular entrances and interior circulation system ranges from fair to poor throughout the site.
- ii. There does not appear to be sufficient signage denoting the entrances and one-way egress points onto South Quinsigamond Avenue.

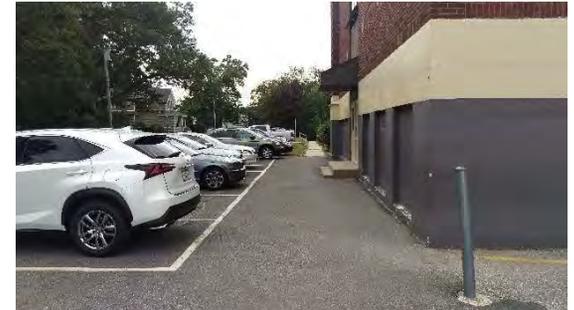
CCS E2

- i. The accessible parking space does not appear to comply with current MAAB standards.
- ii. The pavement condition of the parking areas mirrors that of the vehicular entrances, ranging from fair to poor throughout the site, with little evidence of recent repairs.

- i. Implement a program to bring accessible parking spaces throughout the site into compliance with current MAAB standards, and ensure sufficient quantity of accessible spaces is met.
- ii. Implement a program of replacing damaged or worn pavement throughout the site.

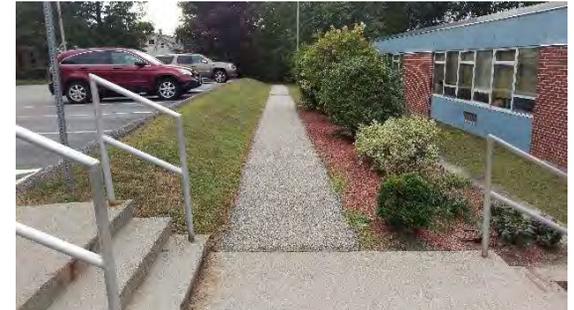
CCS E3

- i. The condition of the bituminous and Portland cement concrete pavement throughout the site ranges from good to fair.
- ii. Accessible route(s) from South Quinsigamond Avenue should be reviewed for MAAB compliance.

- i. Implement a program of replacing damaged or worn pavement throughout the site.
- ii. Implement a program to review accessible pedestrian routes throughout the site for safety and compliance with current MAAB standards.

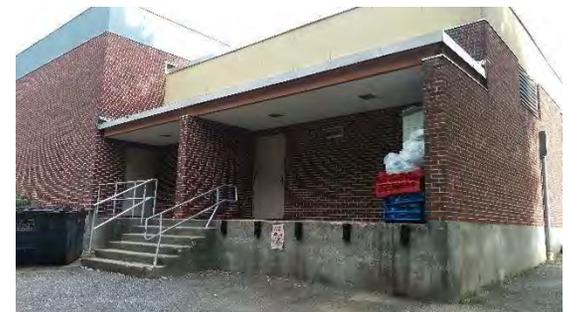
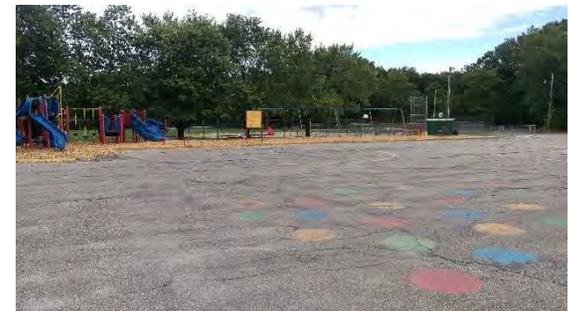
- i. The concrete pavement and furnishings in the south courtyard are in good to fair condition.
- ii. The natural mulch surfacing in the play area does not appear to meet fall zone drop height requirements.
- iii. Due to heavy vehicle traffic at drop-off and pick-up times, the condition of the ground surface in the rear free play area is poor.

- i. Implement a program of replacing damaged or worn pavement throughout the site.
- ii. Replace the existing natural mulch surfacing at the play area with a compliant surface that meets current fall zone height requirements.

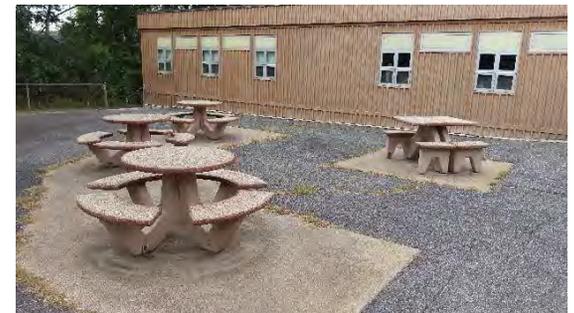
CCS E8

- i. The flagpole does not appear to have an MAAB compliant accessible route.
- ii. There does not appear to be adequate building identification signage denoting the location of the school.
- iii. The bicycle racks, benches, tables appear in fair condition.

- i. Construct an MAAB compliant accessible route to the flagpole.
- ii. Develop a signage identity program for the campus.
- iii. Install site furnishing as necessary throughout the site to better develop exterior congregation areas, and to allow students safe and convenient access to bicycle facilities.

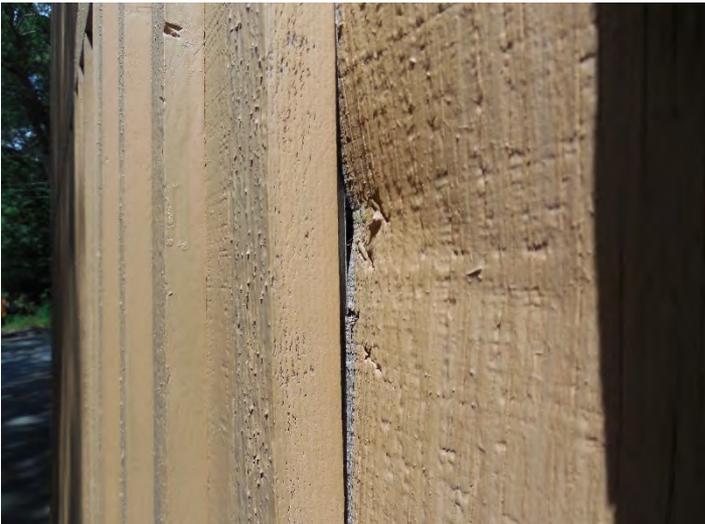
West Elevation, dented and gapped siding

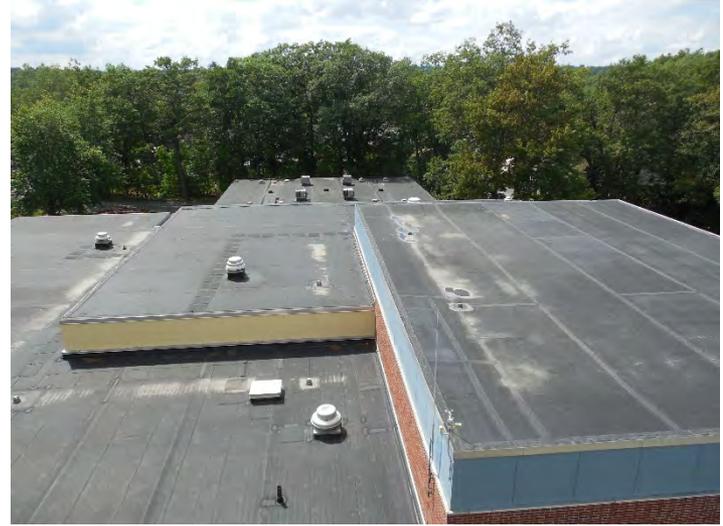
Lower roofs, partial view facing West, evidence of ponding in multiple locations

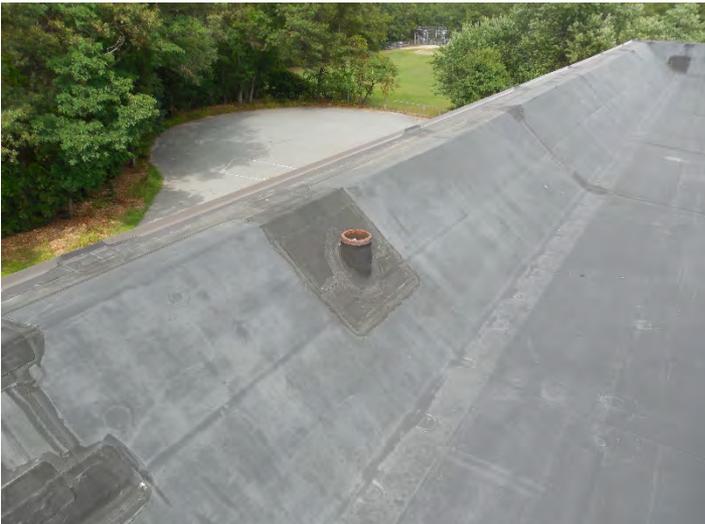
Upper roof, North side, low pipe penetration

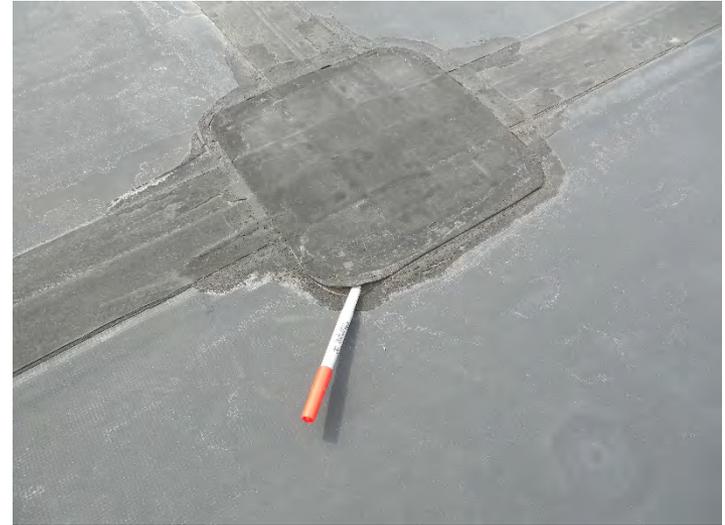
Upper roof, EPDM patch not fully adhered at corner
