TOWN OF SHREWSBURY
FACILITIES CONDITION ASSESSMENT
OF
TOWN BUILDINGS

FINAL REPORT

June 01, 2016

**Shrewsbury
Floral St. School**

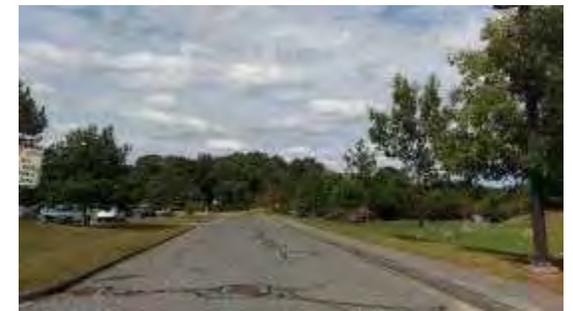
FSS E1

- i. The pavement condition of the vehicular entrances and interior circulation system ranges from good to fair throughout the site. There is some evidence of recent repairs and improvements to the vehicular circulation.

- i. Implement a program of replacing damaged or worn pavement throughout the site.

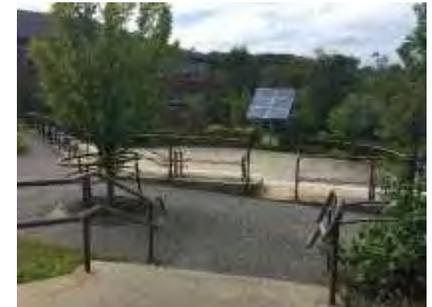
FSS E2

- i. The condition of the structures and ground surface treatment in the playground appears to be in good condition, and meets minimum fall height requirements.
- ii. The surface at the asphalt free play areas is in good condition, although the painted pavement activities appear to be faded.
- iii. The Portland cement concrete surfacing at the outdoor classroom appears to be in good condition.

- i. Implement a program of continued maintenance to the play area surfacing, as natural wood mulch needs to be replenished frequently.
- ii. Implement a program of replacing damaged or worn pavement throughout the site.
- iii. Implement a program to maintain all painted pavement activities on the free play surfacing.

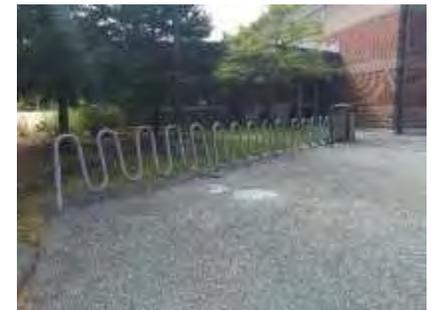
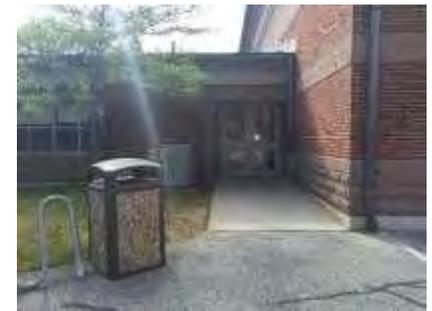
- i. The signage is adequate and appears to be in good condition.
- ii. The flagpole, benches, tables or trash receptacles appear to be accessible and are in fair condition, but are beginning to show signs of wear.
- iii. The bike racks appear to have been struck by a vehicle and are in poor condition, however some segments of the bike rack are still functioning.

- i. Implement a program of continued maintenance for all site furnishing as necessary throughout the site.
- ii. Replace bicycle racks and develop options to reconfigure their location.

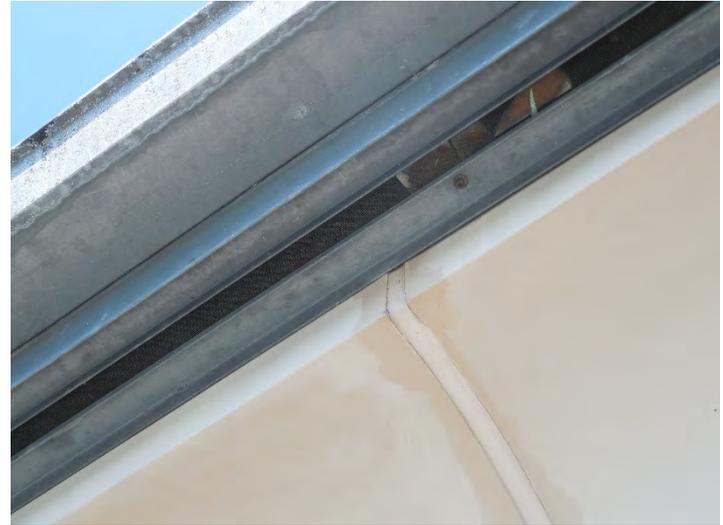
South Elevation, roof eave vent at front entryway

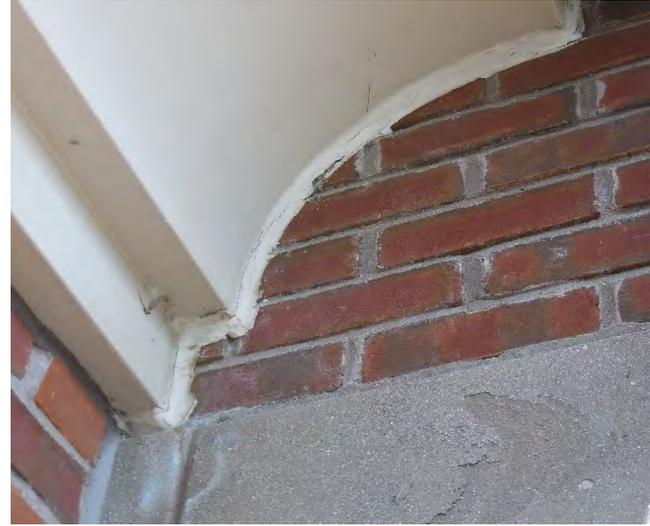
East Elevation, scaled stone and failed sealant

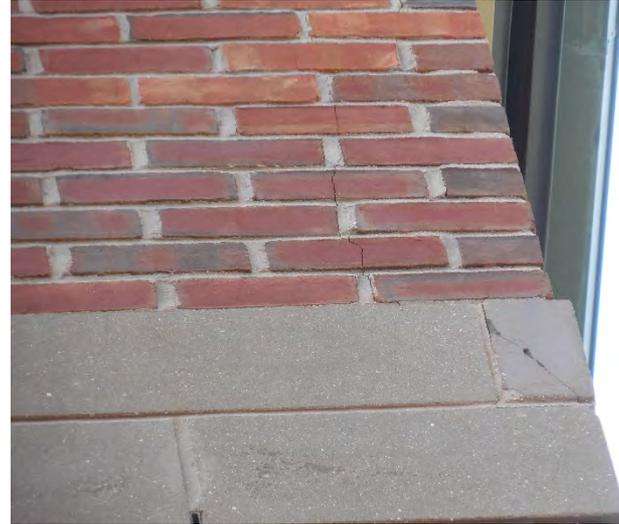
East Elevation, crack through masonry

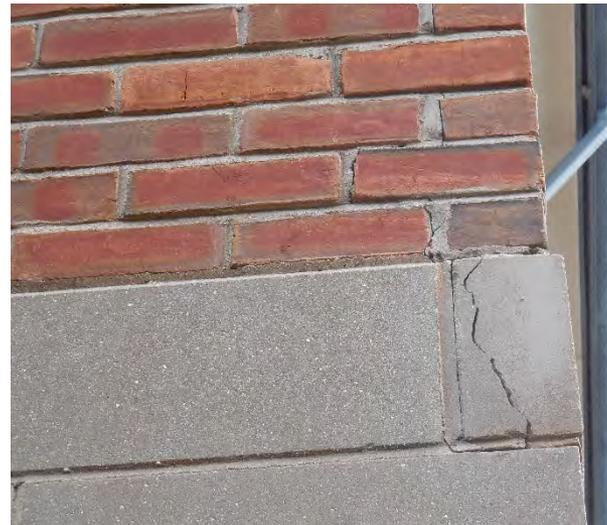
North Elevation, crack through masonry and mortar

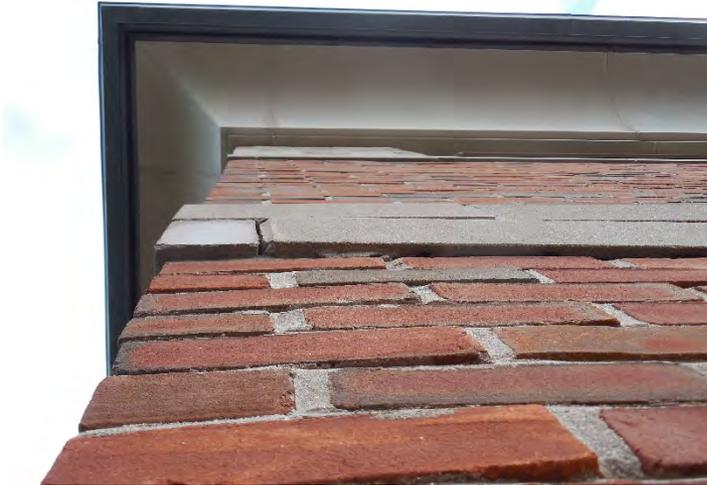
South Elevation, displaced masonry and cracked and deteriorated mortar joints

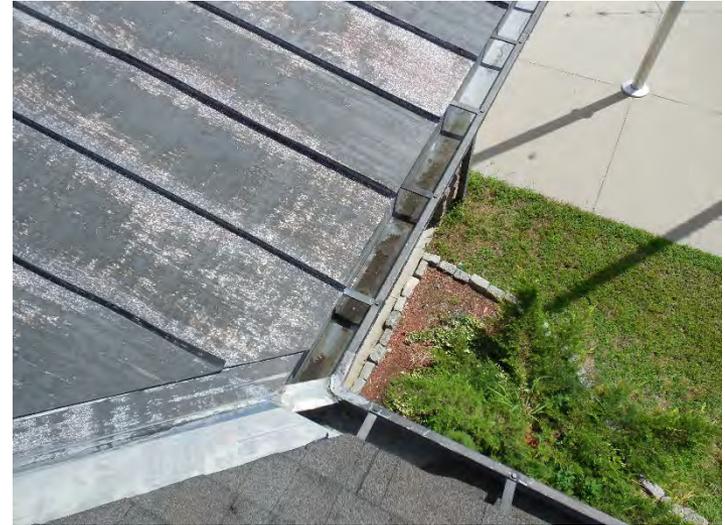
Standing water in gutters at main entrance

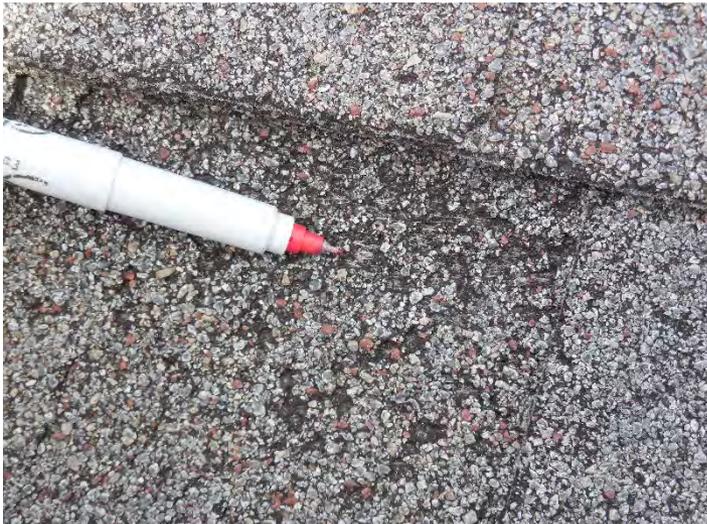
Exposed shingle mat due to granule loss

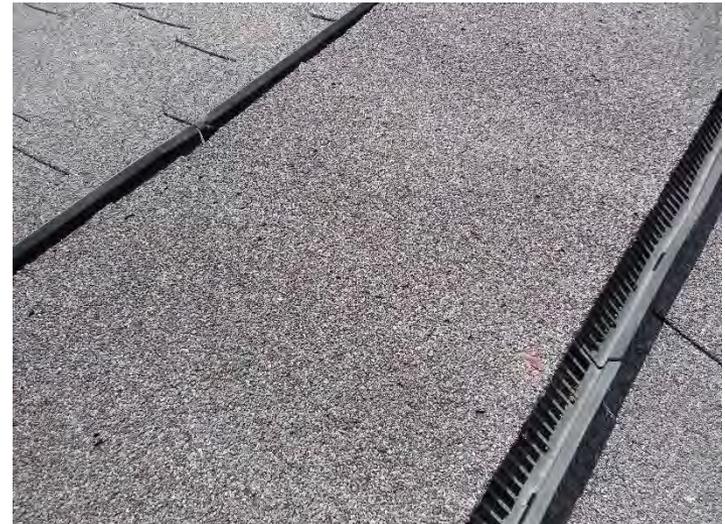
Blisters in ridge shingle

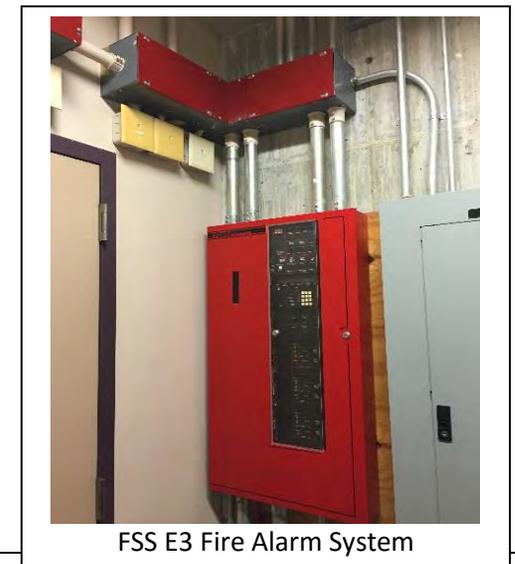
- vi. Fire alarm is a FCI Voice Evacuation addressable system

The fire alarm system is an FCI 7200 addressable voice evacuation system. There are manual fire alarm pull stations and speaker strobes located throughout the building. Heat and smoke detectors are present throughout the facility. The fire alarm system is original to the school and appears to be in fair condition.

- i. Replace all existing GYM lighting with new Fluorescent T5 6-lamp high bay fixtures.
- ii. Replace all fluorescent fixtures with new LED fixtures for energy savings.
- iii. Replace all exterior building mounted HID wall packs with new LED fixtures for energy savings.
- iv. Provide a new fully addressable Voice evacuation Fire Alarm system.

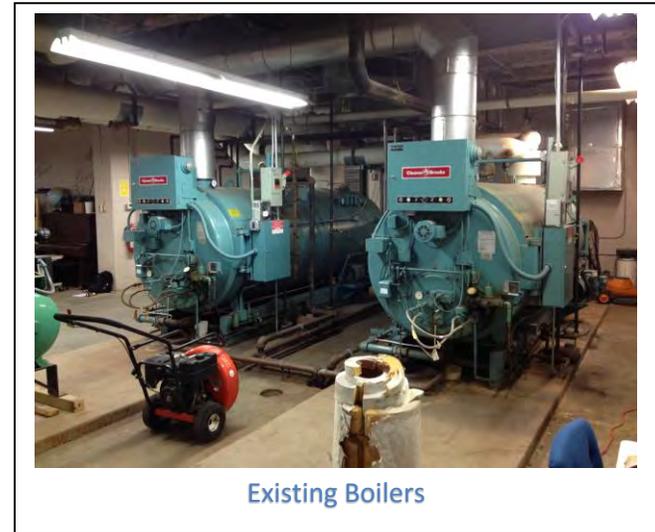
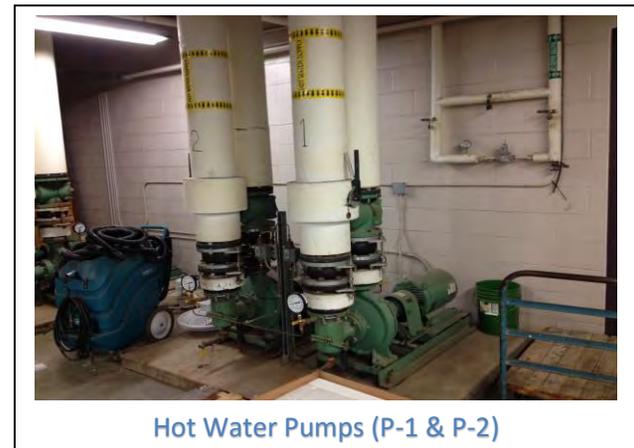
- i. Most of the equipment is original to the 1995 construction.
- ii. Heating Equipment:
 - Boilers: The boiler are Cleaver Brooks Model CB-200 with an output of 4,185 MBH each, even though they are dual fired the fuel oil pumps have been removed and the units no longer have the need to run off oil. The boilers are in good condition.

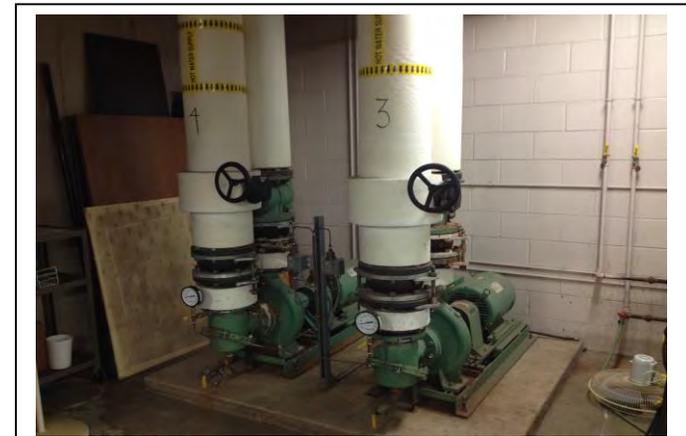
Hot Water Pumps (P-1 & P-2)

- Hot Water Pumps: The existing hot water pumps P-1 & P-2 are Taco model FE251 base mounted pumps. Upon visual inspection the pumps appear to be in good condition with minor signs of corrosion. The existing hot water pumps P-3 & P-4 are Taco model FE301 base mounted pumps. Upon visual inspection the pumps appear to be in good condition also with minor signs of corrosion. The existing hot water pumps P-5 & P-6 are Taco inline pumps. Upon visual inspection P-5 appears to be in fair condition while P-6 was in poor condition and is leaking water.

- i. Install VFD's on Hot Water Pumps
- ii. Replace existing BMS System.
- iii. Remove 10,000 Gallon underground Fuel Oil storage Tank
- iv. Repair leaking at hot water pump P-6.

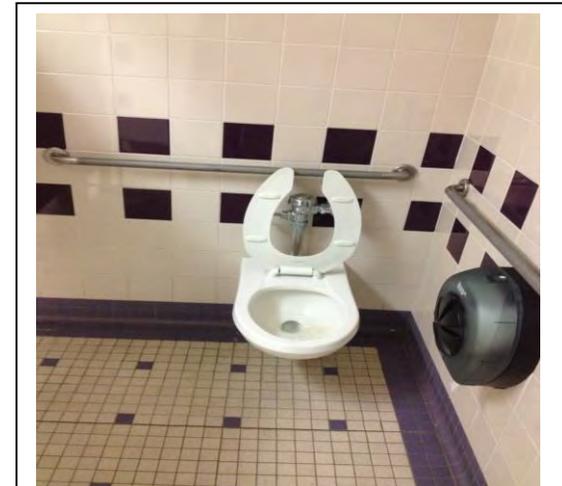
FSS P1 – Water Closet

- i. Most of the plumbing fixtures are original to the 1995 construction and appear to be in good condition.
- ii. The domestic hot water heater is an American Water Heater Company model BCG3100 and was installed in July of 2010. It appears to be in good condition.

- i. Replace existing water closets flush valves with automatic flush valves.
- ii. Replace existing urinals flush valves with automatic flush valves.
- iii. Replace existing lavatories faucets with automatic faucets
