**TOWN OF SHREWSBURY**  
FACILITIES CONDITION ASSESSMENT OF  
TOWN BUILDINGS

**FINAL REPORT**

June 01, 2016

**Shrewsbury  
Town Hall**

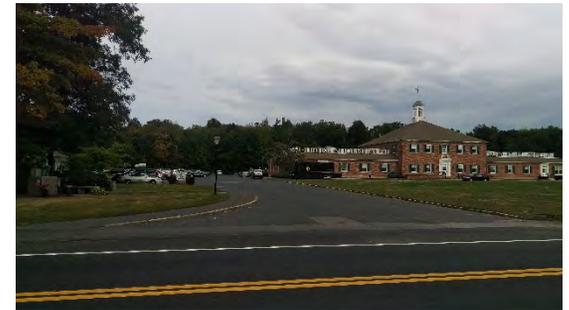
STH E1

- i. The simple circulation route does not create any foreseeable traffic conflicts.
- ii. The pavement condition of the vehicular entrances and interior circulation system ranges from good to fair throughout the site.

- i. Implement a program of replacing damaged or worn pavement throughout the site.

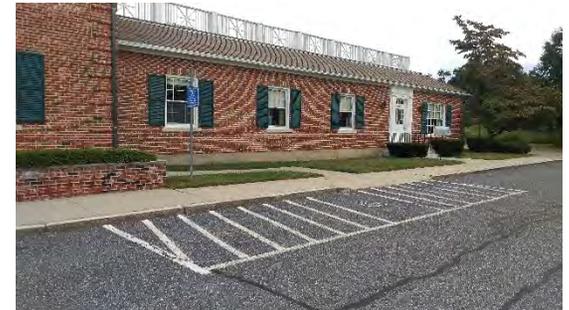
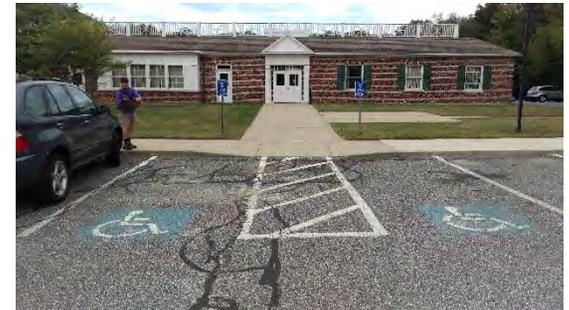
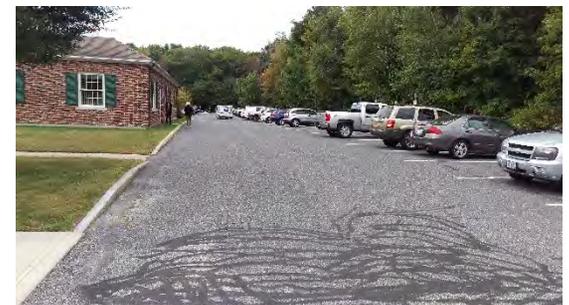
- i. The accessible parking spaces in the parking area along the south drop off drive do not appear to comply with current MAAB standards (see “Pedestrian Accessibility and MAAB Compliance” for further detail).
- ii. The accessible parking spaces in the western portion of the site do not appear to comply with current MAAB standards.
- iii. The pavement condition of the parking areas mirrors that of the vehicular entrances, ranging from good to fair throughout the site, with little evidence of recent repairs.

- i. Implement a program to bring accessible parking spaces throughout the site into compliance with current MAAB standards.
- ii. Implement a program of replacing damaged or worn pavement throughout the site.

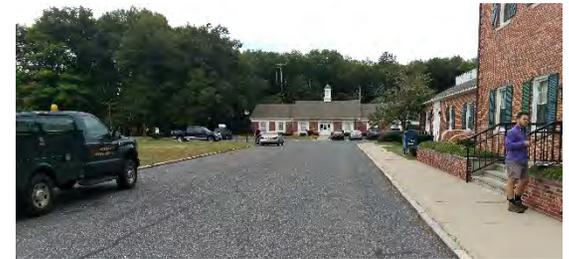
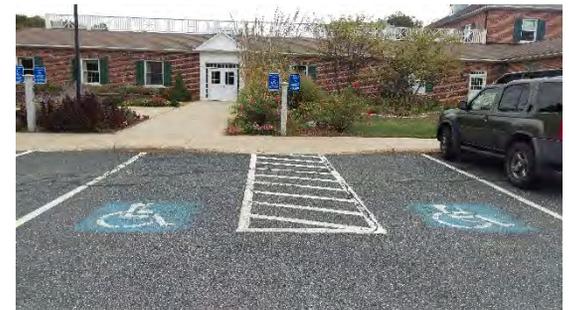
- i. The condition of the bituminous and Portland cement concrete pavement throughout the site ranges from good to fair.
- ii. There are no crosswalks both within the site, and leading to the site, indicating where pedestrians are to safely cross vehicular travel lanes.

- i. Implement a program of replacing damaged or worn pavement throughout the site.
- ii. Implement a program to review accessible pedestrian routes throughout the site for safety and compliance with current MAAB standards.

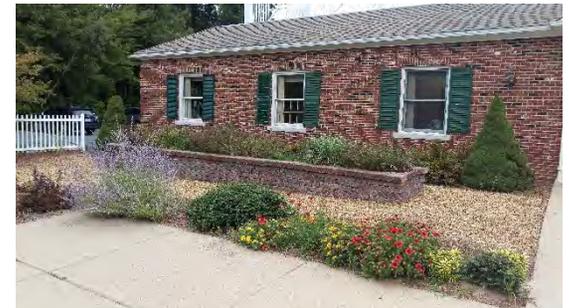
STH E7

- i. The concrete pavement and furnishings in the large courtyard are in good condition.

- i. Maintain condition of courtyard and furnishings in this area.

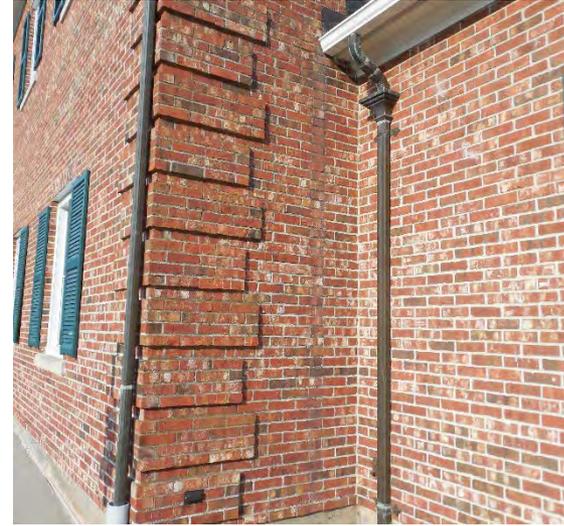
Southeast Elevation, staining on masonry at end of gutter

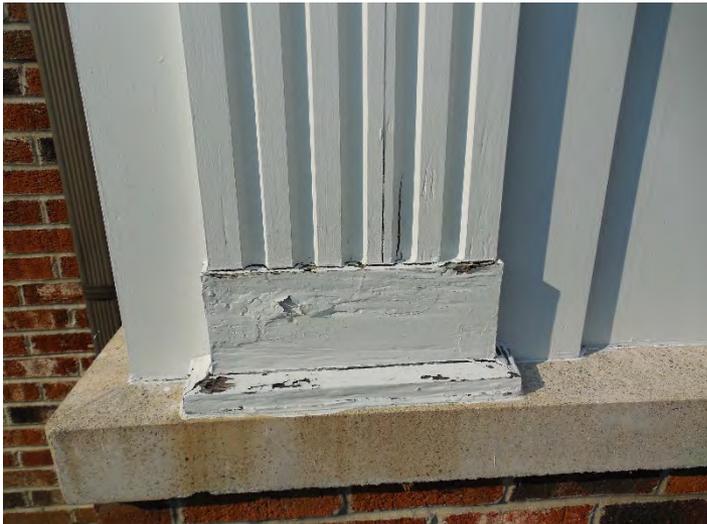
Northeast Elevation, peeling paint and rotted wood trim

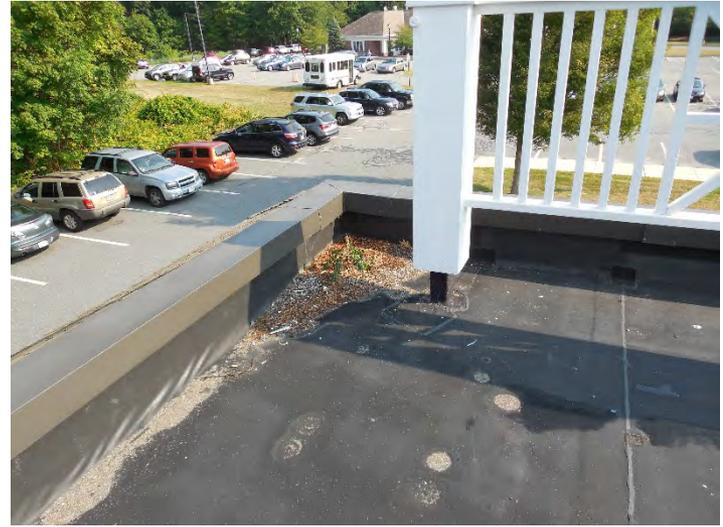
Northwest Wing, dirt, debris, and plant growth in corners of low-slope roof areas

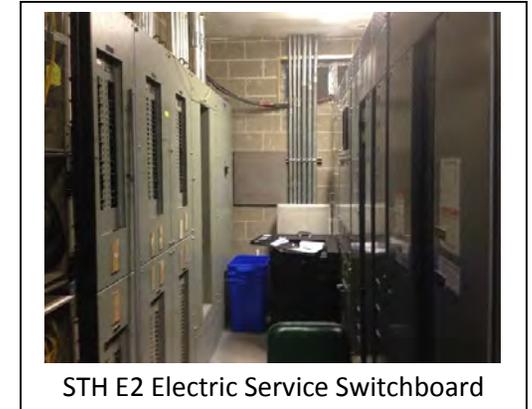
STH E2 Electric Service Switchboard

- i. Main service is 1600A at 120/208V, 3-phase, 4-wire
- ii. There a several code violations within the main electrical room.
