TOWN OF SHREWSBURY
FACILITIES CONDITION ASSESSMENT OF
TOWN BUILDINGS

FINAL REPORT

June 01, 2016

**Shrewsbury
Walter J. Paton
School**

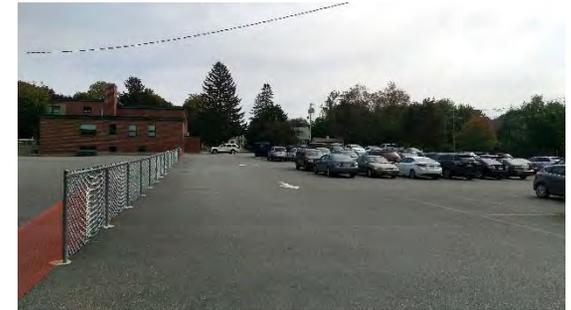
WPS E2

- i. The pavement condition of the vehicular entrances and interior circulation system ranges from good to fair throughout the site. There is some evidence of recent repairs and improvements to the vehicular circulation.

- i. Implement a program of replacing damaged or worn pavement throughout the site.

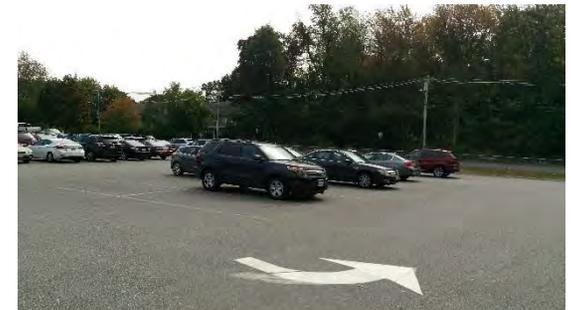
WPS E3

- i. All of the accessible parking spaces appear to comply with current MAAB standards
- ii. It is our understanding that the existing quantity of parking spaces is sufficient for normal school hours, and for after school functions.
- iii. The pavement condition of the parking areas range from good to fair throughout the site.

- i. Maintain condition of accessible parking areas to ensure safety and continued MAAB compliance.
- ii. Implement a program of replacing damaged or worn pavement throughout the site.

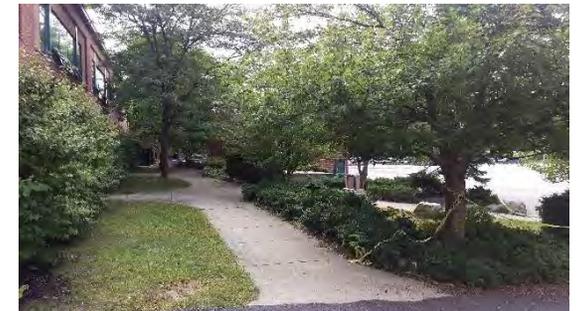
WPS E5

- i. i. The condition of the bituminous and Portland cement concrete pavement throughout the site ranges from fair to good.

- i. i. Implement a program of replacing damaged or worn pavement throughout the site.

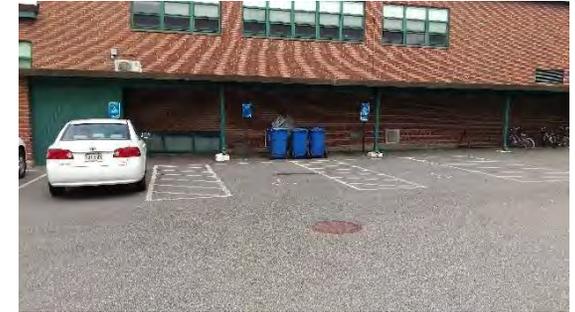
WPS E6

- i. All three (3) parking spaces, signage, access aisles and the accessible route from the faculty lot appear to comply with current MAAB standards.
- ii. On the north side of the school exists a compliant accessible ramp that is in good condition.
- iii. There is a compliant accessible route into the building from the free play area as well.

- i. Maintain condition of accessible parking areas to ensure safety and continued MAAB compliance.
- ii. Maintain condition of accessible pedestrian routes to ensure safety and continued MAAB compliance.

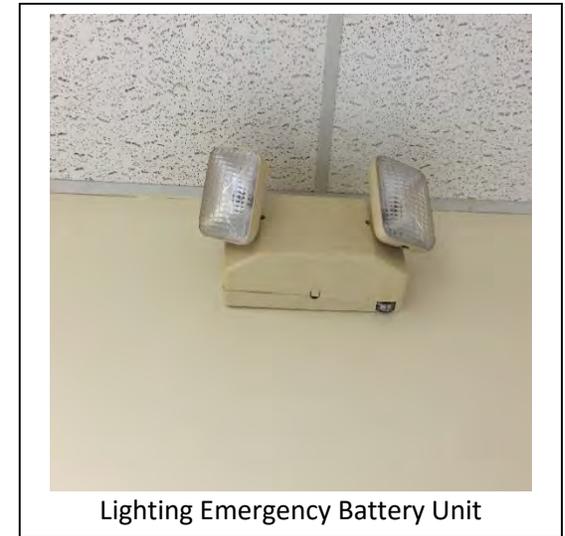
- iv. Emergency lighting is from battery pack units.

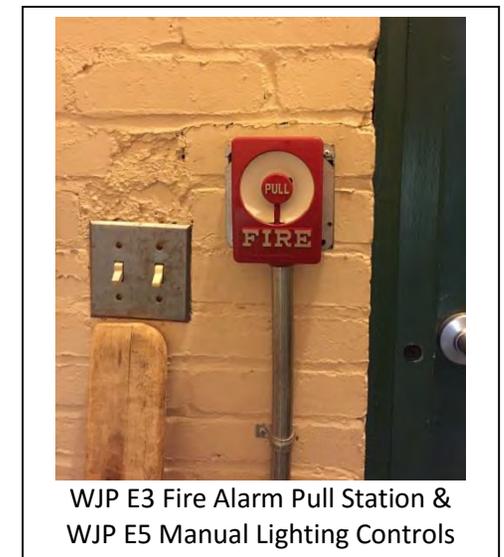
- v. Fire alarm is a Gamewell addressable system
